PNW-1

A CASE HISTORY OF A MUD AND ROCK SLIDE

ON AN EXPERIMENTAL WATERSHED

R. L. Fredriksen

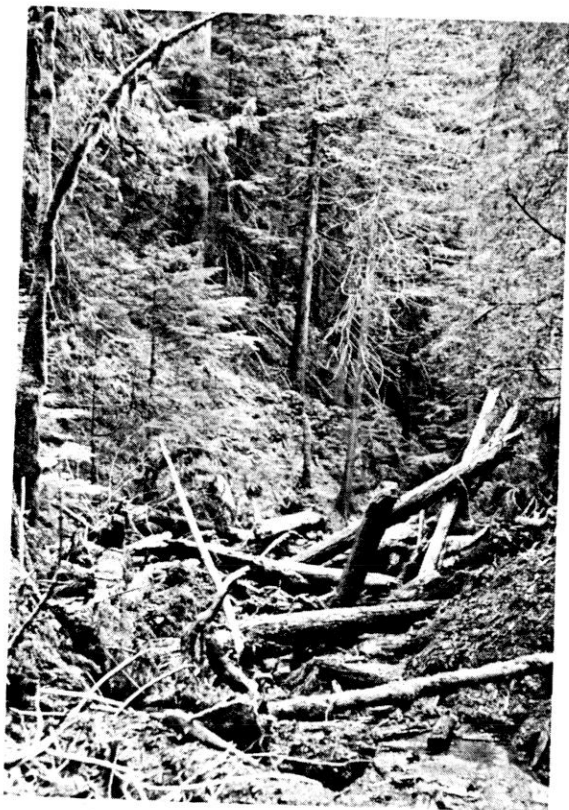
Figure 1.--Debris dam left in the stream channel by the slide.

created a short-lived dam which, when breached, triggered a massive flow of mud, rock, and logs. More debris was picked up as the flow moved down the channel, plucking whole down trees from the side slopes of the drainage. For almost 3,000 feet, the channel was scoured to bedrock leaving behind isolated gravel deposits, small log jams, and two large debris dams (figs. 1 and 2). About 1 acre of mineral soil was exposed along the margin of the stream channel.

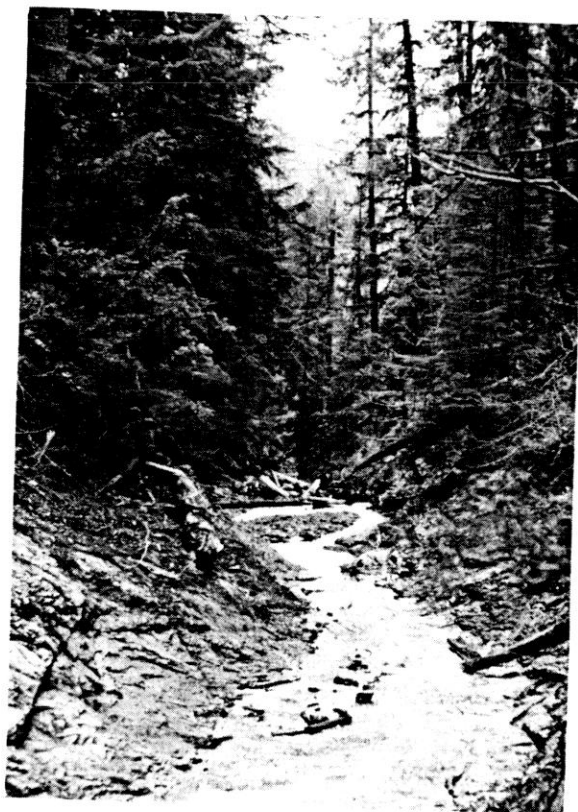
Figure 2.--Stream channel scoured to bedrock by the slide (looking downstream).

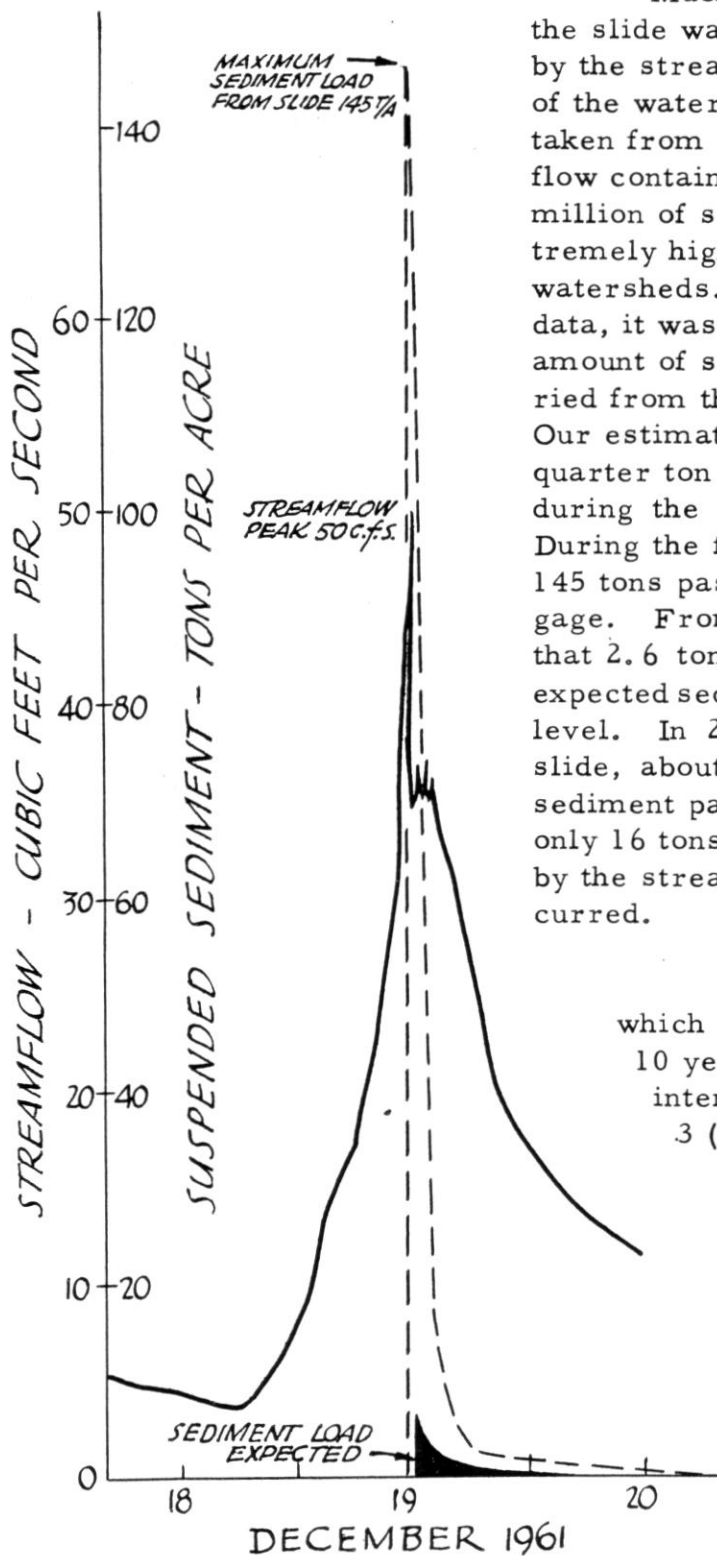
The accompanying chart traces some of the events occurring during the storm. As a result of rain on snow, streamflow rose rapidly to about 37 cubic feet per second (c.f.s.). At this stage, a surge of water, carrying silt, sand, and gravel, passed through the gage where streamflow is measured. The stream reached a peak discharge of over 50 c.f.s. and then settled down to some minor fluctuations, probably associated with the shifting and settling of the debris dams.
