A REPORT ON THE MASS WASTING (LANDSLIDE)
HAZARDS IN THE URBAN AND
URBANIZING AREAS OF
THE CITY AND BOROUGH OF JUNEAU, ALASKA

GEOPHYSICAL HAZARD INVESTIGATION
Juneau, Alaska

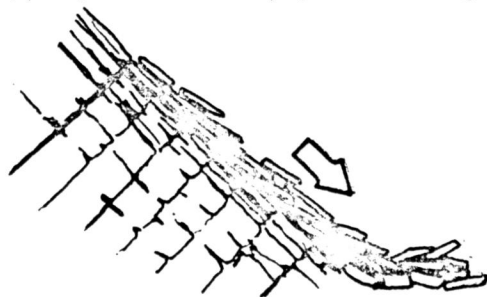
FIGURE 1

Fragments of slate and phyllite, which dominate the colluvial soil matrix, are characteristically hard, platy and high in mica content. When accumulated on the slope, they tend to orient parallel to the slope in a shingled fashion (overlapping) (Figure 1) producing small, discrete failure planes where fragments overlap. These planes are low in frictional resistance due to the smooth surfaces and the occasional lubricating effect of the mica weathering to clay, thus greatly decreasing overall stability of the colluvial soil.

--Diagrammatic cross-section of a slope showing the shingling effect of overlapping slate and phyllite fragments.

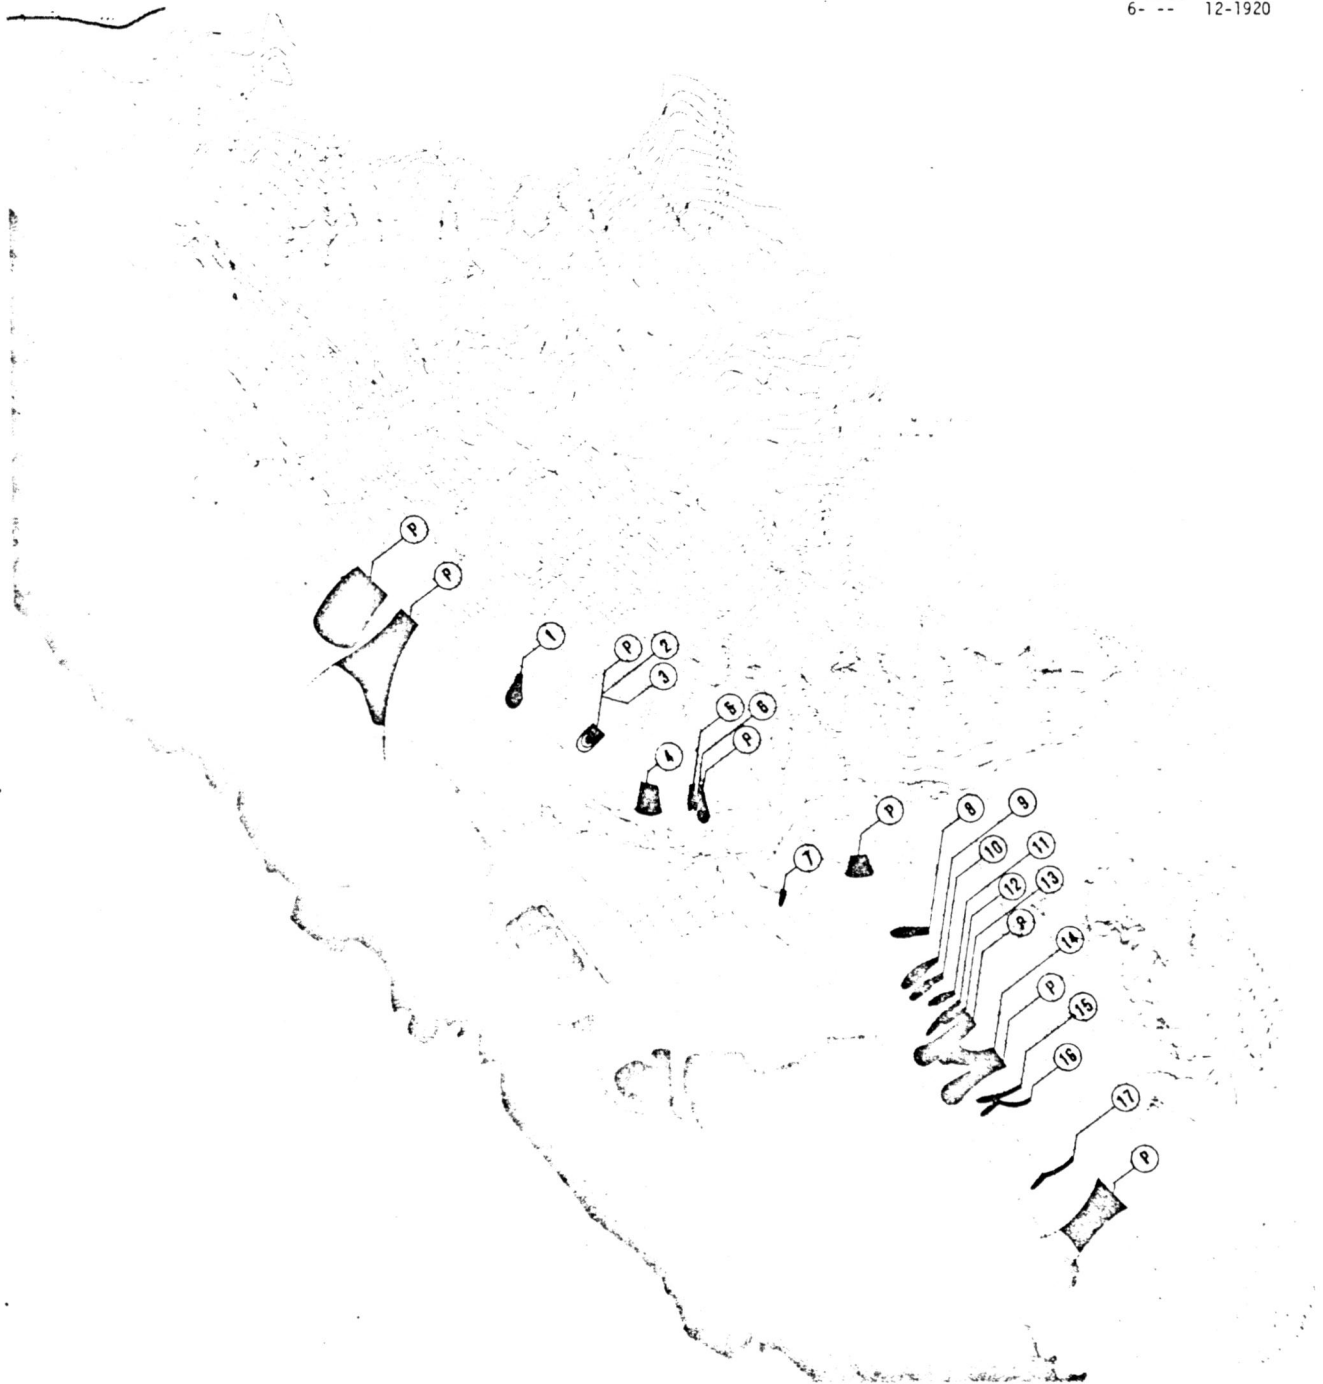
FIGURE

All are indicators of active or dormant instability and of potential landslide recurrence. As a result, each of the landslide tracks have been carefully mapped, their probable points of origin indicated and the entire slope assessed in terms of immediate or potential hazard. The results of this investigation are shown in Figures 5, 6 and 7. Pre-settlement landslides and post-settlement landslides are shown in Figure 5.

HISTORIC LANDSLIDE DEPOSITS

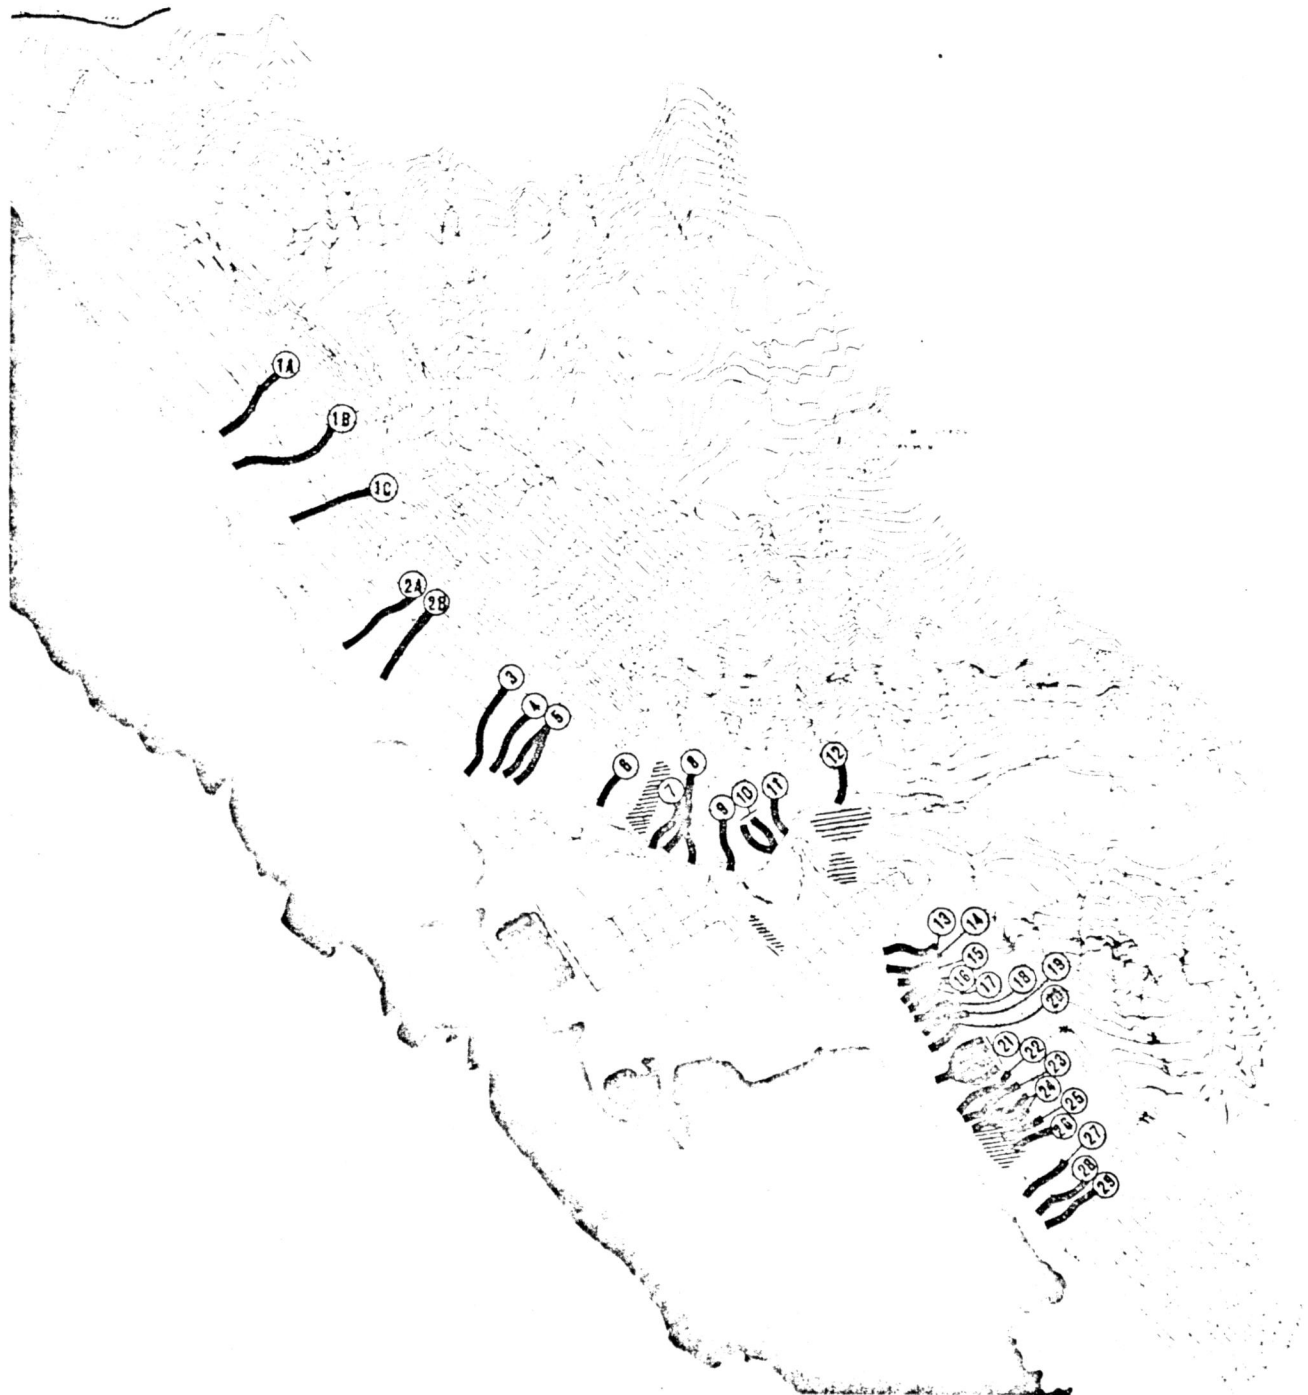
MASS WASTING CHANNELS AND ROCK SLIDE AREAS

Broad areas of high and potential hazard from landslide damage are shown in Figure 6. Specific gullies and channels with a known or indicated history of past debris avalanche and debris flow activity are mapped in Figure 7.

Gullies with a high hazard rating exhibit substantial accumulations of organic debris, rocks and soil in their channels and have had a past history of debris avalanche-debris flow activity. These are mapped in Figure 7. Those with a potential rating do not exhibit substantial accumulations of debris, but extend to the upper slope and exhibit some evidence of past debris avalanche-debris flow activity. Table 1 summarizes the major historical landslides in the Juneau area with dates of occurrence, approximate location, associated 24-hour rainfall and damage.
