Experimental and field observations of breach dynamics accompanying erosion of Marmot cofferdam, Sandy River, Oregon

WORLD ENVIRONMENTAL AND WATER RESOURCES CONGRESS 2008

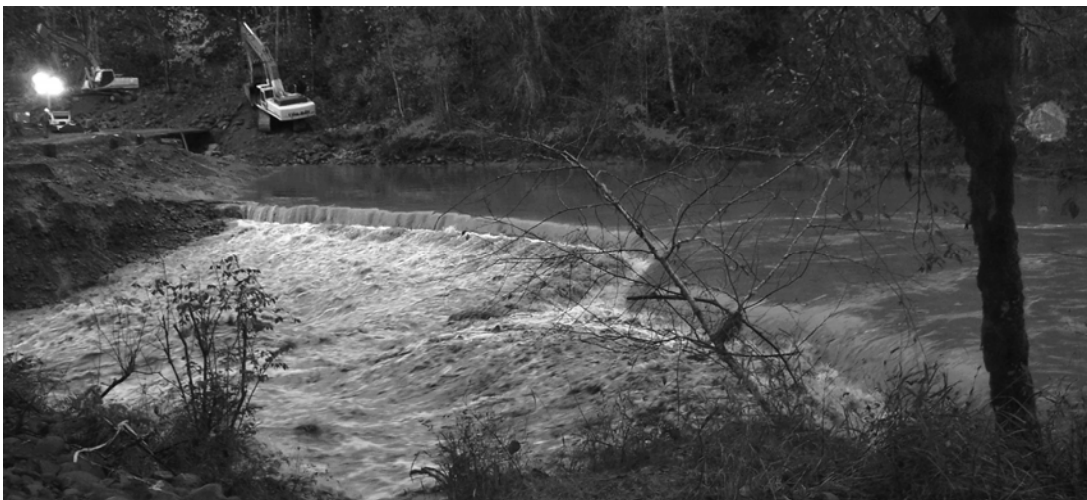
Figure 2. Knickpoint migration after cofferdam notch. The lateral (river right) and longitudinal (river left) arcuate knickpoints have migrated several meters from the cofferdam notch (located just out of the picture on the left). *photo credit: J. Rose Wallick*

fans at the base of the dam. The initial notched channel did not appear to carry much sediment and was quite small, so the forklift operator continued to work to enlarge and deepen the channel. By 5:15 pm, the volume of flow in the notch channel had increased noticeably, and the channel began to incise up the face of the dam, with rapidly increasing volume and incision of several meters. By 5:20 pm, the notch was 3-4 m wide and 1-2 m deep; no knickpoint was observed at the dam crest. Within several minutes, flow became increasingly violent, with large steps (2-3 m) and hydraulic jumps forming along the channel down the dam face; these migrated upstream at rates of meters per minute. Bank material began to calve off, and areas of the dam appeared to be liquefying as they sloughed into the channel. By 5:45 pm a knickpoint had formed at the notch location, and migrated approximately 2-3 m upstream of the cofferdam crest; this knickpoint immediately separated into two arcuate knicks, with the arch pointing upstream (Figure 2).

This double knickpoint began migrating upstream very rapidly (meters per minute), with river right knick moving laterally towards north shore, and the river left (RL) knick moving longitudinally upstream. The lateral knick quickly stalled because the longitudinal knick incised more rapidly, thereby starving the lateral knick of flow. As the longitudinal knick moved upstream, it established a straight thalweg along the south bank. Darkness fell at around 6:30 pm, limiting further observations. By the following morning (approximately 10 am), the entire cofferdam had been eroded, as had much of the sediment in first 0.5 km above the dam. The knickpoint had eroded backward to a location over 400 meters above the former dam site (Figure 3). The rate of retreat was extremely rapid, averaging 3 meters per min of retreat during the first hour following knickpoint formation.

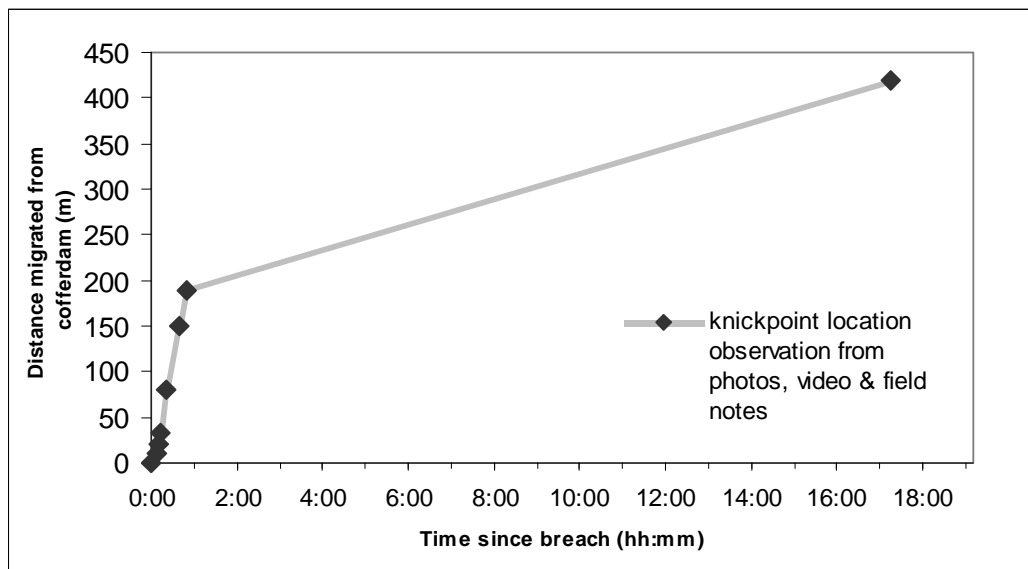
Figure 3. Preliminary observations of knickpoint migration upstream of cofferdam on October 19 and 20, 2007.
