Stephanie Rae Bianco for the degree of Master of Science in Water Resources Engineering presented on May 30, 2018.

Title: A Novel Approach to Process-based River Restoration in Oregon: Practitioners' Perspectives, and Effects on In-stream Wood

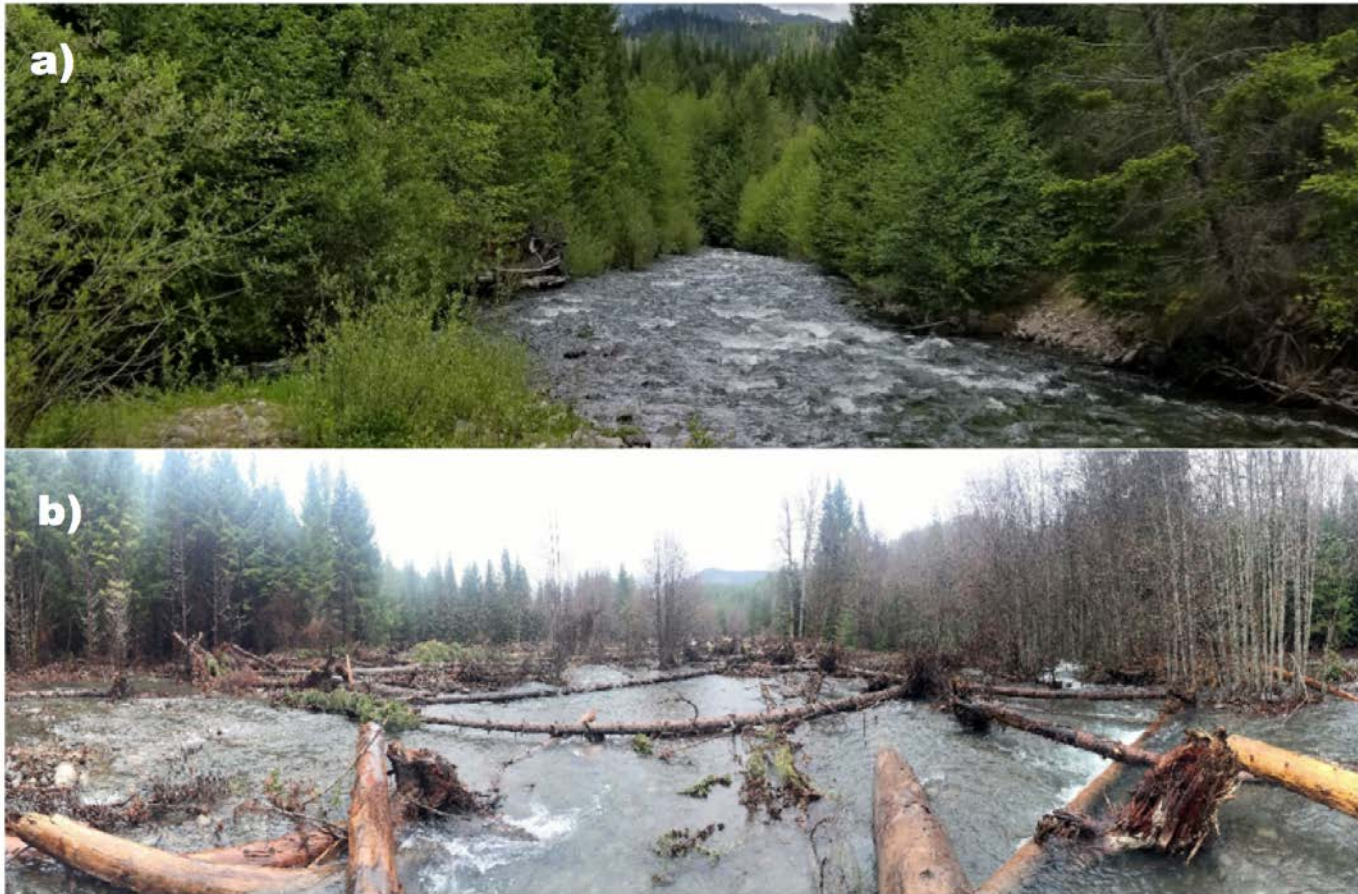
Figure 2.2: Stage 0 restoration project on Lower Staley Creek (a) before restoration in Summer 2017, and (b) a few months after restoration in Fall 2017. Photos courtesy of Matt Helstab (USFS) and Johan Hogervorst (USFS), used with permission.

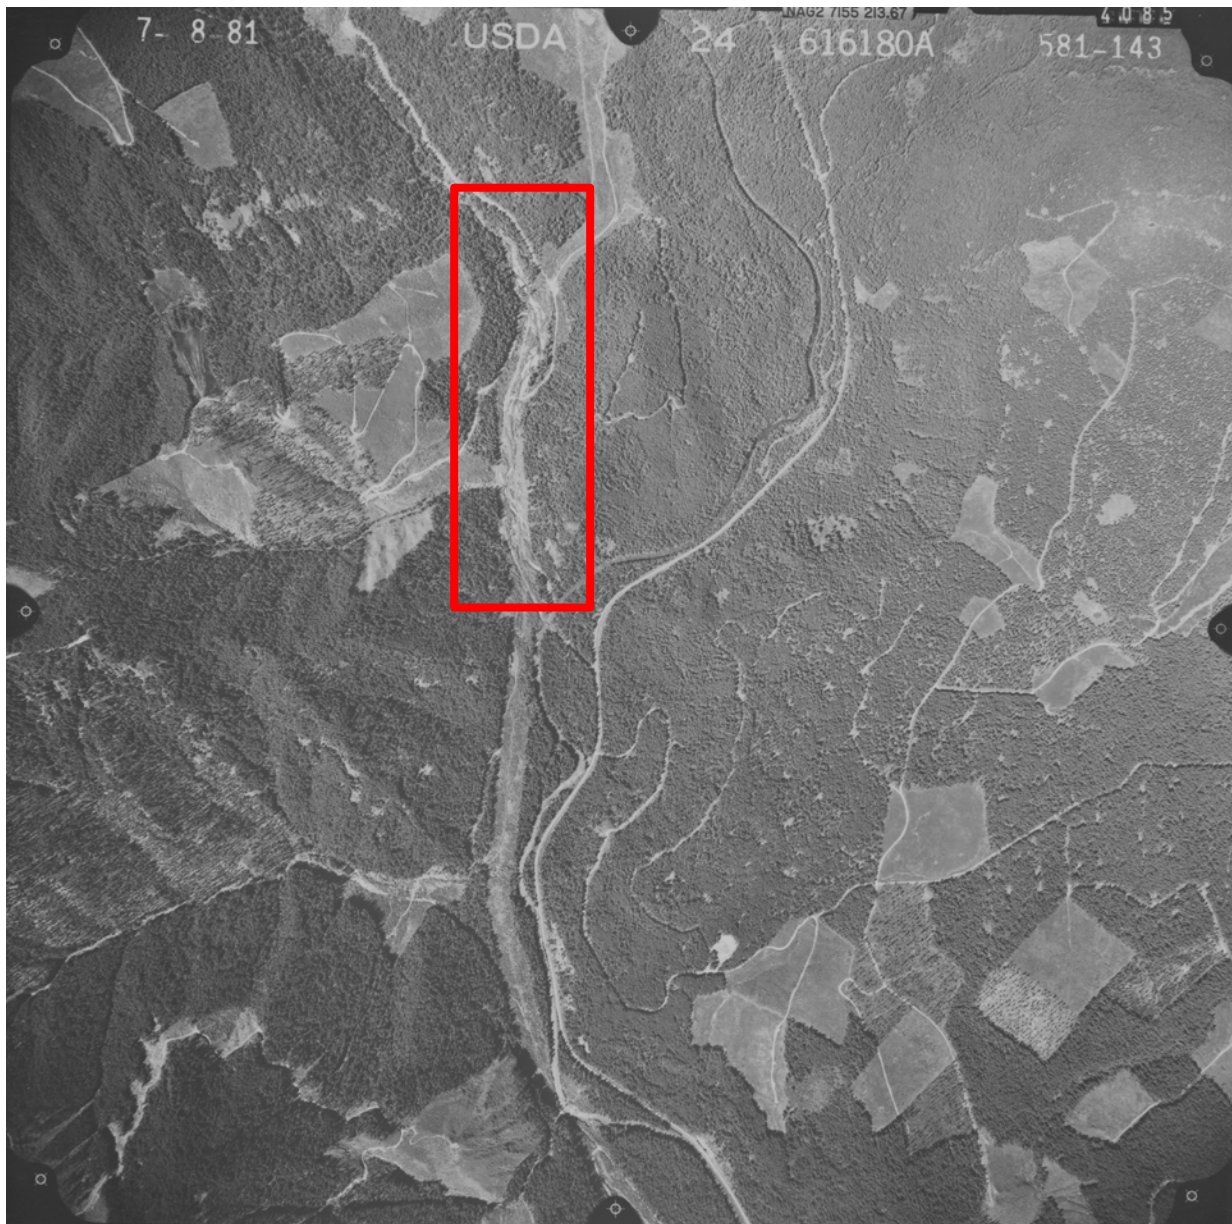
Figure 3.2: Historic aerial photograph of the Upper McKenzie River, July 1981. McKenzie River runs N-S along Highway 126. Red rectangle shows the approximate area of the Stage 0 restoration project on lower Deer Creek. Note the vegetation cleared along the transmission line extending from the top center to the bottom center of the image. Obtained from the University of Oregon Map Library.

The Eugene Water & Electric Board (EWEB) operates a transmission line that runs within 50 m of the active channel of lower Deer Creek for 1,390 m (450 m of which are in the active channel itself) in the area where the Stage 0 restoration project was completed. The construction of the transmission line in 1960 required the clearcutting of vegetation within and adjacent to the corridor (Figure 3.2), and maintenance of the corridor requires continued tree felling (Stillwater Sciences, 2006b). In the wake of the construction of the transmission line, the 1964 flood denuded the entire valley bottom of nearly all remaining standing vegetation (Figure 3.3). The wood that was delivered to the stream was salvaged by the USFS (USDA Forest Service, 2016). The largest flood of record in 1996 further reduced large wood in Deer Creek (Stillwater Sciences, 2006b). The riparian area of lower Deer Creek is currently comprised of red alder (*Alnus rubra*), bigleaf maple (*Acer macrophyllum*), and immature conifers, predominantly Douglas-fir (*Pseudotsuga menziesii*).

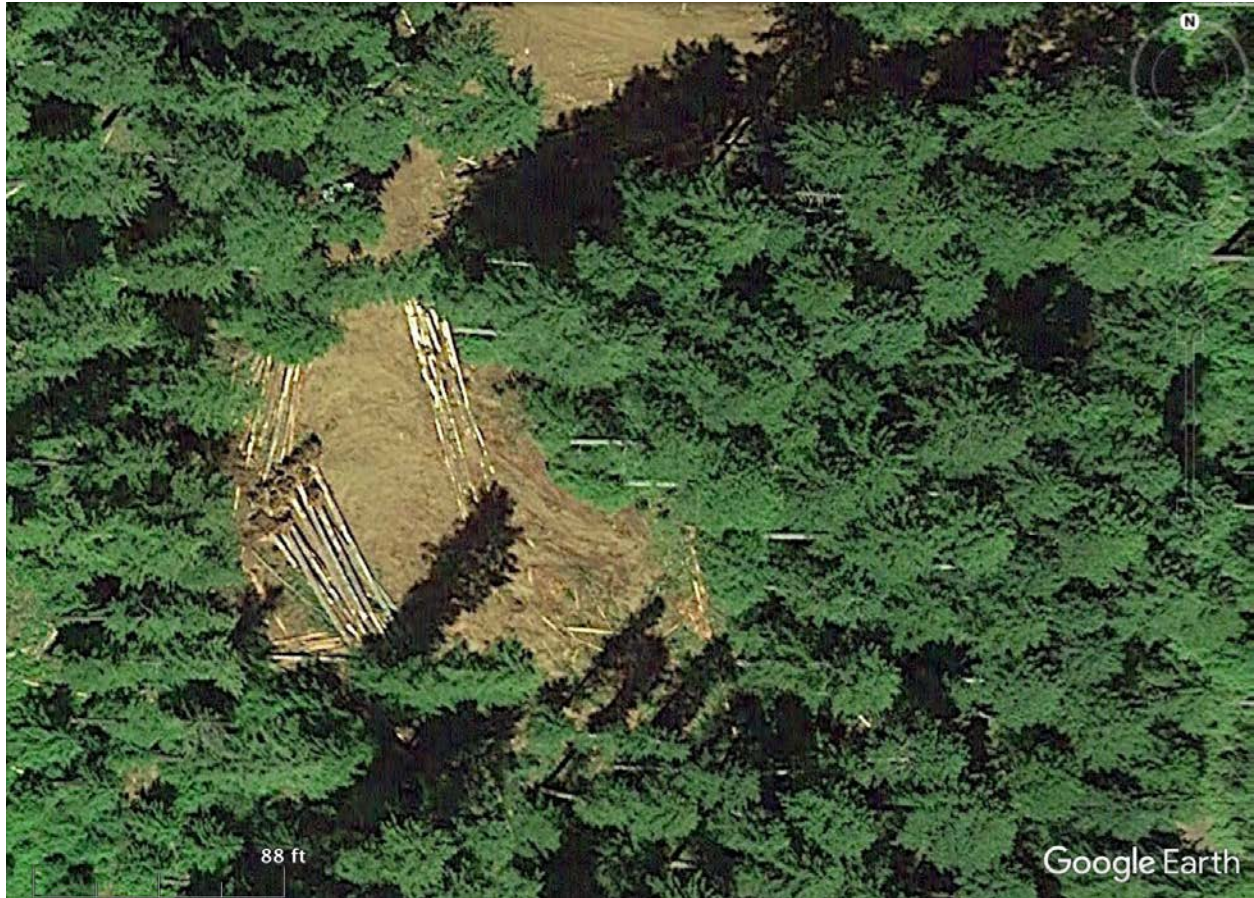
Figure 3.7: Upland stand gap for large wood procurement (~0.2-ha). Trees were broken in half, with the bottom ends pushed over to preserve rootwads (visible on some pieces). Pieces are stacked and ready for transportation down to the restoration site.

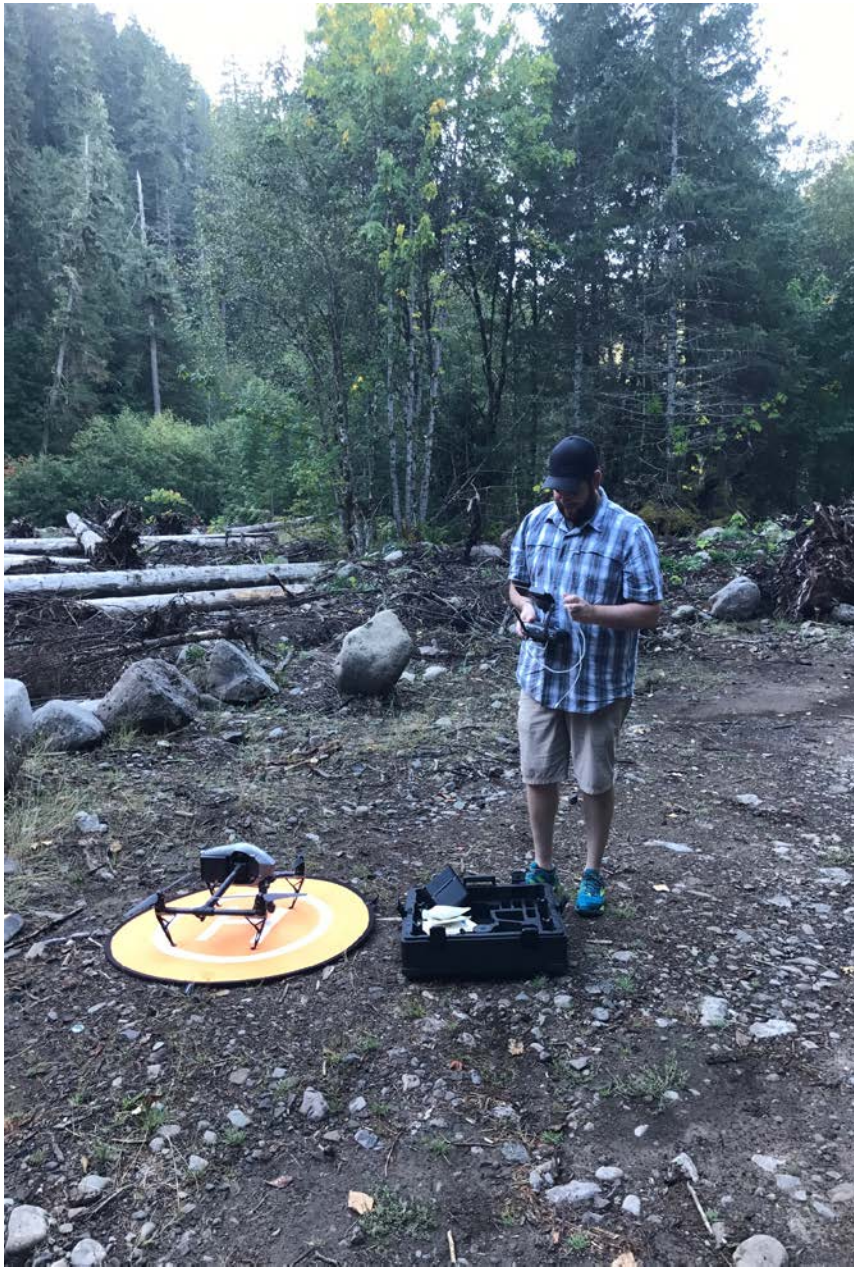
Figure 3.10: Jared Ritchey setting up the UAV to collect aerial imagery at Deer Creek on September 28th, 2017.

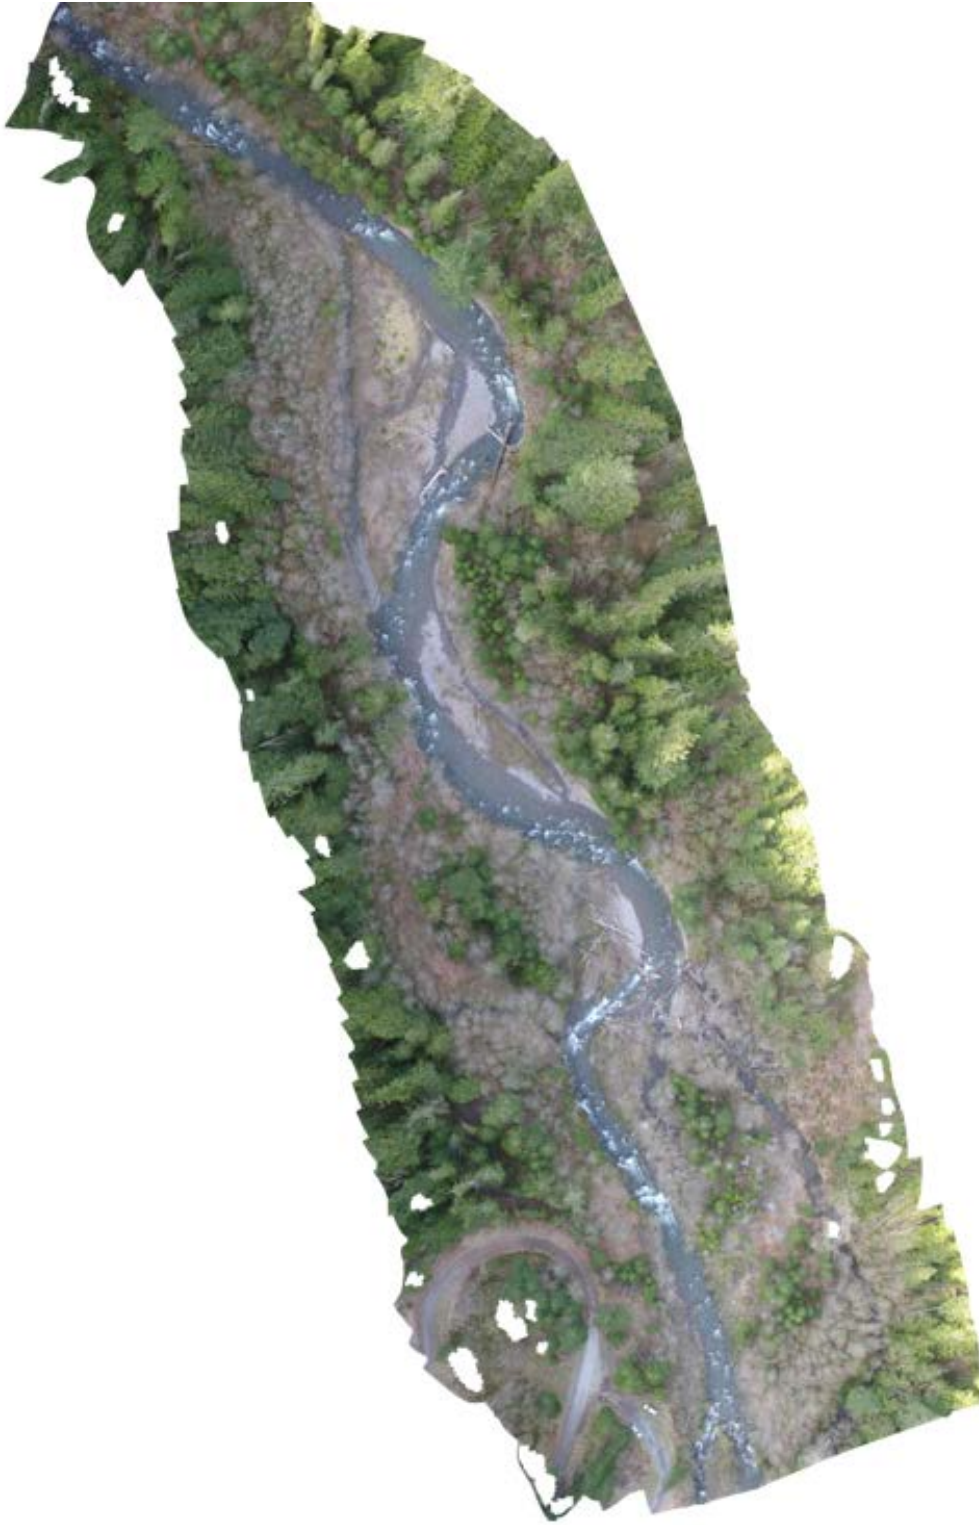
Figure 3.11: Orthomosaic of Deer Creek at Site 4 in April 2016, before Stage 0 restoration was completed. Created with 217 UAV-captured aerial images.

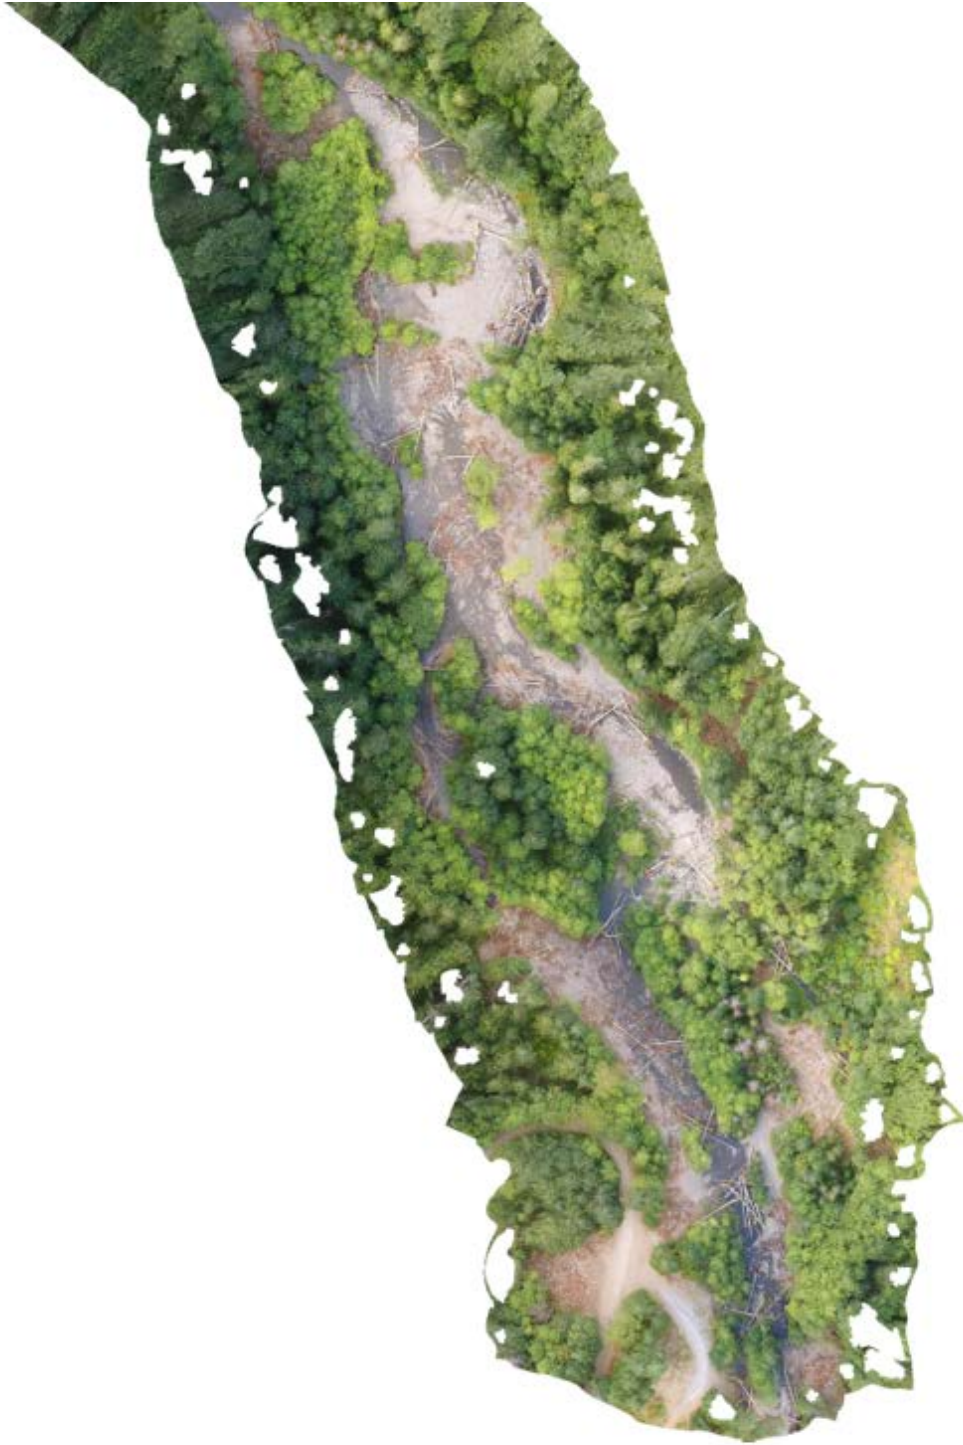
Figure 3.12: Orthomosaic of Deer Creek at Site 4 in September 2016, immediately after Stage 0 restoration was completed. Created with 237 UAV-captured aerial images.

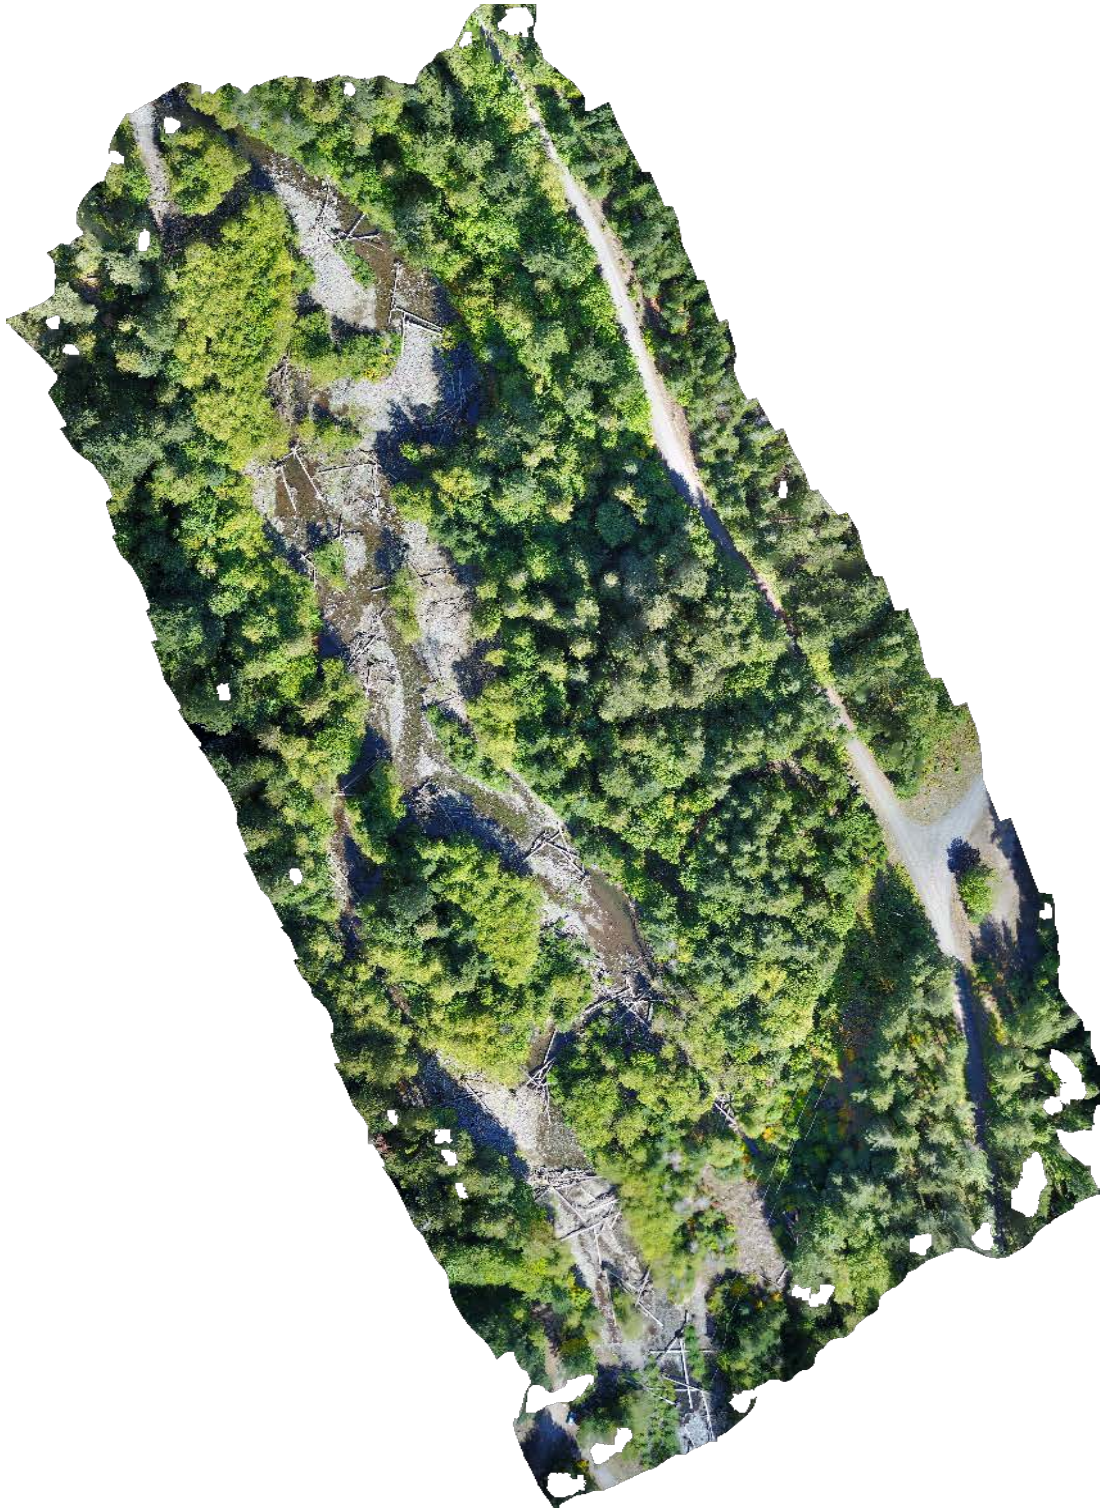
Figure 3.13: Orthomosaic of Deer Creek at Site 4 in September 2017, one year after Stage 0 restoration was completed. Created with 268 UAV-captured aerial images.

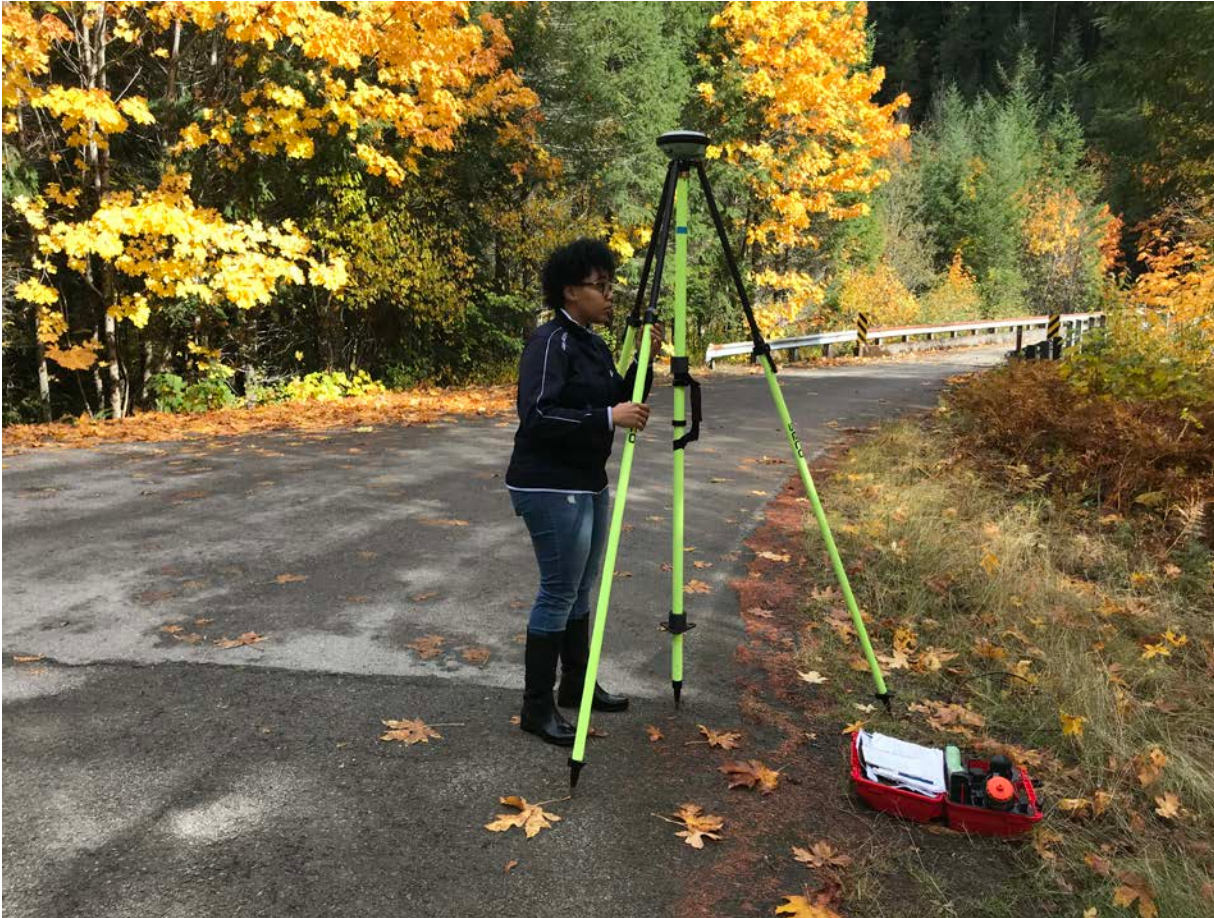
Figure 3.14: Fatima Taha setting up the Leica GS14 GNSS receiver at CP006 for collection of rapid static data on October 24th, 2017.

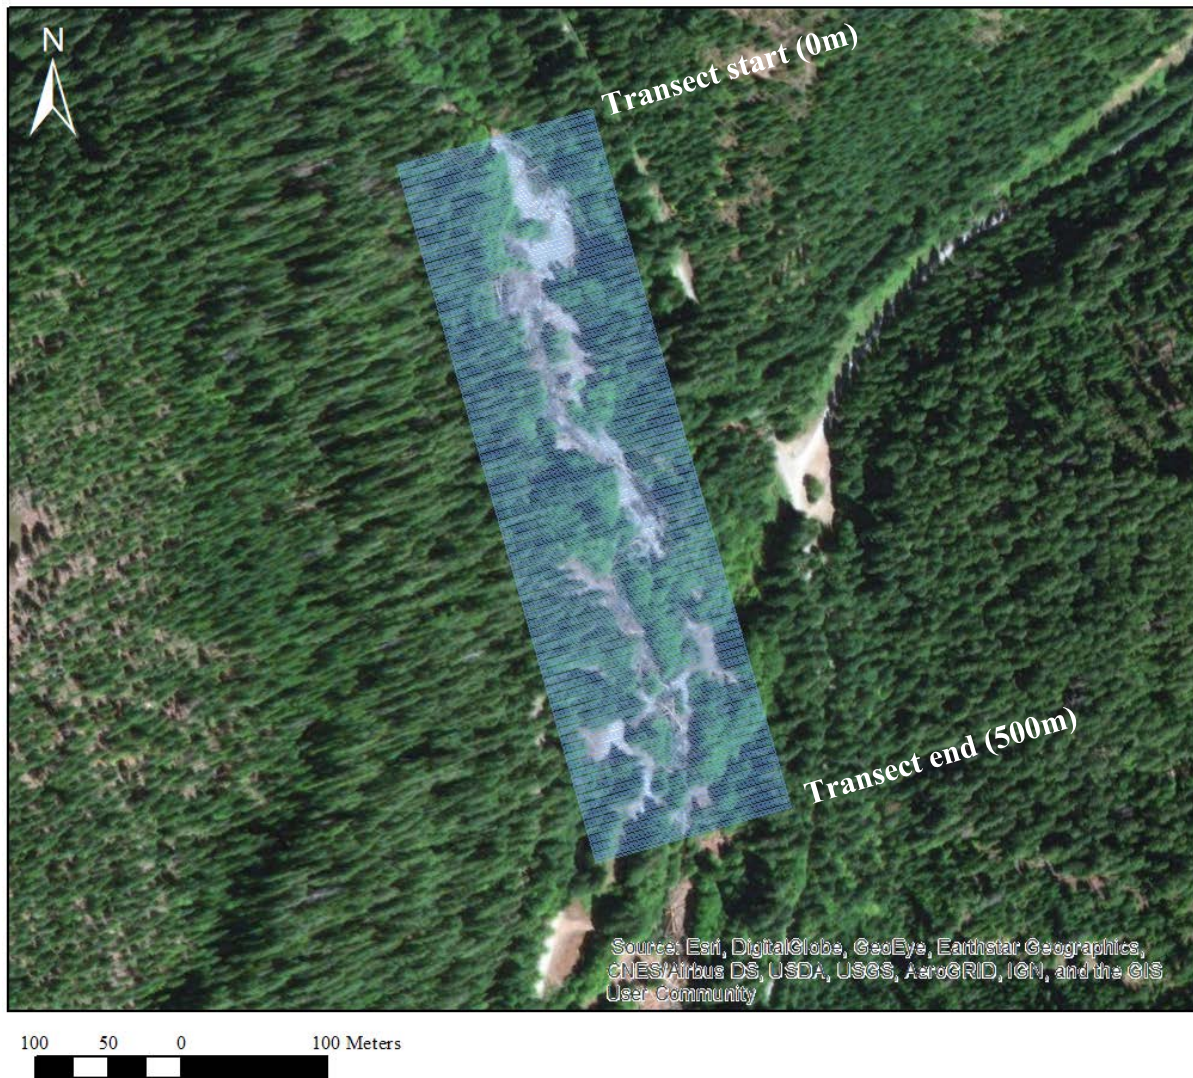
Figure 3.15: Transect for mapping wood in ArcMap. Total length 500 m, width 140 m, split into 1 m-tall polygons.

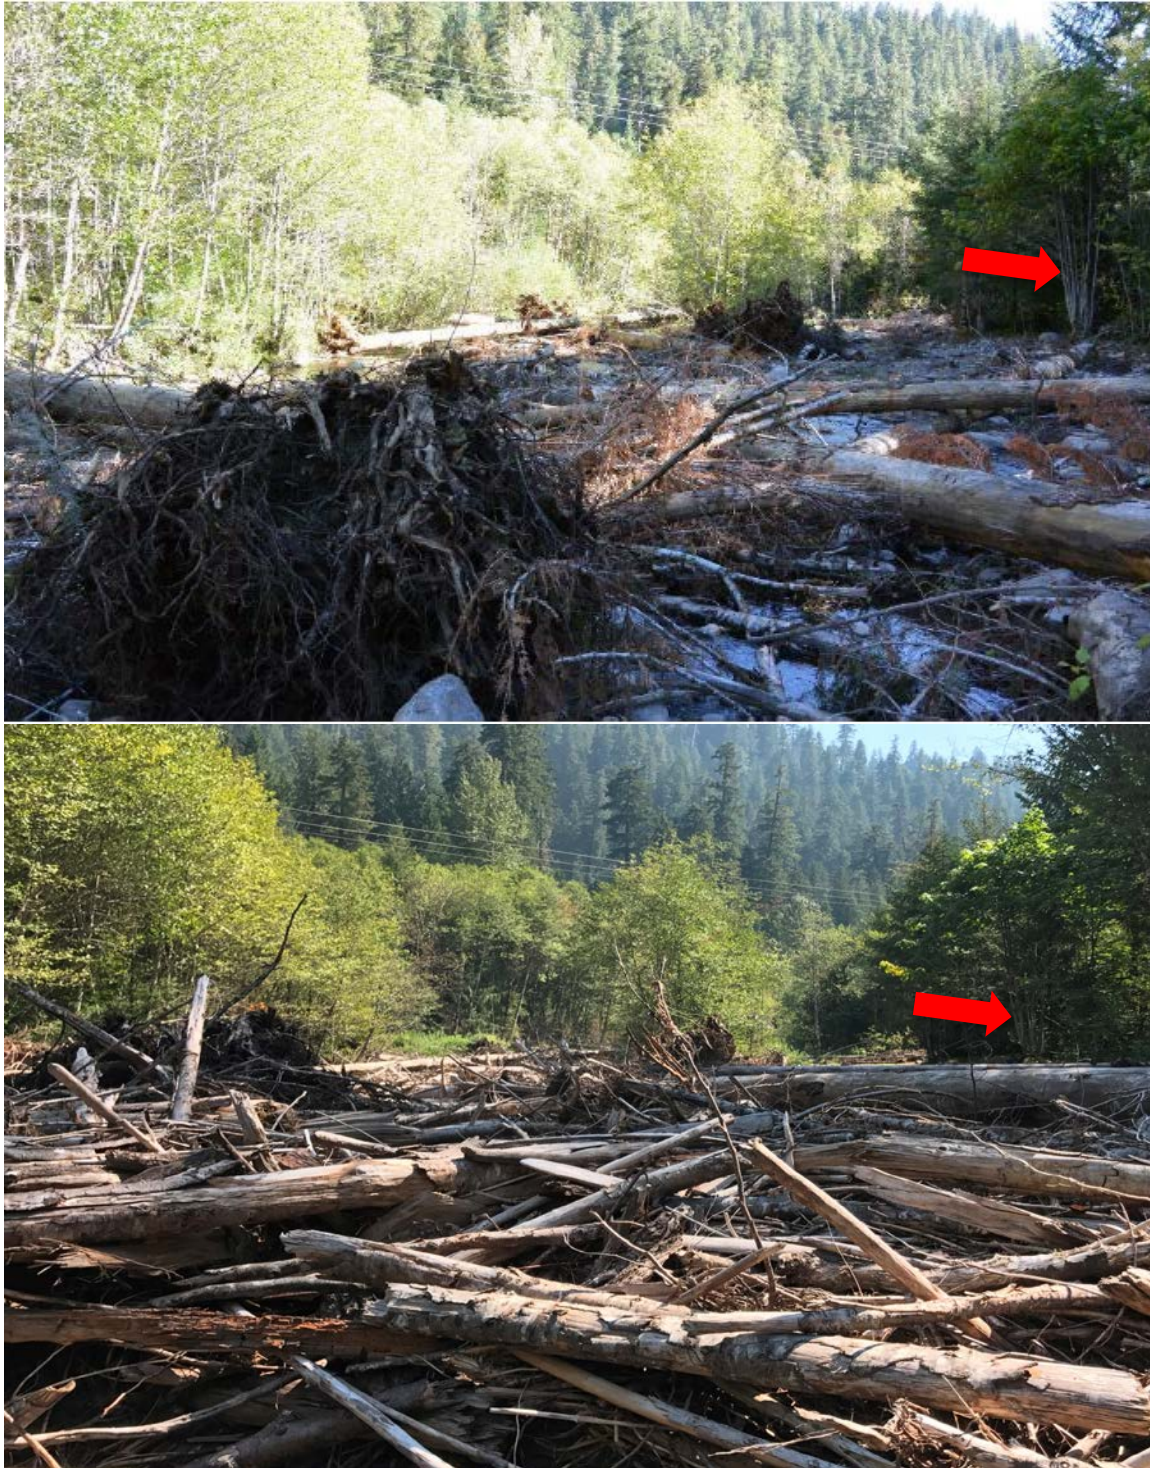
Figure 3.24: Georeferenced photopoint PP38D (facing downstream) on Sep. 2016 (top), and Aug. 2017 (bottom). Red arrow shows stationary clump of alders on shore. Wood accumulated in foreground.

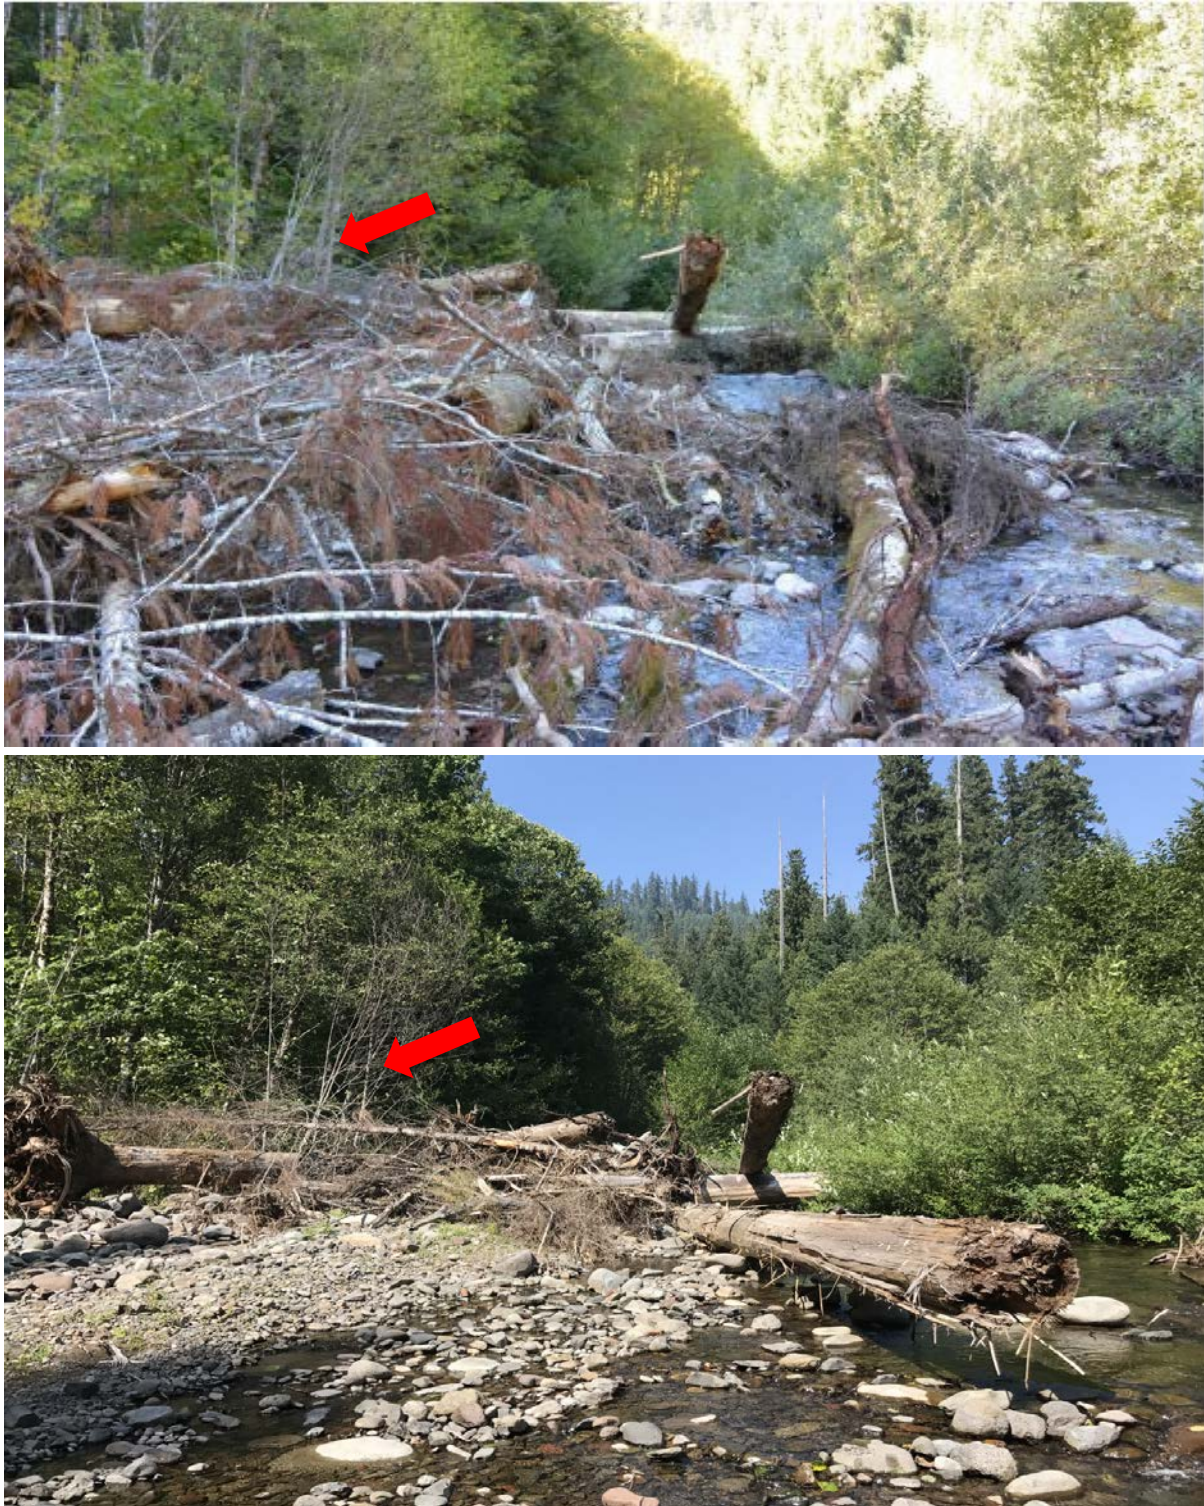
Figure 3.25: Georeferenced photopoint PP39U (facing upstream) on Sep. 2016 (immediately after restoration), and Aug. 2017 (one year after restoration). Red arrow shows stationary clump of alders on shore. Wood visible in foreground in Sep. 2016 is no longer visible in Aug. 2017.

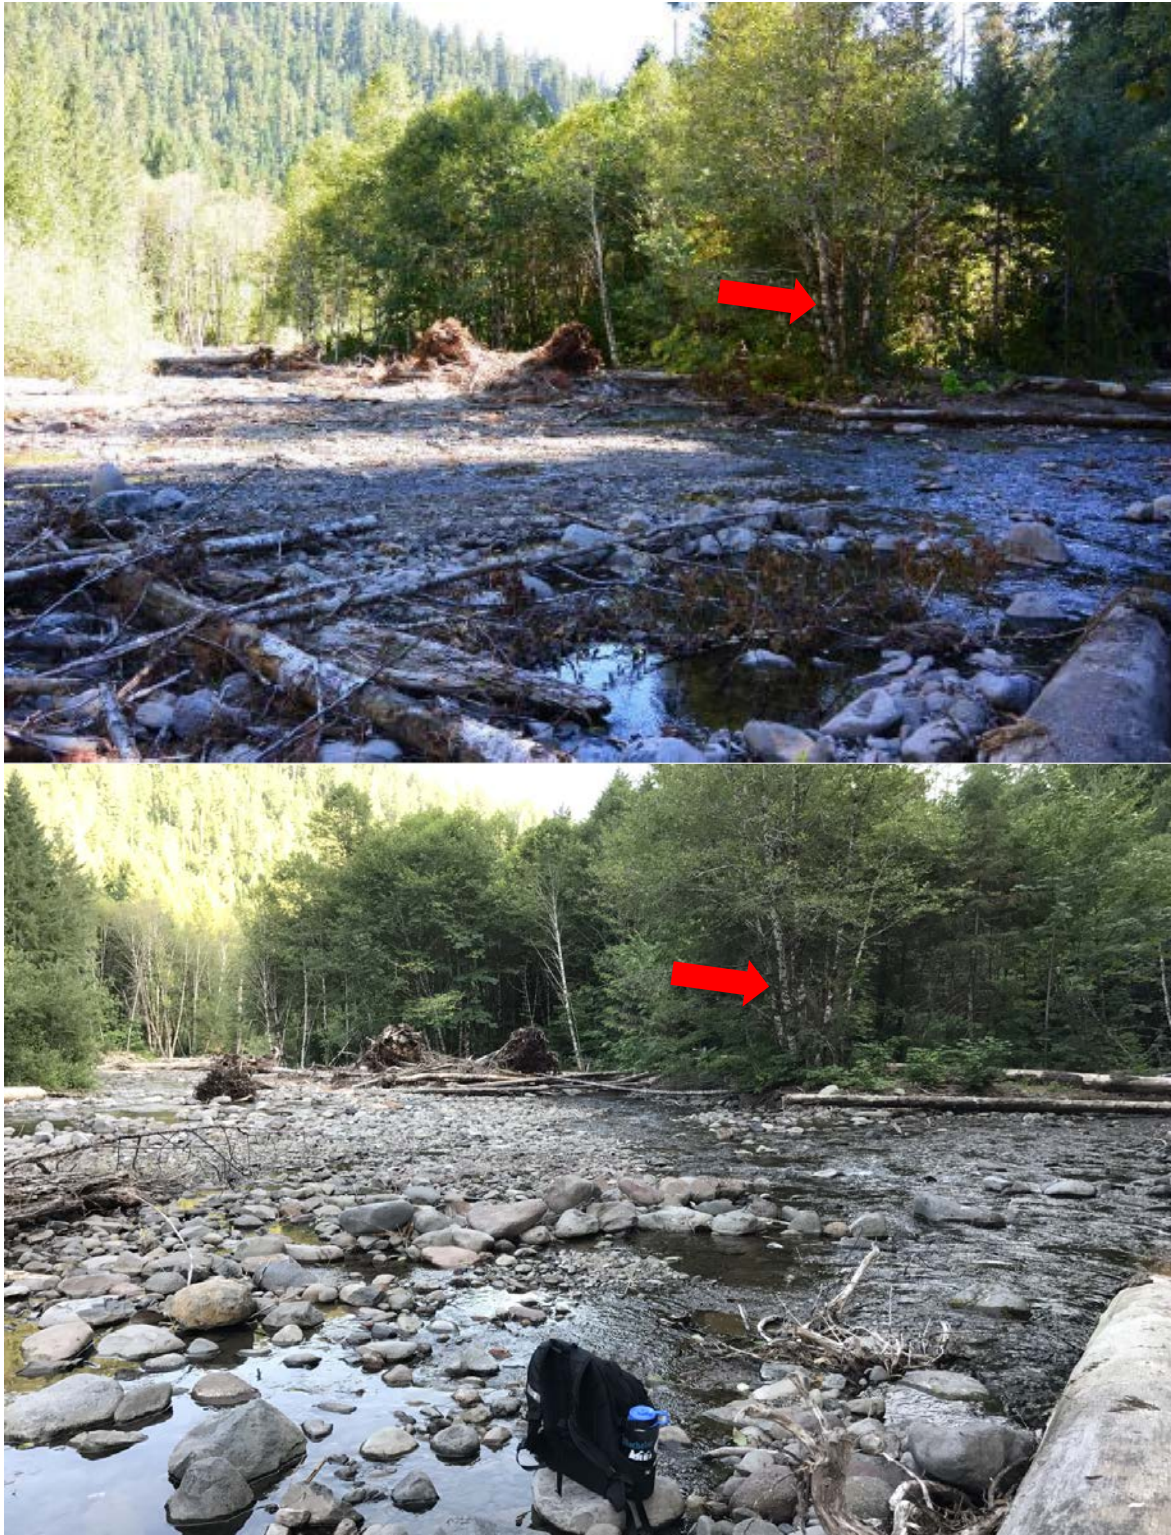
Figure 3.26: Georeferenced photopoint PP48D (facing downstream) on Sep. 2016 (top), and Aug. 2017 (bottom). Red arrow shows stationary clump of alders on shore. Small pieces of wood visible in foreground in Sep. 2016 are no longer visible in Aug. 2017.

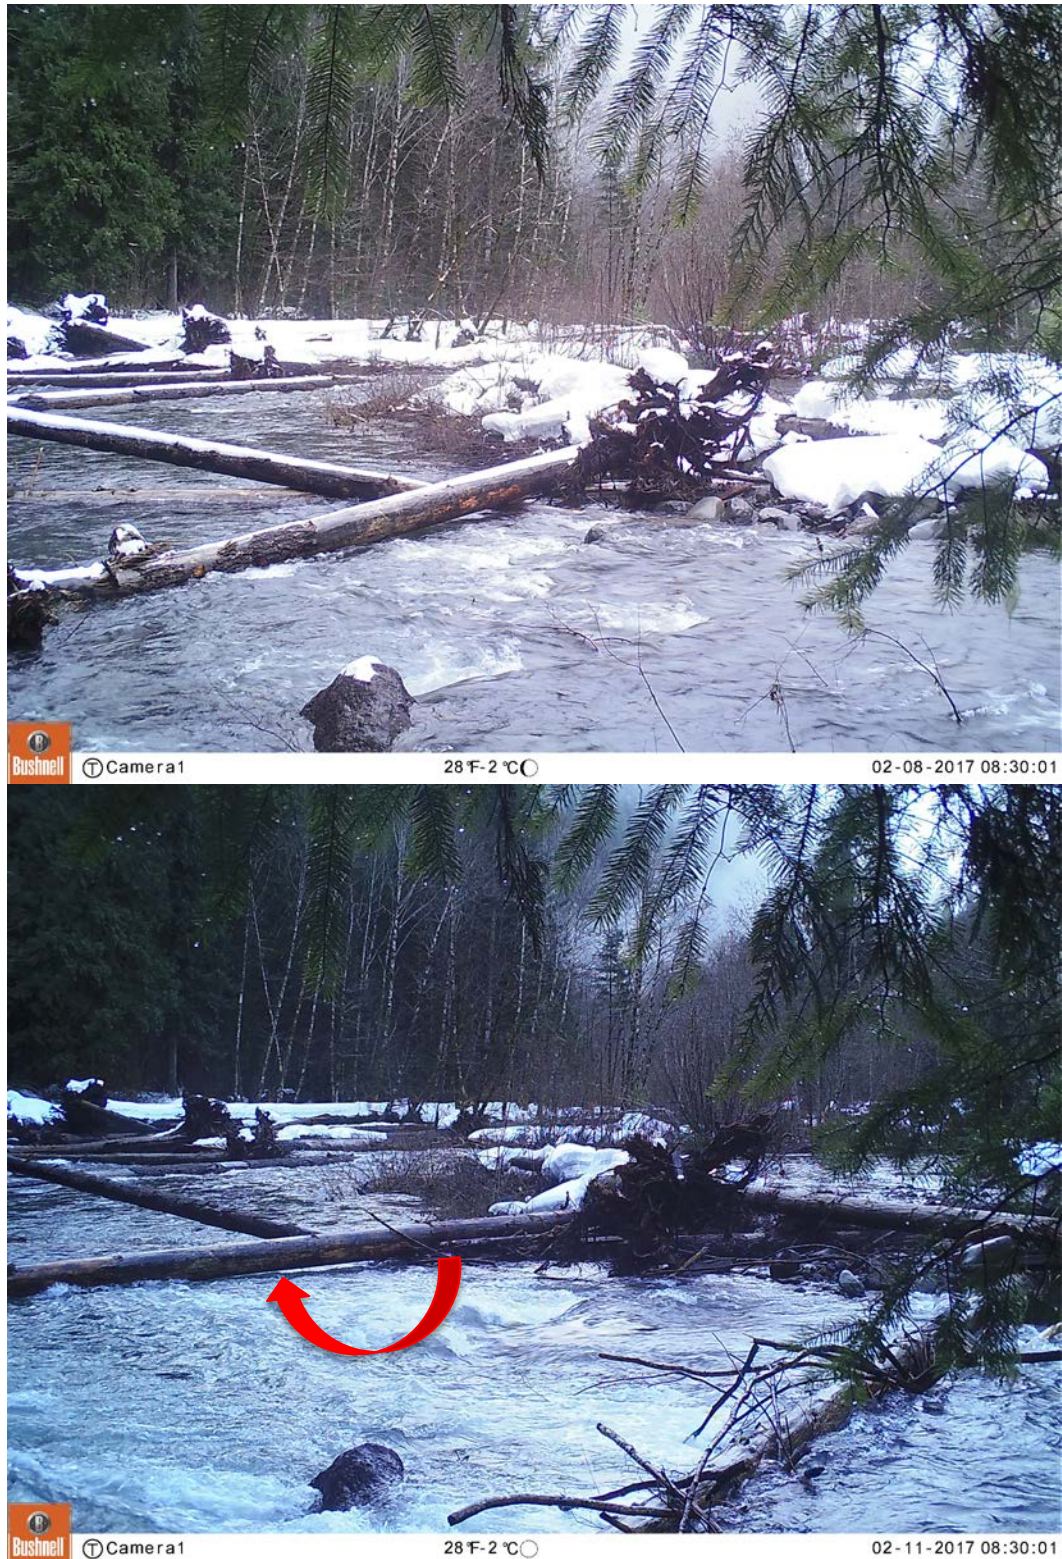
Figure 3.27: Timelapse images from Camera 1 on 2/8/17 and 2/11/17. The red arrow in the bottom panel shows the piece that rotated from high flows on 2/9/17. Note the increased distance between the log and the boulder in the foreground.

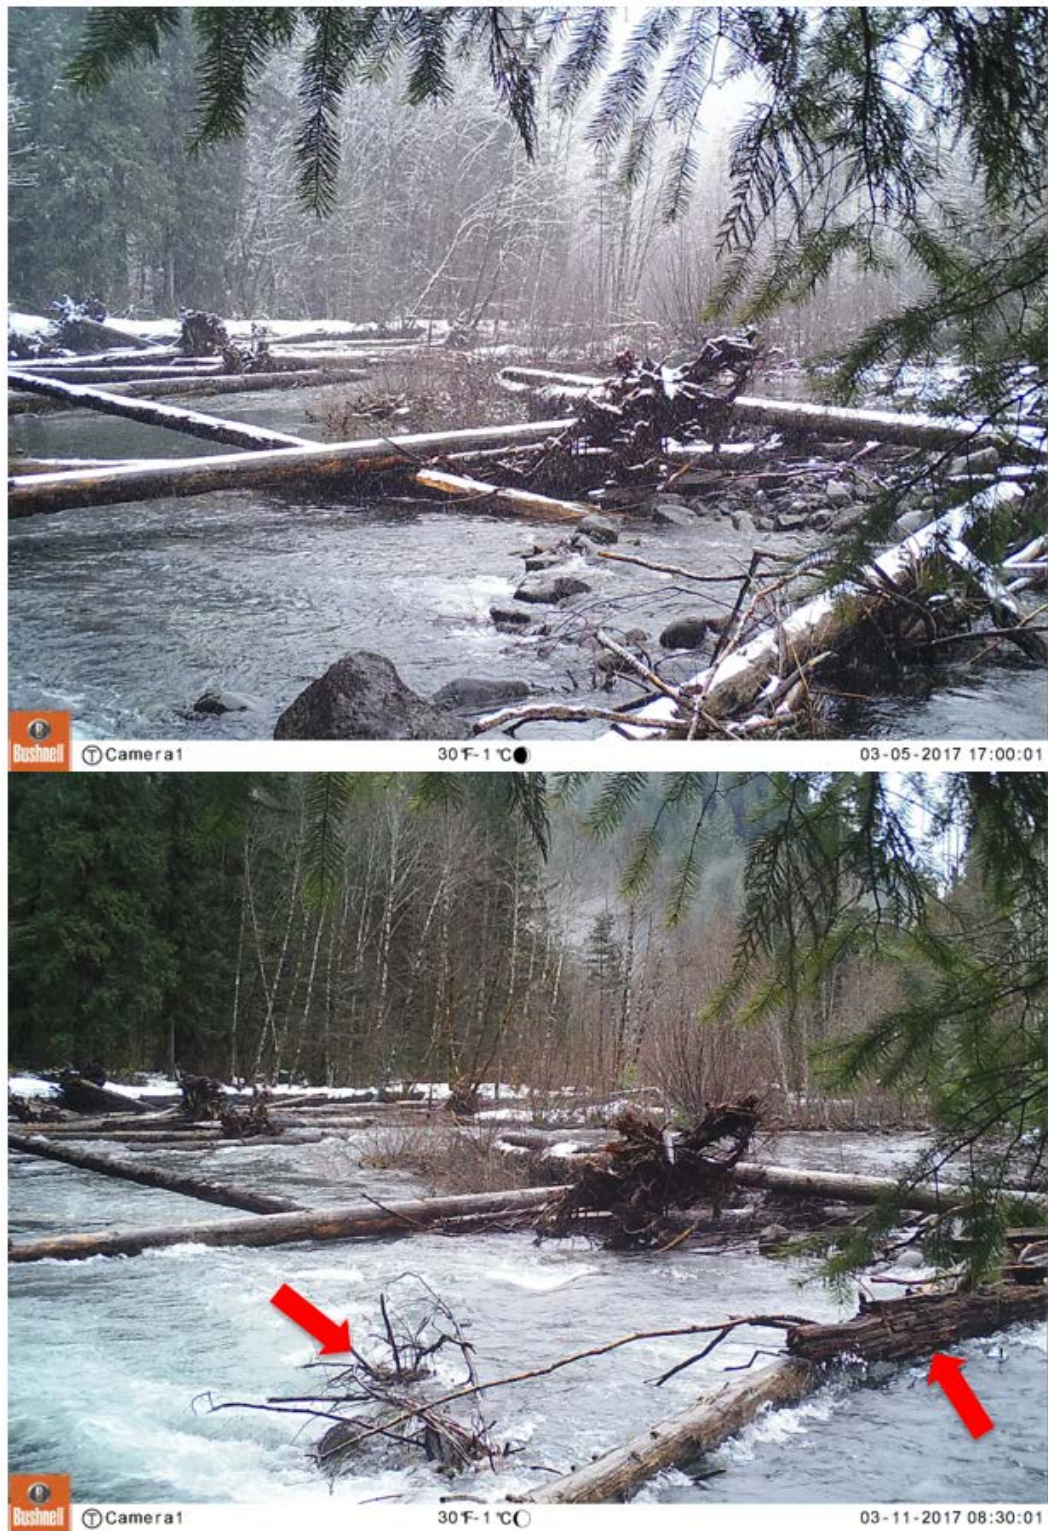
Figure 3.28: Timelapse images from Camera 1 on 3/5/17 and 3/11/17. Red arrows show wood that was deposited during the high flows on 3/9/17.
