**Stream Channel Response to Peak Flows in a Fifth-Order Mountain Watershed**

**A DISSERTATION**

**Oregon State University**

John M. Faustini for the degree of Doctor of Philosophy in Geology presented on April 27, 2000. Title: Stream Channel Response to Peak Flows in a Fifth-Order Mountain Watershed.

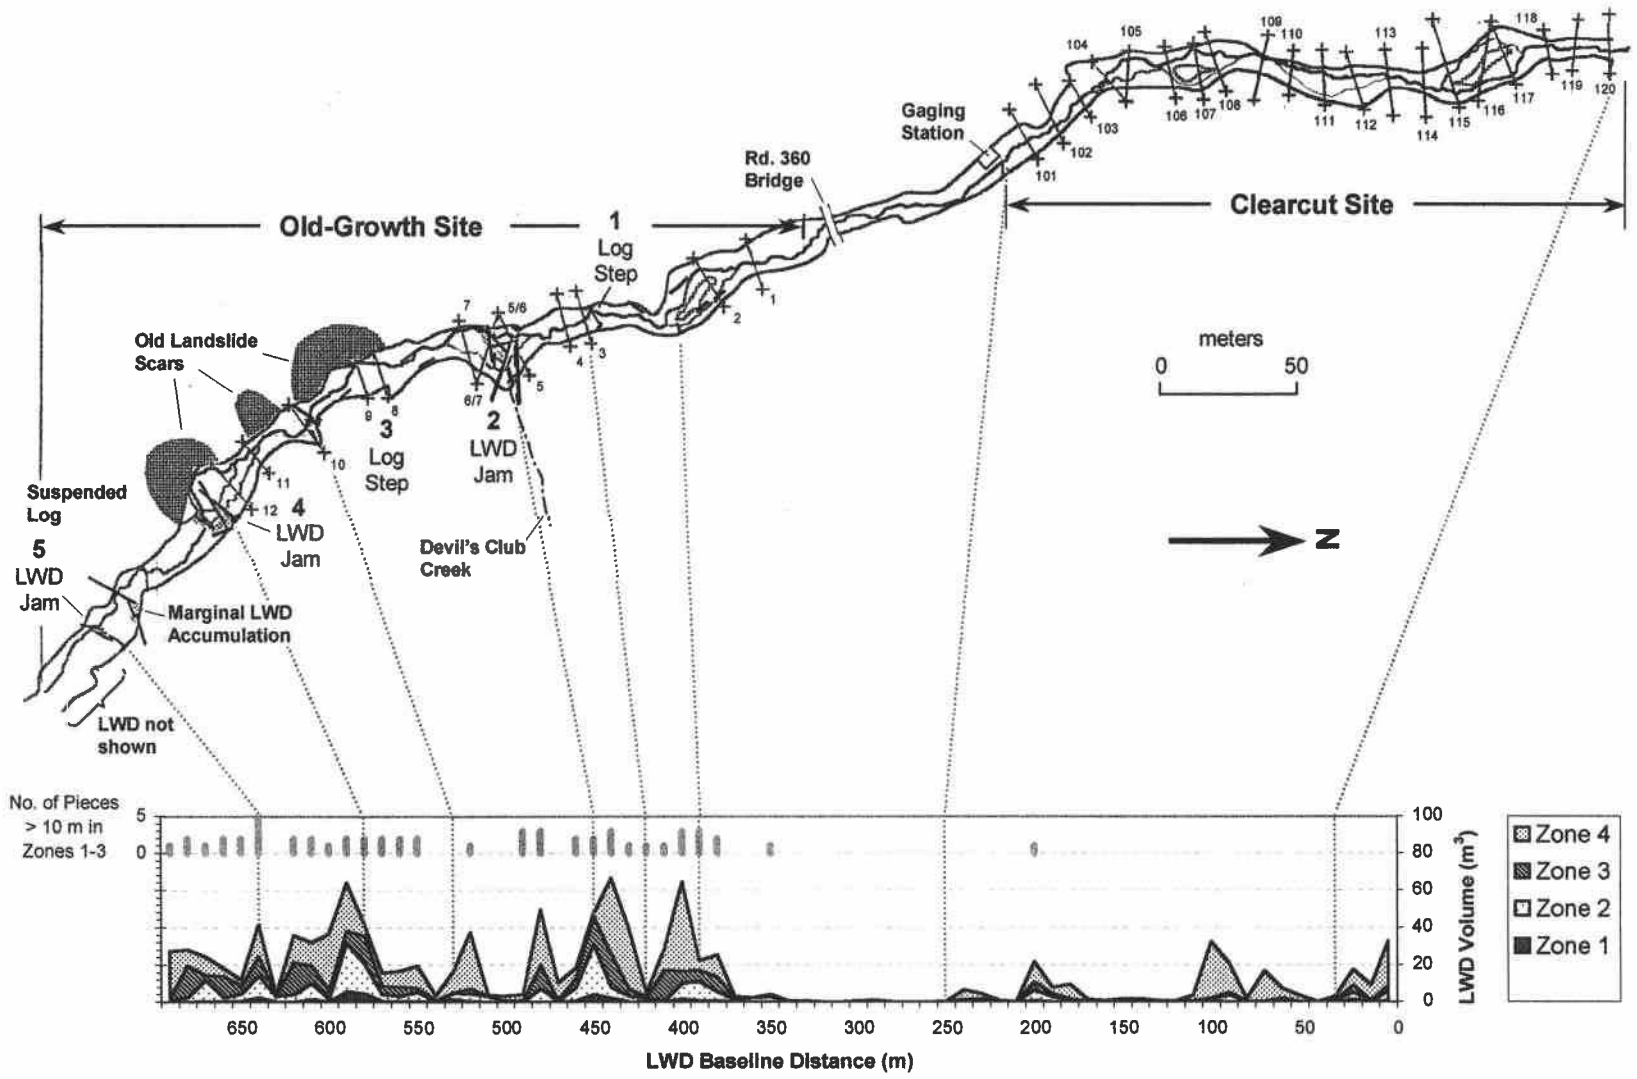
Figure 3.2. Map of Mack Creek old-growth and clearcut cross section sites showing LWD structures, cross section locations, and longitudinal distribution of LWD. Bars at top of lower plot show the number of pieces of LWD >10 m in length located at least partially within the channel, counted in 10-m channel segments. Bottom portion of lower plot shows the estimated volume LWD in 10-m channel segments within each of four zones relative to the channel: *zone 1*– within the low-flow channel; *zone 2*– within the bankfull active channel outside or suspended above the low-flow channel; *zone 3*– suspended above bankfull stage within the bankfull channel width; and *zone 4*– laterally outside the bankfull channel. LWD data from S. V. Gregory (unpublished data).

1. LWD is abundant in the old-growth reach and largely absent in the clearcut reach (Figure 3.2), and

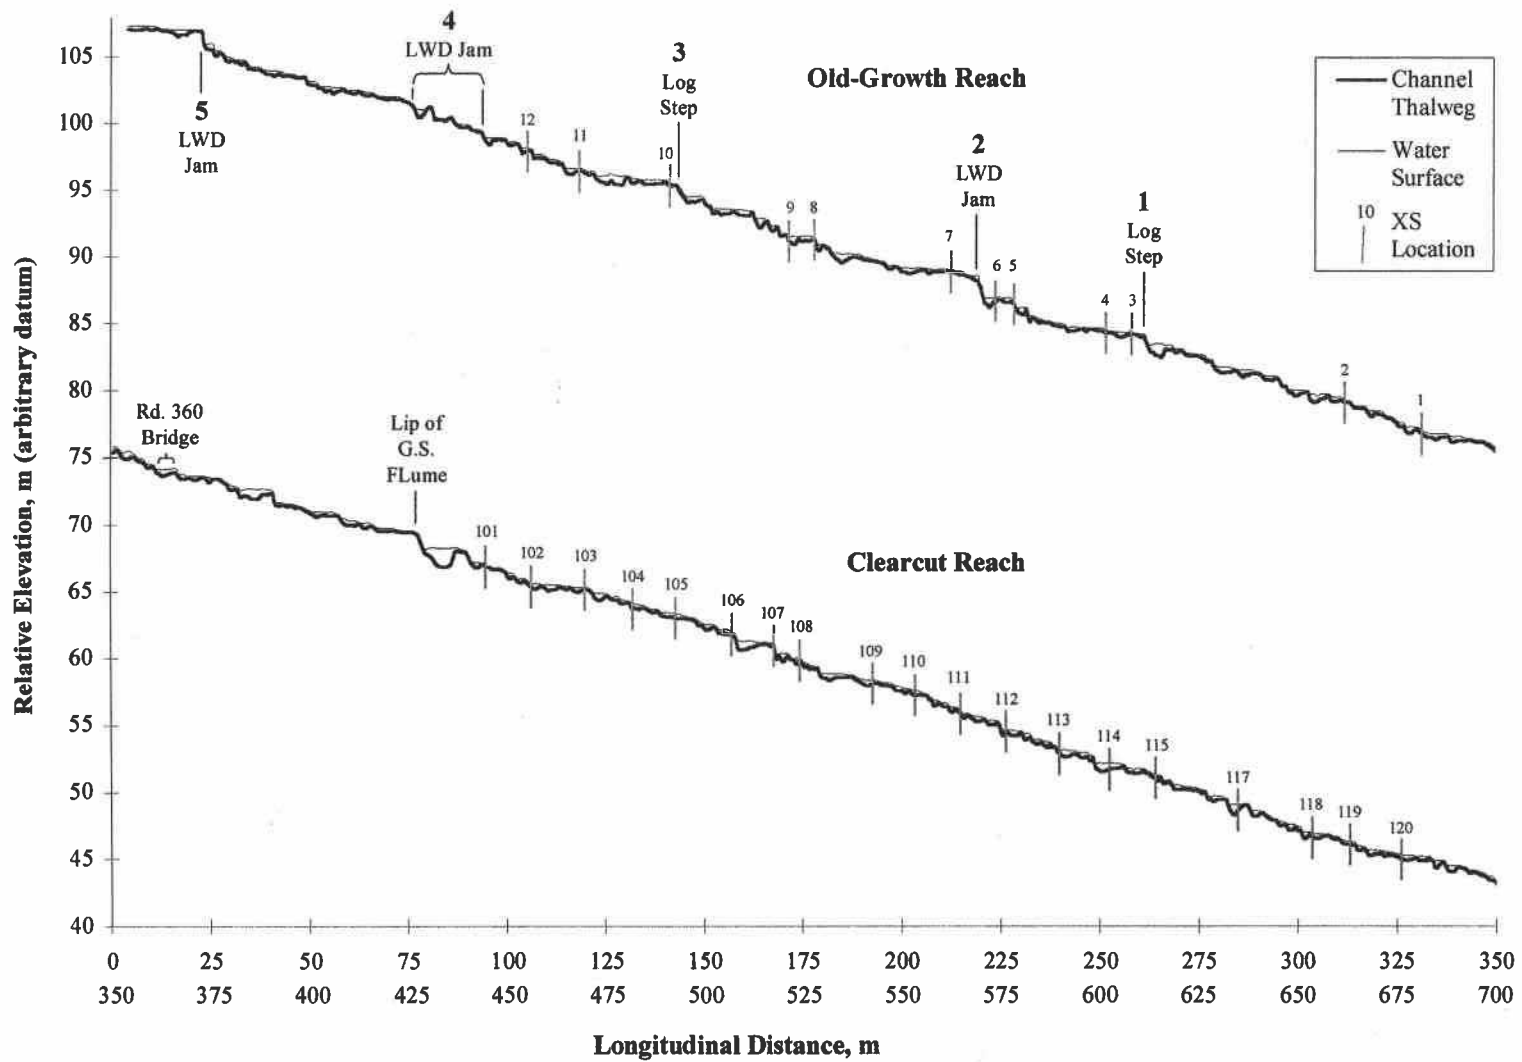
Figure 4.1. Longitudinal profile for the portion of Mack Creek shown in Figure 3.2. The longitudinal distance is based on an 11-point moving average of the  $x$ - and  $y$ -coordinates of the surveyed points along the channel thalweg, but the vertical coordinate has not been smoothed. The upper row of labels for the horizontal (longitudinal distance) axis apply to the upper plot (old-growth reach), while the lower row of labels apply to the lower plot (clearcut reach). Numbered features correspond to numbered LWD structures in Figure 3.2.

LWD-caused steps in the longitudinal profile of the old-growth reach are significantly larger than most boulder-related steps in either reach. A few large boulder steps in the clearcut reach (e.g., at XS 106 and 107, Figure 4.1) have a height of 1 m or more, rivaling the log steps (LWD structures 1 and 3, Figure 4.1), but the boulder steps do not create the 20- to 40-m long segments of low-gradient channel that are found upstream of the LWD structures. The two log steps have heights of about 1

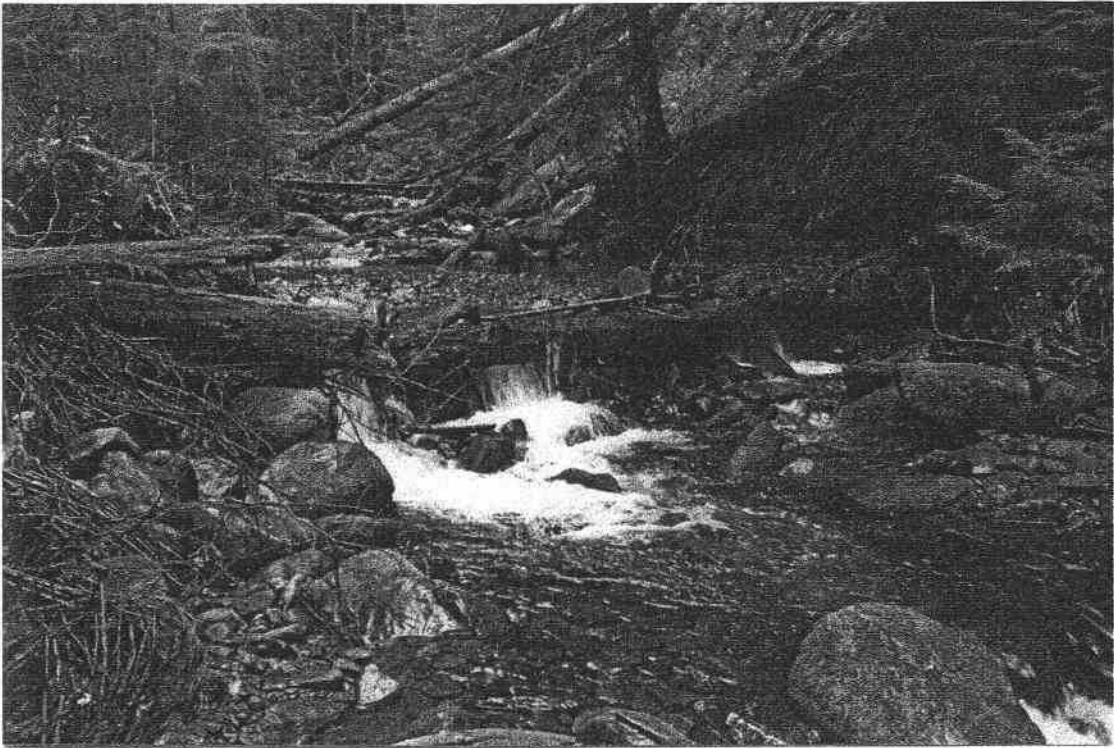
Figure 4.2. Log step at the Mack Creek old-growth (MAC) site. Cross section 10 crosses the channel just upstream of the step. Note the fine gravel deposit upstream of the step. Orange disc is 30 cm (1 ft) in diameter; step height is just over 1 m.

to 1.5 m each (Figure 4.2), while the LWD jams produce steps about 2 to 2.5 m in height (Figure 4.3).

The largest patches of relatively fine, readily transportable bed material (gravel and small cobbles) were typically observed just upstream of log steps and LWD jams (Figures 4.2, 4.4). This observation is supported by the particle size data. Cross sections located immediately upstream of channel-spanning LWD structures tended to have significantly finer bed material, particularly at the coarse end of the size distribution, than the reach as a whole. Cross sections located immediately downstream of LWD structures tended to have bed material somewhat coarser than the reach average (Figure 4.11). The fining effect of LWD structures on upstream particle size was particularly pronounced. In the 2 post-flood years (1996 and 1997), the three cross sections located upstream of LWD structures (XS 3, 7 and 10) had the smallest  $D_{84}$  values of all 12 old-growth cross sections (Appendix A).

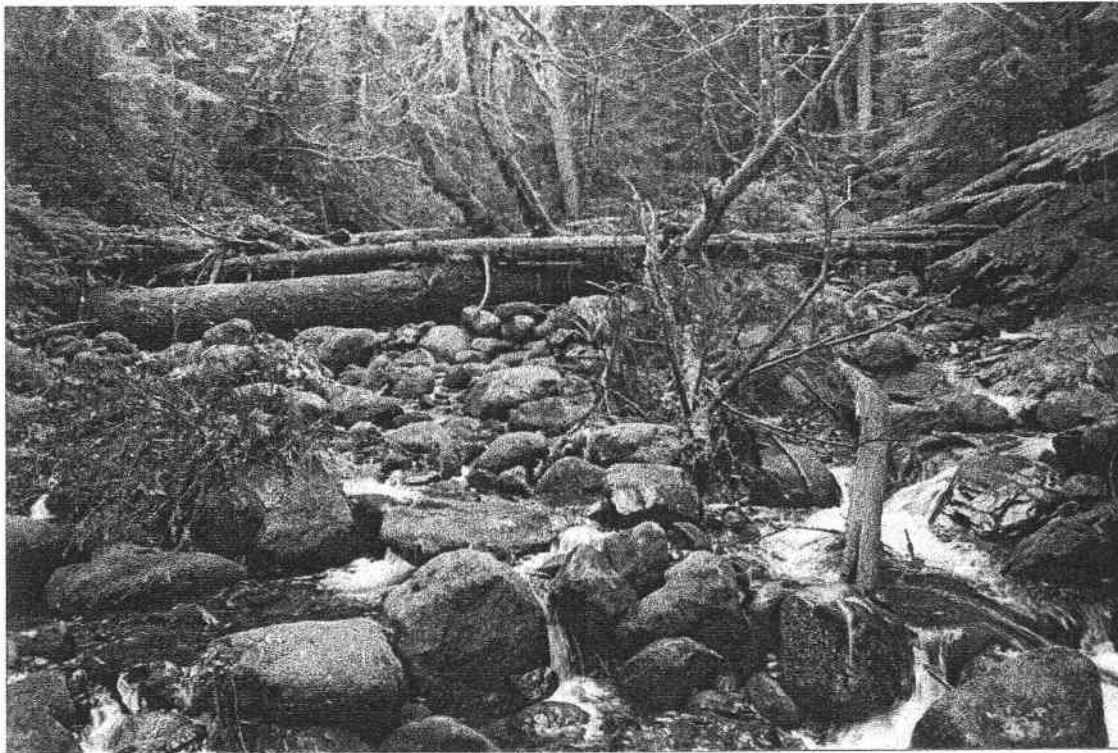
Figure 4.3. View of channel at Mack Creek old-growth (MAC) site showing armored channel bed downstream of a large LWD jam. Vertical distance between water surface immediately up- and downstream of the jam is approximately 1.5 m; total height of the structure is a little over 2 m.

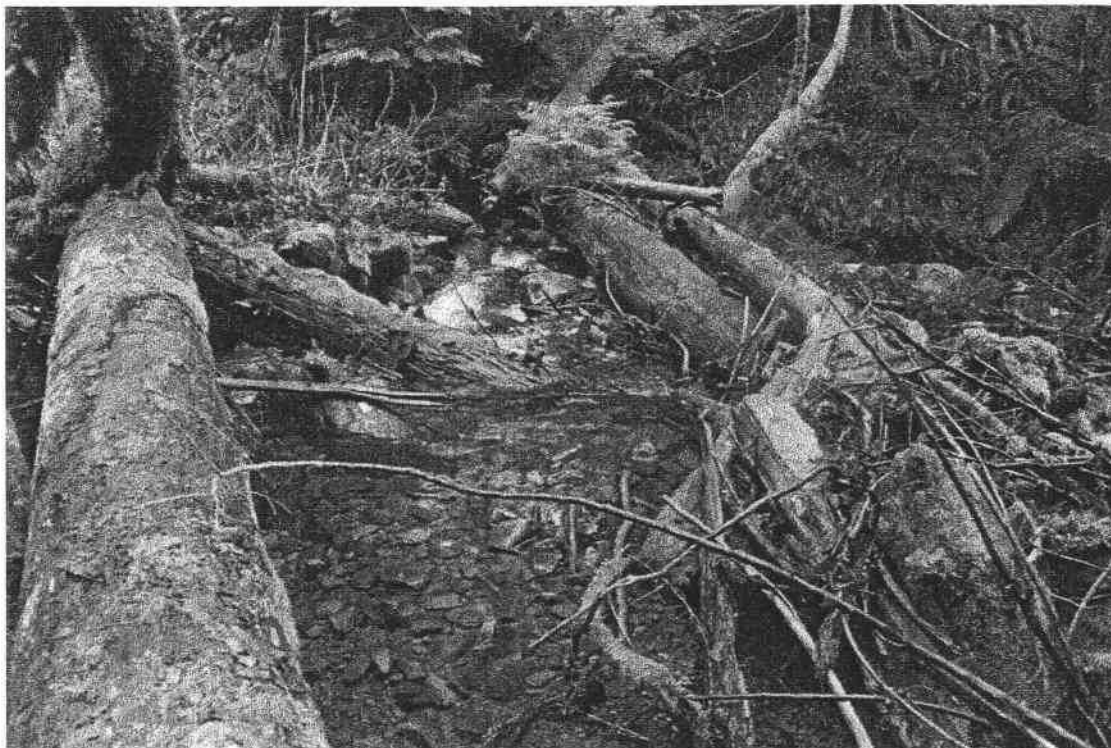
Figure 4.4. View of channel within LWD jam (structure no. 4 in Figure 3.2). Flow is diverted down a boulder cascade and against the left bank, which consists of exposed bedrock. Note the gravel in the foreground, which is typical of sediment stored upstream of LWD jams in Mack Creek, but is relatively uncommon elsewhere in the channel.

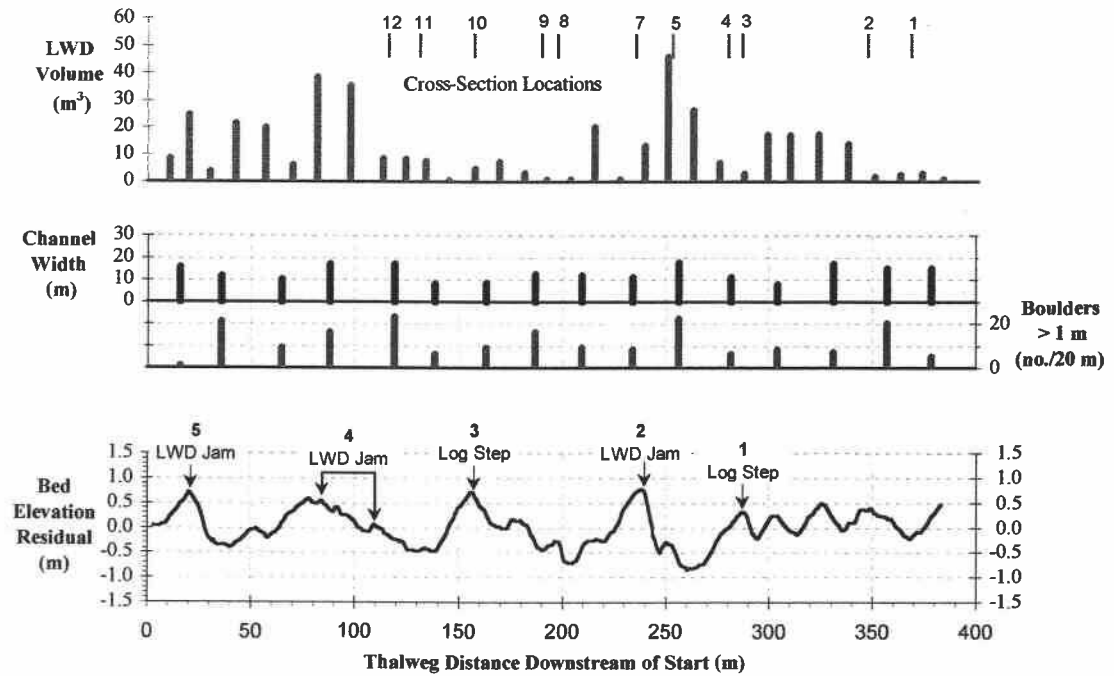
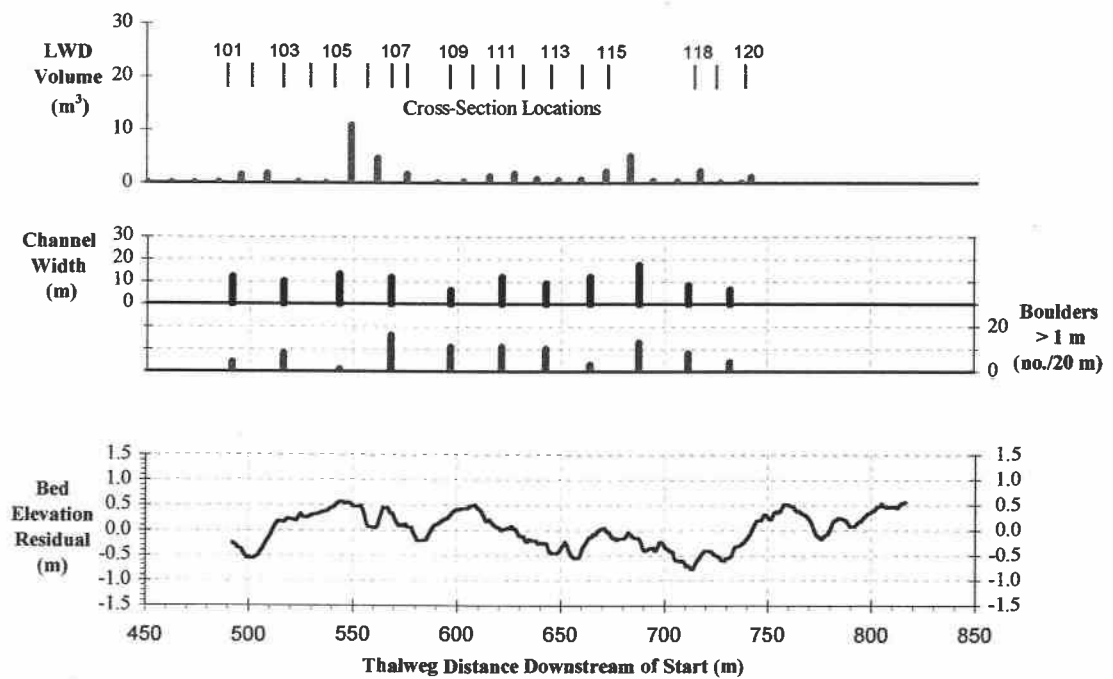
**(a) Old-Growth (MAC) Site**

**(b) Clearcut (MCC) Site**

The differences in the structure of the longitudinal profile between the old-growth and clearcut reaches are revealed more clearly in the smoothed, de-trended longitudinal profile (lower plots in Figures 4.5 [a] and [b]). A positive slope on the

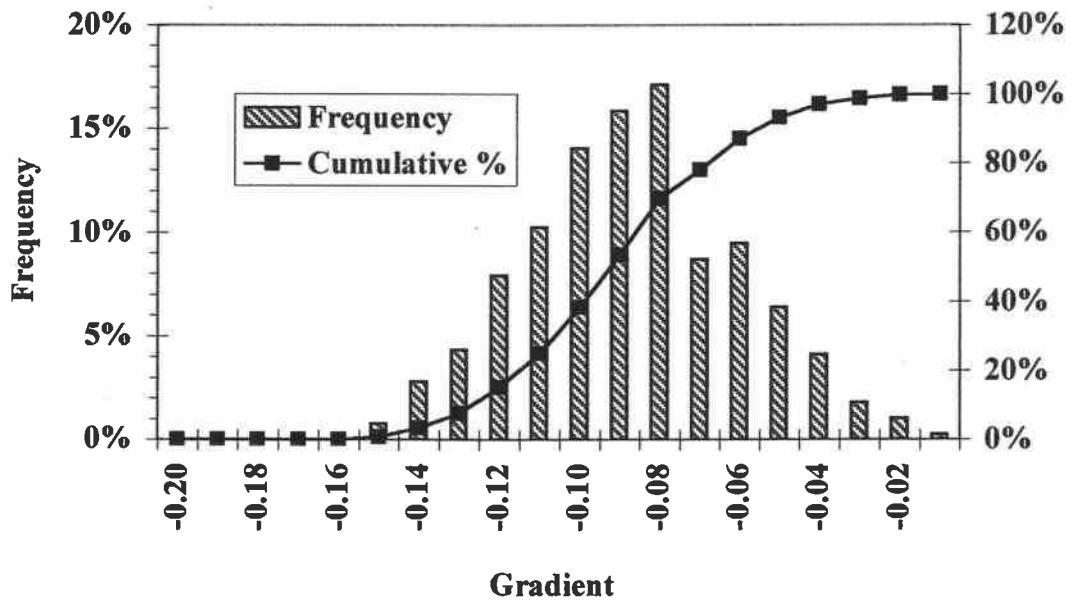
Figure 4.6. Frequency distribution for the local low-flow water surface gradient in Mack Creek: (a) old-growth (MAC) site; (b) clearcut (MCC) site. Water surface slope was calculated over a 10-m interval centered on each point in a 5-point moving average of the longitudinal profile in Figure 4.1.

As suggested above, an important effect of large LWD on the channel is that it alters the frequency distribution of channel gradient along the longitudinal profile. Figures 4.6 (a) and (b) show the frequency distribution for the low-flow water surface gradient for the old-growth and clearcut reaches, respectively, calculated over a 10-m

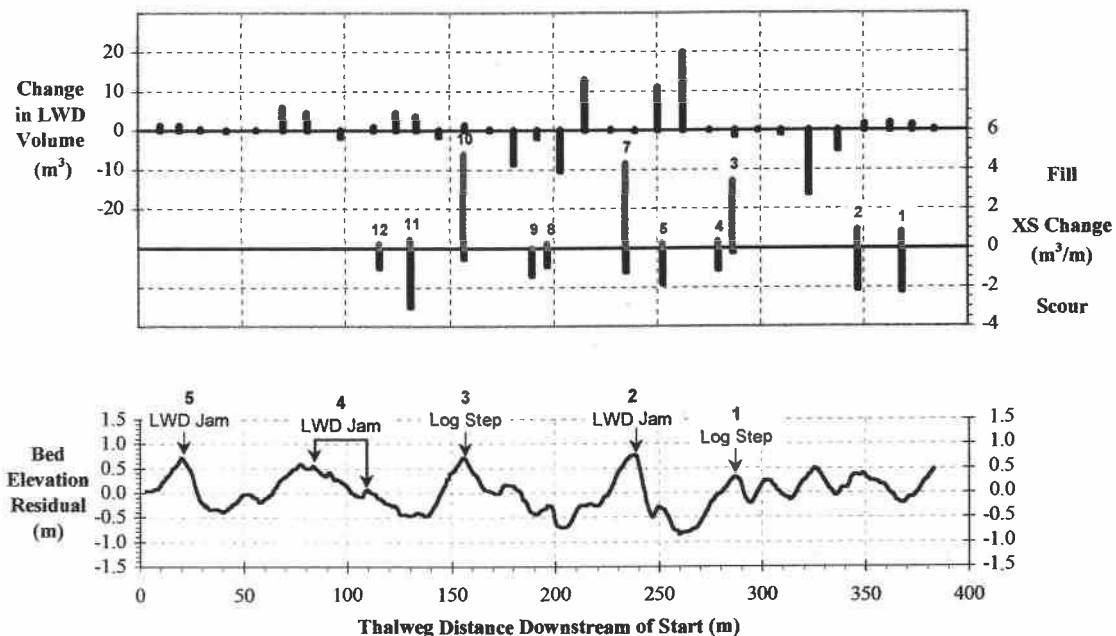
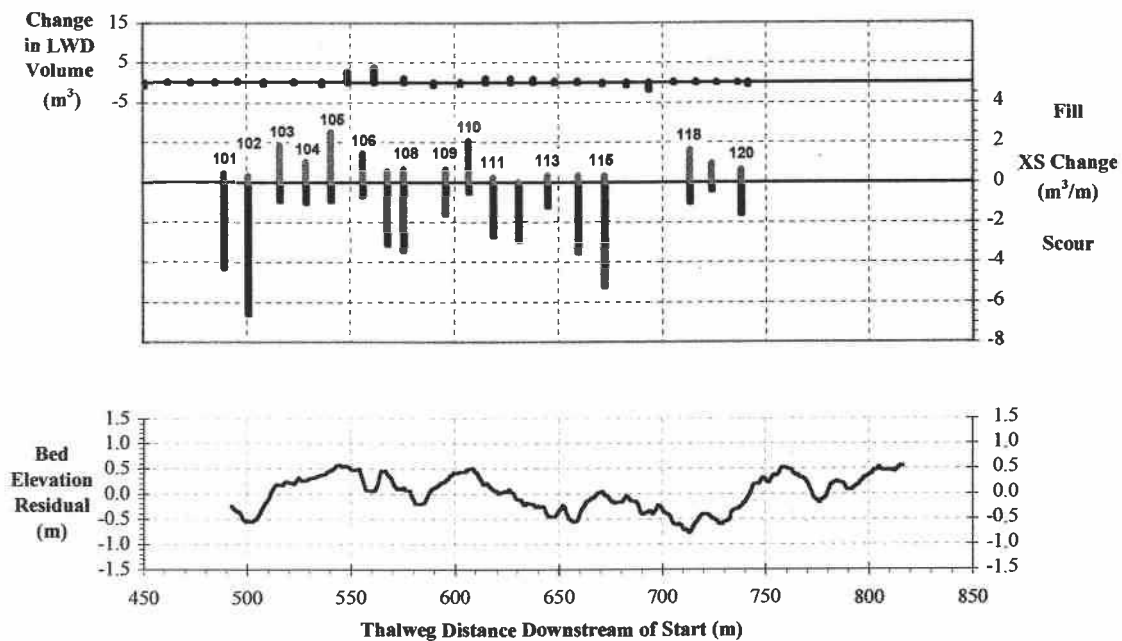
Figure 4.9. Longitudinal plot showing 1995-96 change in volume of in-channel LWD, cross section scour and fill, and bed elevation residual for the Mack Creek cross section sites: (a) old-growth site; (b) clearcut site.

LWD volume within the channel (Figure 4.9 [a]). Partial dismantling of a channel-spanning LWD accumulation at the head of a mid-channel bar just upstream of XS 2 in the 1996 flood may have contributed to scour at XS 2, while accumulation of additional LWD by the LWD jam immediately downstream of XS 7 may have contributed to aggradation at XS 7. (Scour at XS 1 may be related to a removal of a 10-ft diameter culvert 30 m downstream of in September 1994 to improve fish passage and prevent mass failure of the road fill [Gregory, personal communication]. Approximately 1200 to 1500 cubic yards of sediment were excavated from the channel at that time [Cissel, personal communication].) In the clearcut reach, there was little LWD in the channel to start with and hence little redistribution of LWD volume. Thus, channel changes in the clearcut reach clearly were not driven by redistribution or new inputs of LWD (Figure 4.9 [b]).

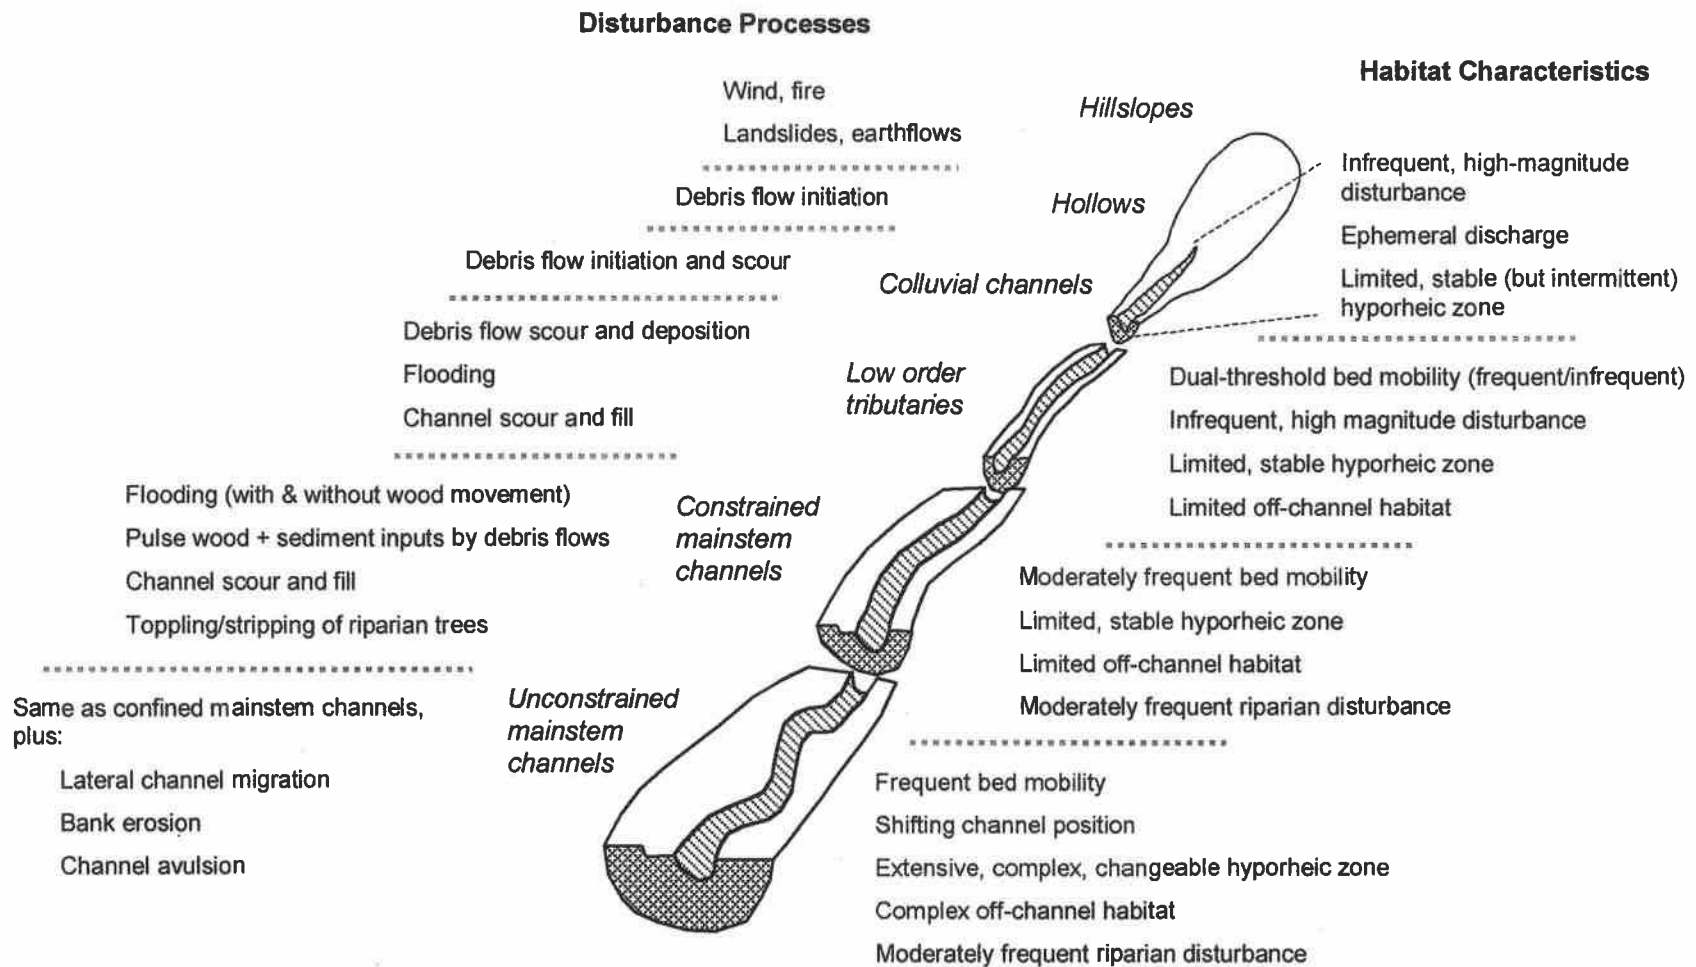
Figure 8.1. Schematic illustration of stream channel network showing characteristic disturbance processes and associated habitat characteristics for different portions of the channel network. (Modified from Montgomery [1999].)

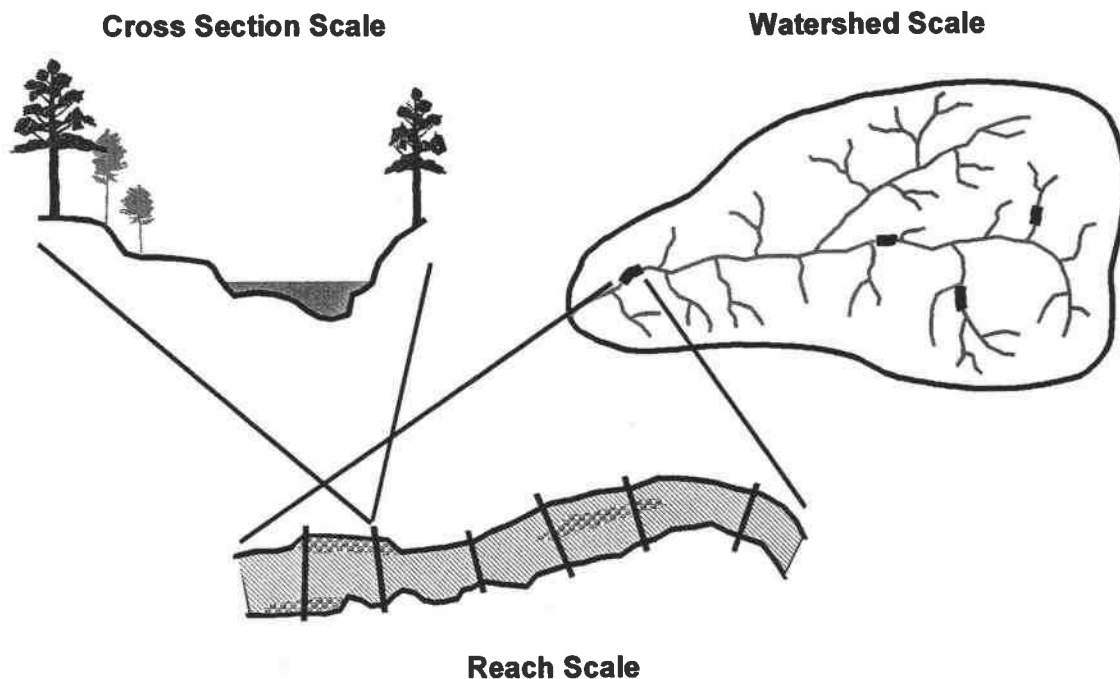
Figure 8.3. Schematic diagram showing nested cross section sampling design

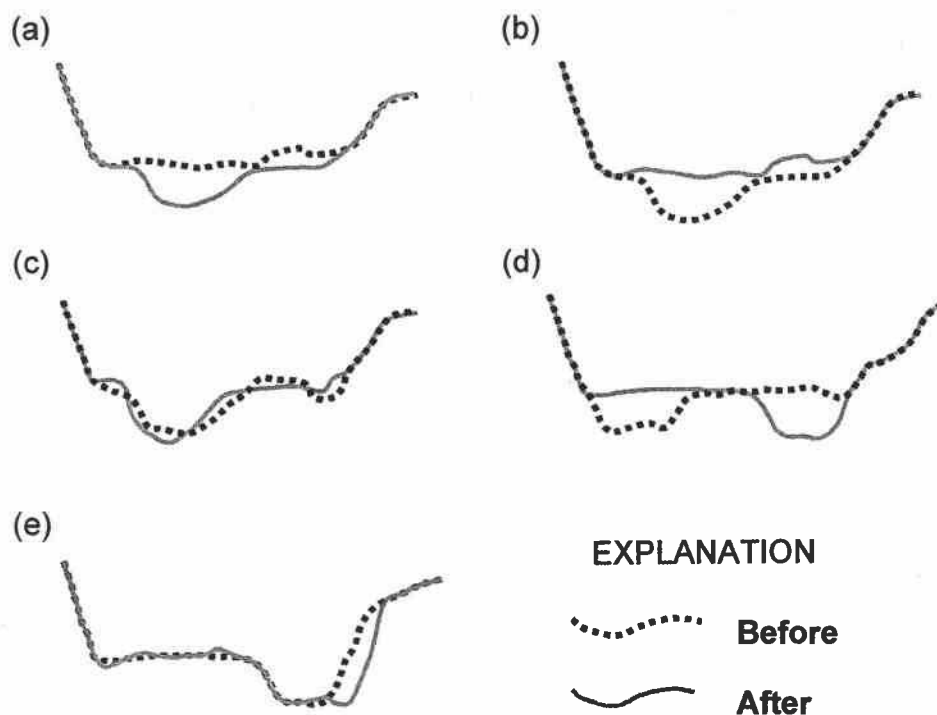
Figure 8.4. Styles of channel response inferred from hypothetical cross section profile changes: (a) degradation or scour, (b) aggradation or fill, (c) mixed scour and fill, (d) lateral channel shift, and (e) bank erosion.

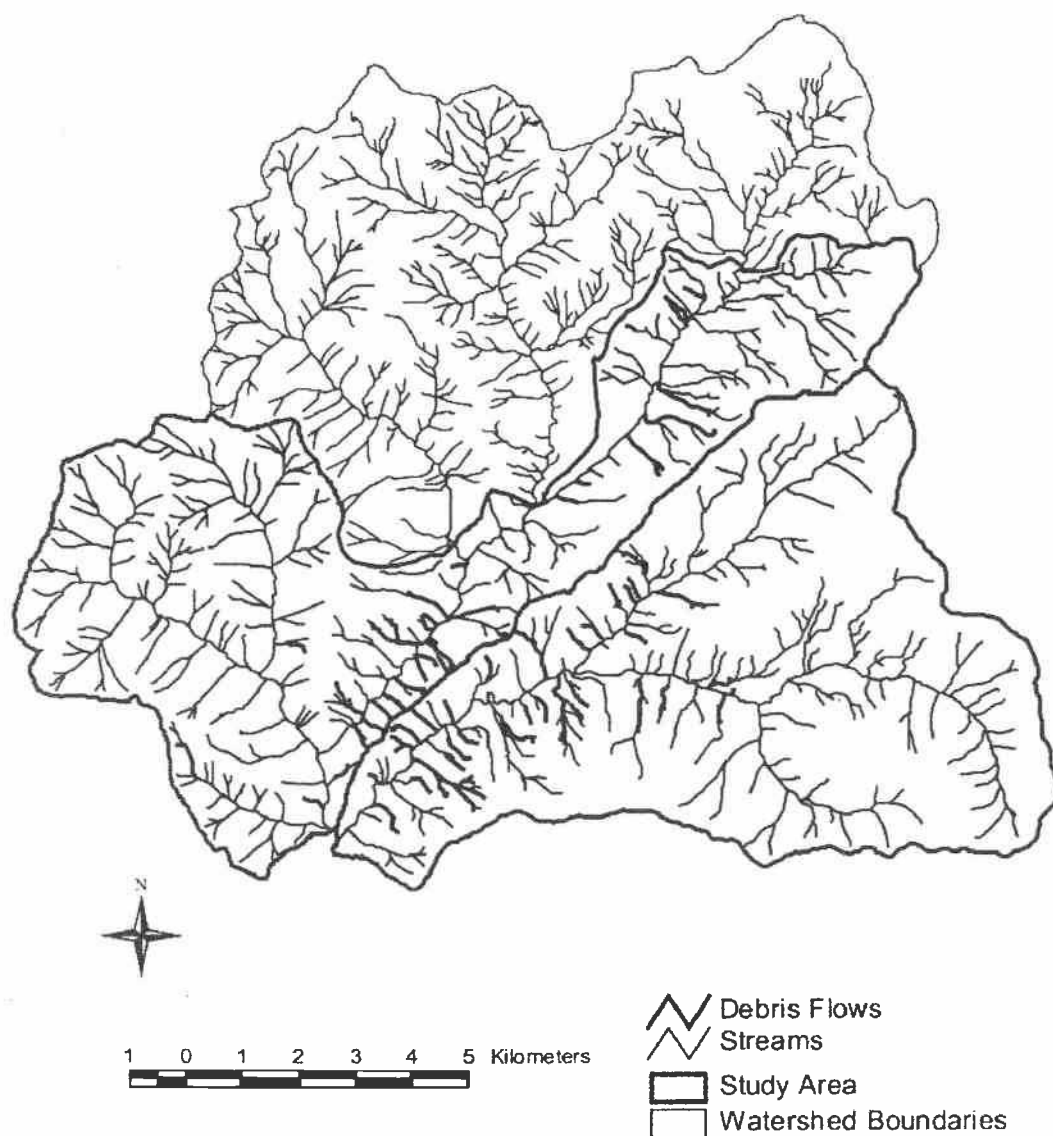
Figure 9.1. Locations of known debris flows in the Lookout Creek watershed and a portion of the Upper Blue River watershed, 1946-1996. (Source: Snyder, in preparation)

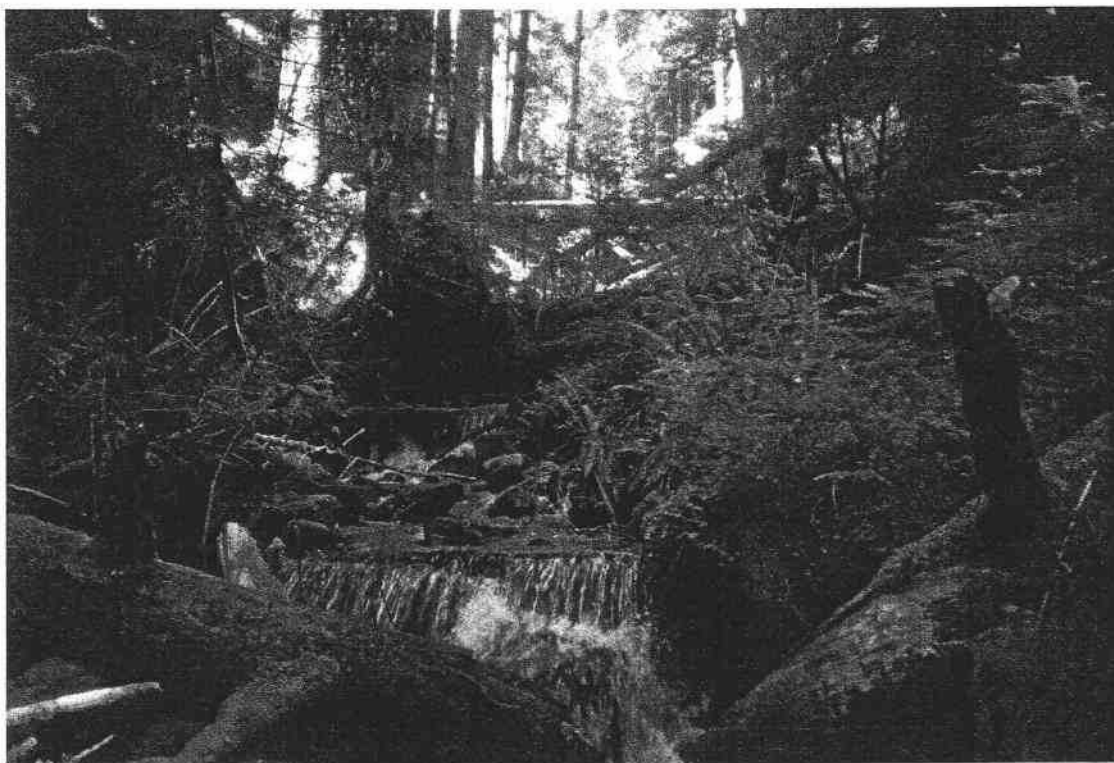
Figure 9.2. View of channel at the Cold Creek (COC) cross section site.

The channel contains many large boulders and logs (Figures 9.2 and Appendix C, Figures C.1 through C.6) which appear to be immobile under the current hydrologic regime, at least with respect to purely fluvial transport processes. Even small boulders and larger cobbles are typically moss-covered, indicating lack of recent transport.

However, pools and other low-gradient channel units between longitudinal steps contain a substantial amount of gravel- to cobble-sized sediment (as well as minor sand) which appears to be actively transported.

to the channel width in length) which created or destroyed small step structures (Figure 9.2) by capturing or releasing gravel and small cobbles. Because of the steep slope of low-order channels, the effects of such occurrences on channel form were quite localized.

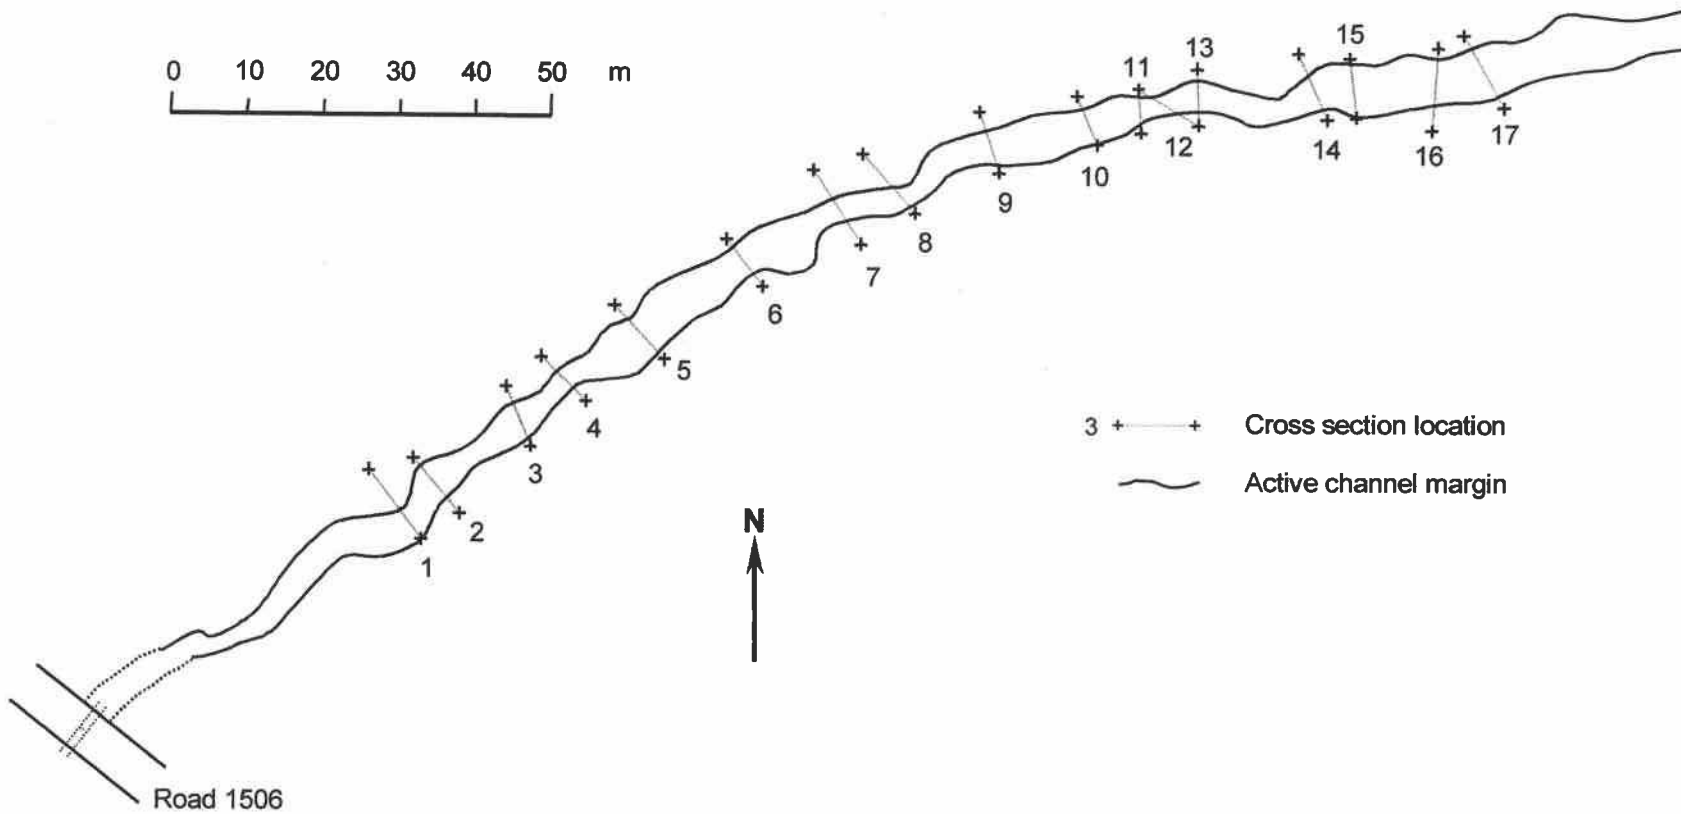
Figure 9.3. Map of Cold Creek (COC) site showing cross section locations.

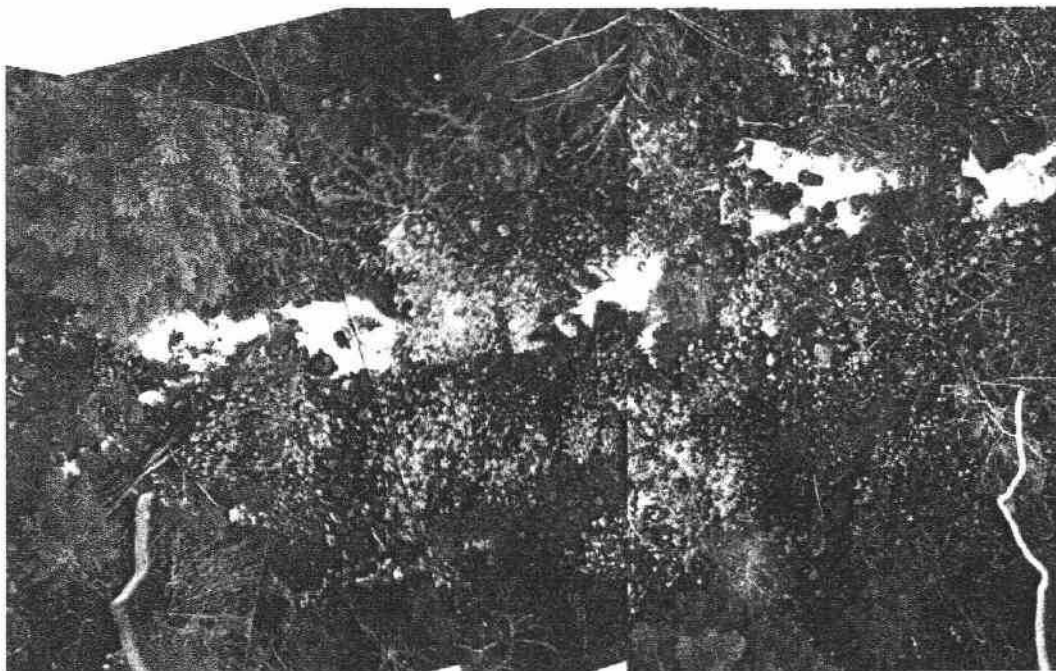
Figure 9.5. Aerial view of a portion of the Mack Creek clearcut (MCC) reach. Note step, step-pool configuration of main channel. Side channel at bottom of photo, separated from main channel by a willow-covered bar, is active at this moderate fall flow.

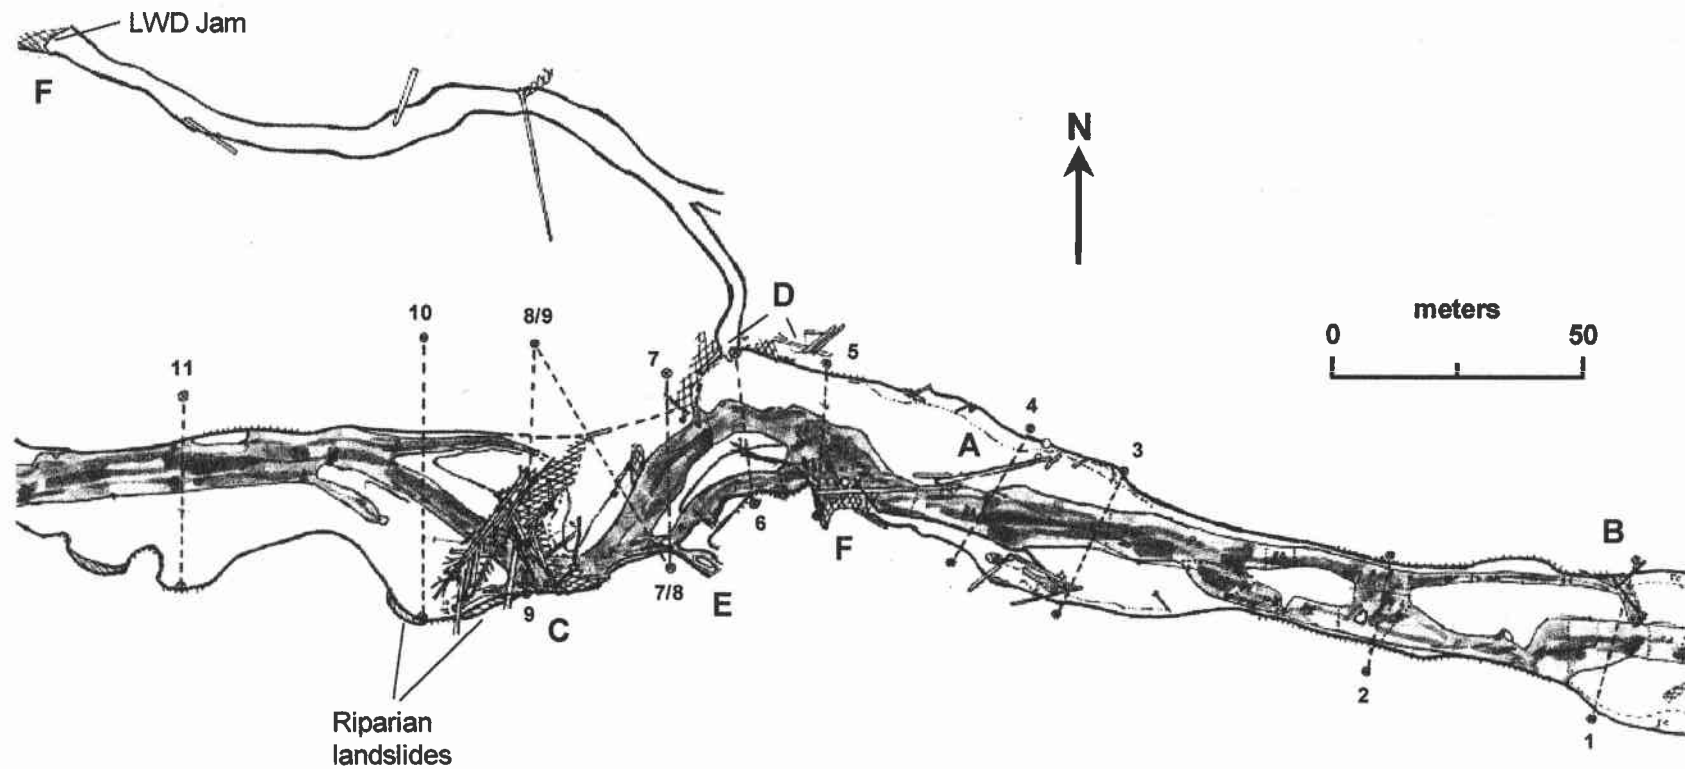
Figure 9.6. Map showing channel features and cross section locations at the middle Lookout Creek (LOM) site, fall 1996. Letters identify locations of features referred to in text: A – large log anchoring up- and downstream bars; B – marginal LWD accumulation anchoring upstream bar and protecting downstream bar; C – channel-spanning LWD jam formed in February 1996 flood; D – entrances to back channels in floodplain, plugged by sediment and woody debris; E – junction of combined back channel and small tributary with main channel; F – marginal LWD accumulation anchored by channel-spanning log; G – LWD jam in back channel emplaced in February 1996 flood.

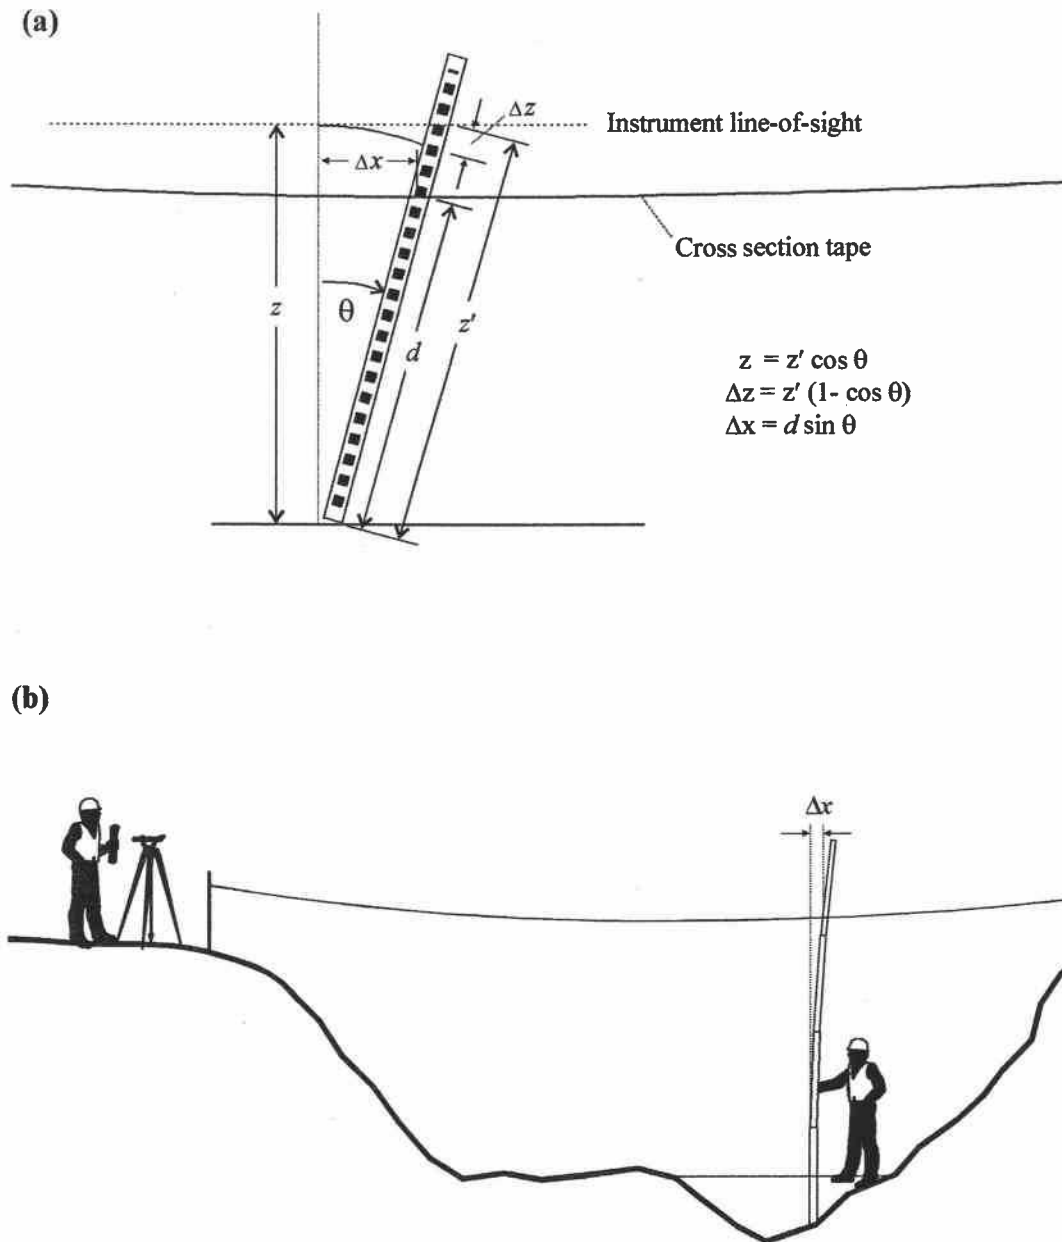
Figure 9.10. Effects of stadia rod lean on cross section survey errors: (a) errors in vertical ( $z$ ) and horizontal ( $x$ ) coordinates resulting from non-verticality of a straight rod; (b) error in measuring the horizontal position of a segmented stadia rod due to hinging at segment joints.

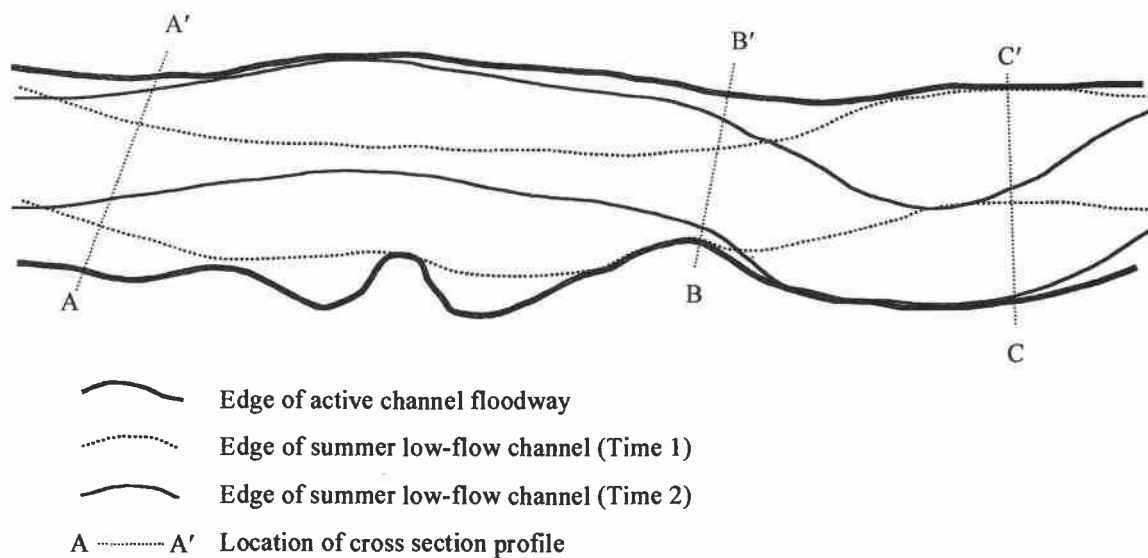
Figure 9.15. Examples of different possible relationships between the orientations of the low-flow channel, active channel floodway, and cross section profiles. See text for discussion.
