**Stream Channel Response to Peak Flows in a Fifth-Order Mountain Watershed**

**A DISSERTATION**

**Oregon State University**

John M. Faustini for the degree of Doctor of Philosophy in Geology presented on April 27, 2000. Title: Stream Channel Response to Peak Flows in a Fifth-Order Mountain Watershed.

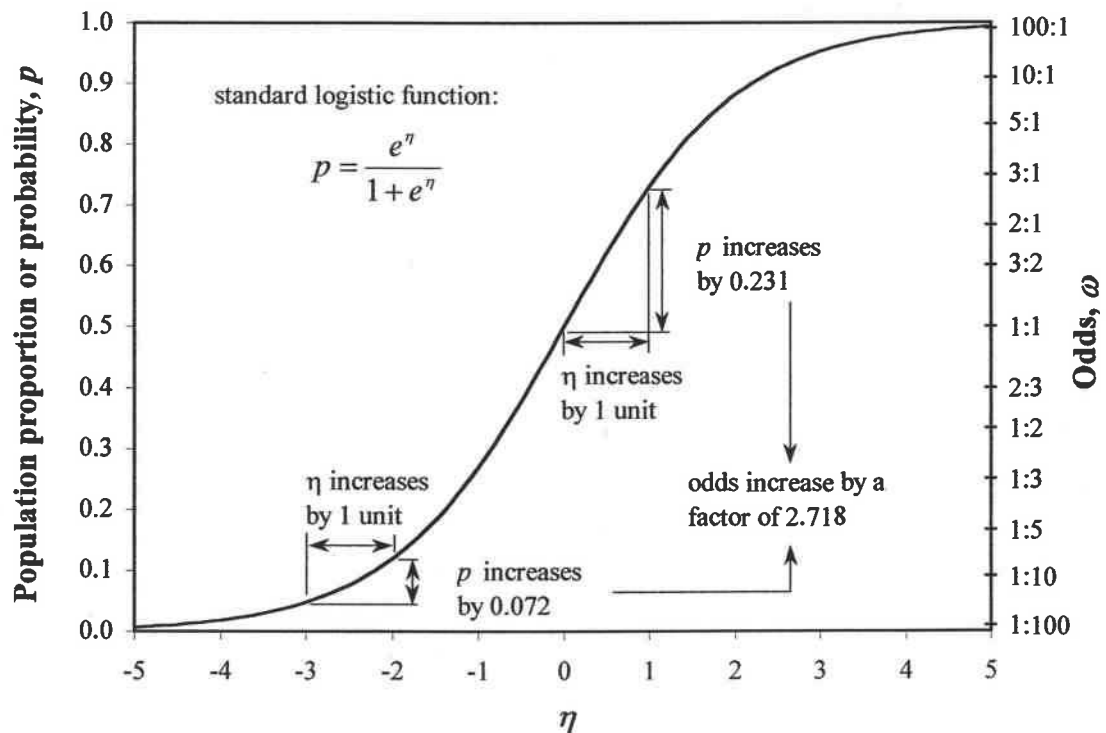
Figure 9.18. The standard logistic function and the relation between the probability and odds for an event occurring. The logistic function is the inverse of the logit function and gives the probability  $p$  of an event as a function of the value of the linear predictor  $\eta$  in a logistic regression model. The odds,  $\omega$ , are the ratio of the probability  $p$  that an event will occur to the probability  $1-p$  that it will not occur. (Modified from Ramsey and Shafer [1997].)

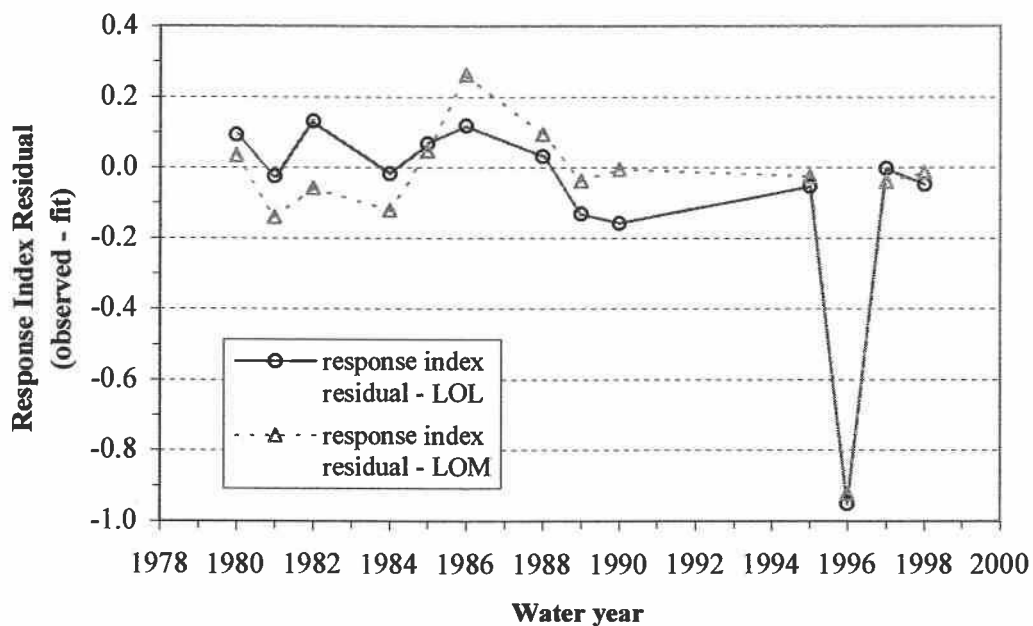
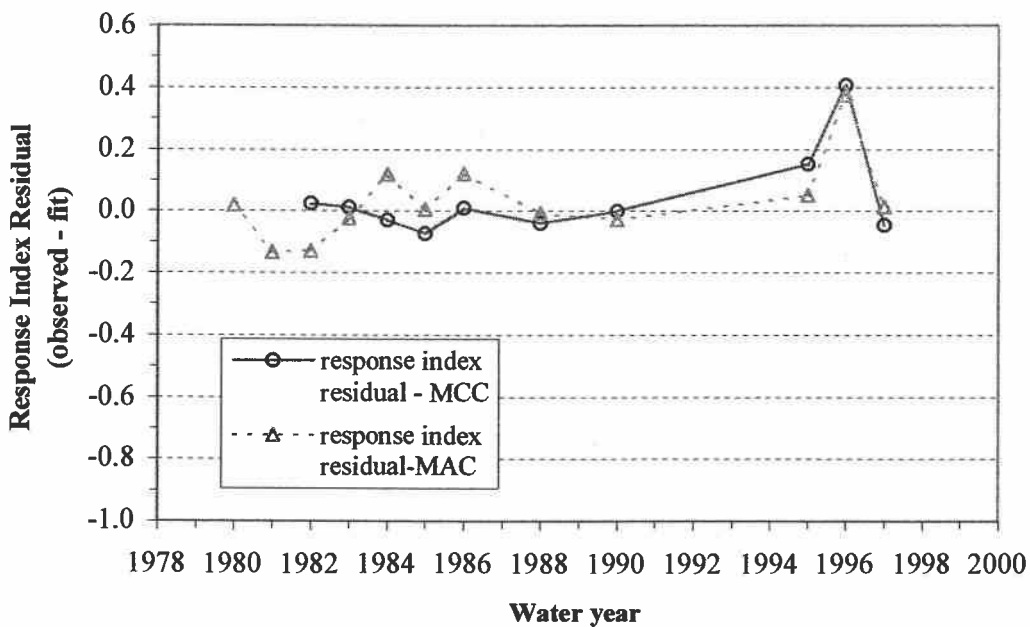
Figure 9.19. Residuals from regression of cross section response index scores vs.  $Q^*$  plotted by water year: (a) Lookout Creek sites, and (b) Mack Creek sites. The 1996 flood was omitted from the regression model.

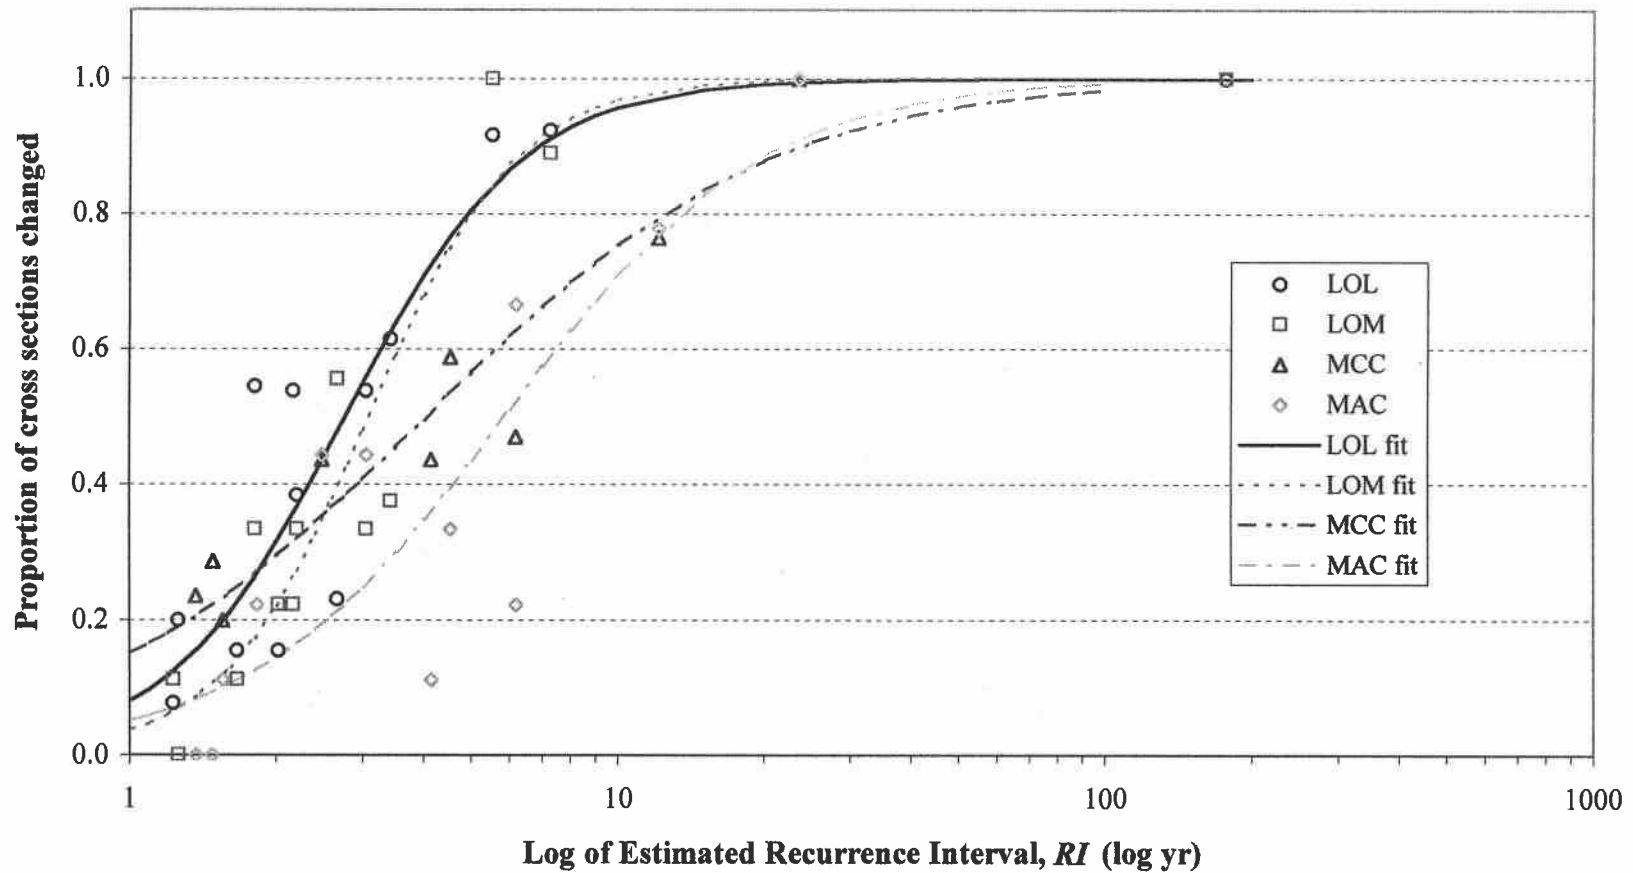
Figure 10.17. Proportion of cross sections exhibiting change versus estimated recurrence interval of maximum instantaneous peak discharge for Lookout and Mack Creek sites. Lines give quasi-likelihood logistic regression fit (using  $\log(RI)$  and *Site* as explanatory variables).

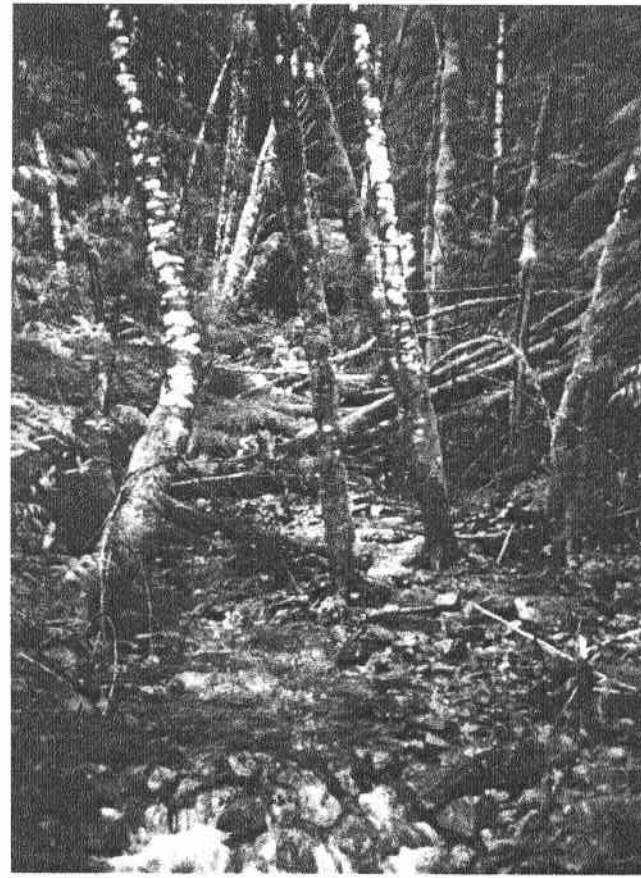
Figure 11.2. Two views of the stream channel in Watershed 1: (a) February 7, 1996 (during flood); (b) after the flood. Riparian alders and woody debris within the channel were not affected by the flood, and the channel afterwards shows no obvious evidence of the flood's passage. (Photos by F. J. Swanson, USFS)

Within the Andrews Forest, steep, low-order tributary channels with drainage areas on the order of 1 km<sup>2</sup> or less (e.g., Cold Creek or small watersheds 1, 2, and 3, Figure 3.1) appear to exhibit essentially a binary response to large flood events. Those channels that experience debris flows (Figure 9.1) are subject to severe channel and riparian disturbance in which the entire valley floor is thoroughly reworked (Swanson et al., 1998). The entire channel may be scoured to bedrock over much of its length (Figure 11.1), with much or all of its alluvial sediment and standing crop of both riparian trees and in-channel LWD transferred downstream to a larger tributary or mainstem channel. In contrast, small tributary channels that do not experience debris flows typically show little evidence of significant channel or riparian disturbance even following major floods (Figure 11.2). The extent of flood disturbance in these channels is largely limited to patchy reworking of the channel bed associated with fluvial bedload transport, mainly of finer, more mobile fractions of the bed material (i.e., gravel and small cobbles). Conifer logs are large relative to channel dimensions in low-order tributaries, and even large floods are typically incapable of mobilizing them. Stands of riparian alder and maple (in logged areas such as WS 1, Figure 11.2) help to stabilize the channel margins and are able to withstand flood flows in the absence of large moving logs that could be used to batter and topple riparian vegetation.

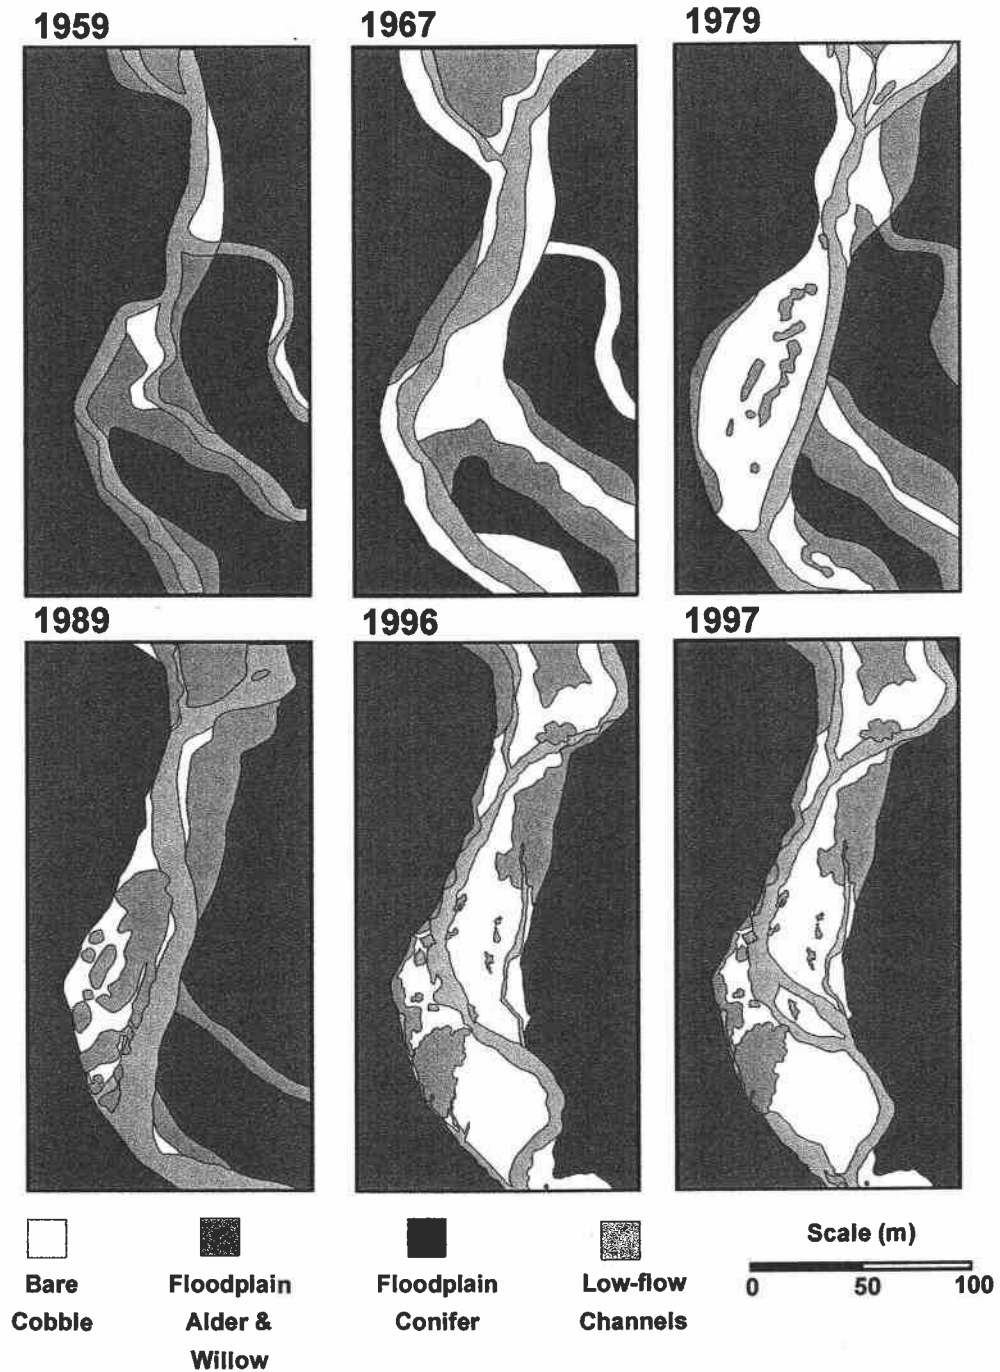
Figure 11.3. Time series of channel plan form maps for a portion of Lookout Creek immediately downstream of the McCrae Creek junction. The active channel floodway (low-flow channel, bare cobble, and floodplain alder & willow) was widened dramatically by the flood of December 1964. Channel widening occurred in the downstream end of the reach (toward bottom of map) in response to the flood of February 1996. Lateral shifts in the position of the low-flow channel occurred in response to both the 1964 and 1996 floods, as well as between 1967 and 1979 and between 1996 and 1997. (Source: Johnson et al., in press.)
