PNW-71

December 1967

GRASS-LEGUME MIXTURES FOR ROADSIDE SOIL STABILIZATION

C. T. Dyrness, *Principal Soil Scientist*

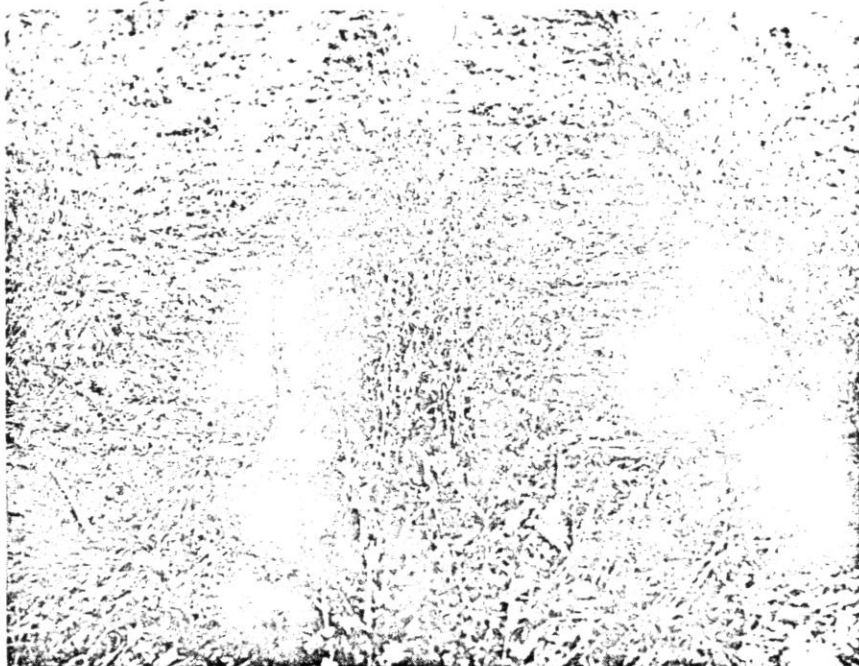
Figure 3.--Fall-seeded big
trefoil plants 2 years
after seeding
(Alsea plot).

1. *Big trefoil* (fig. 3). In all cases, this species germinated very well, and for the first 2 months, rows were extremely dense.

The smaller number of surviving plants on the Blue River plots was largely due to extensive winter mortality, probably caused by frost heaving. The remaining plants, however, were at least moderately vigorous, set seed, and showed considerable spread. Big trefoil transplants survived well at both plot sites and showed vigorous growth. Rate of growth was considerably greater at the Alsea plot where, 2 years after transplanting, maximum spread was approximately 3-1/2 feet.

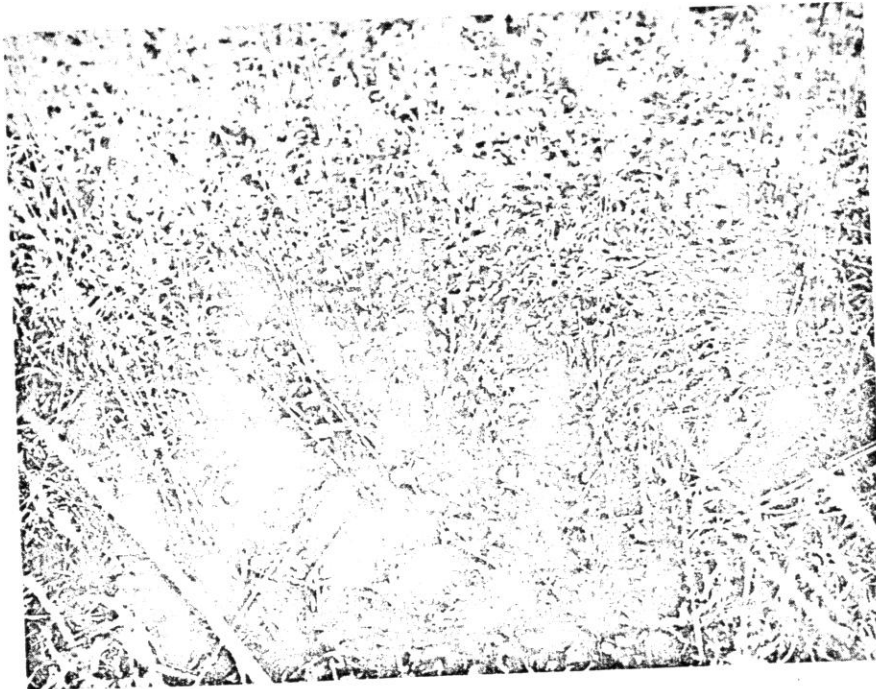
Figure 4.--Spring-seeded New Zealand white clover plants 1-1/2 years after seeding (Alsea plot).

3. *New Zealand white clover* (fig. 4). This variety performed in a manner almost identical to white Dutch clover in the Alsea plots. In the Blue River plots, it showed slightly better growth than white Dutch clover. Therefore, New Zealand white clover may prove to be better adapted than white Dutch clover to conditions in the western Cascades.

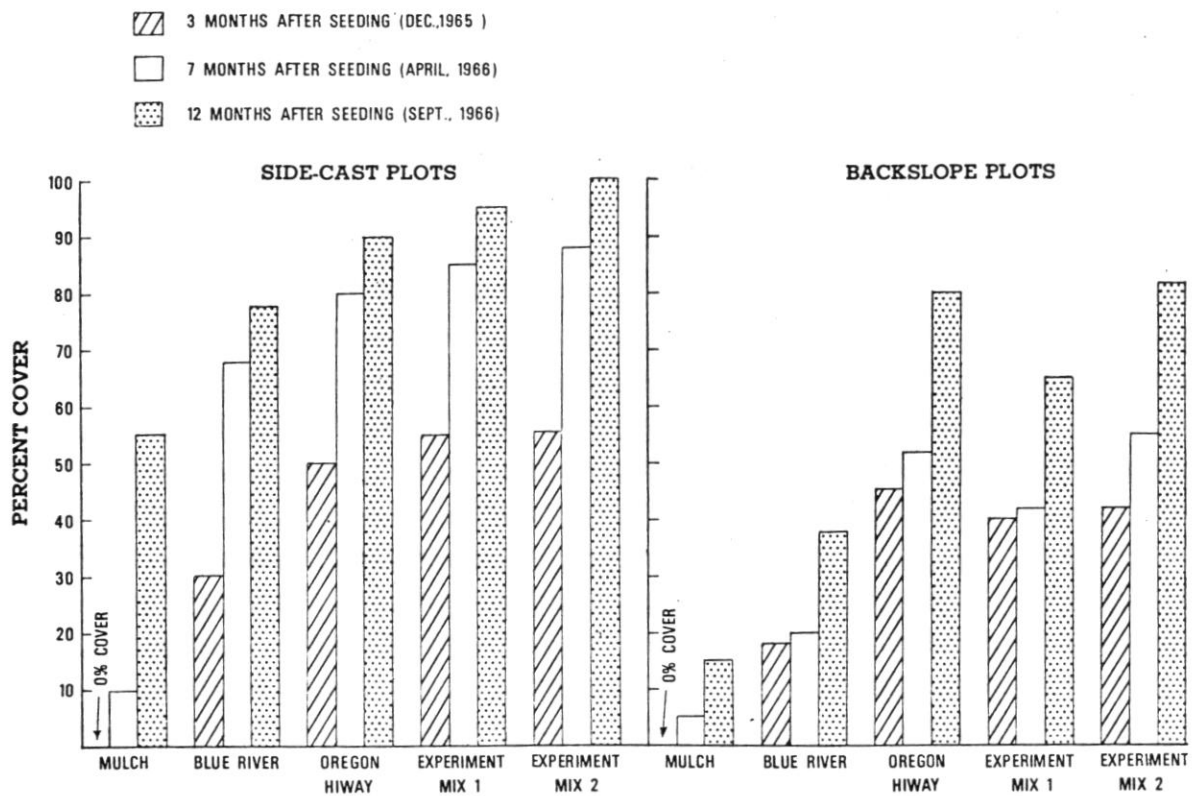
Figure 6.--Vegetative cover on roadside plots 3, 7, and 12 months after seeding.

At the end of a full year, all seeded plots at the side-cast location had a very satisfactory grass stand. Total cover ranged from a little less than 80 to 100 percent (fig. 6). Even the plots which were not seeded but only mulched were covered with a moderately dense stand of vegetation--largely grass. Vegetative cover was lower on the back-slope plots but generally dense except for small gaps, usually at steep midslope locations (fig. 11). The only exceptions were the Blue River mixture plots, where only about one-third of the total plot area was covered by grass. The other seeded plots were at least two-thirds covered by the end of the year (fig. 6).

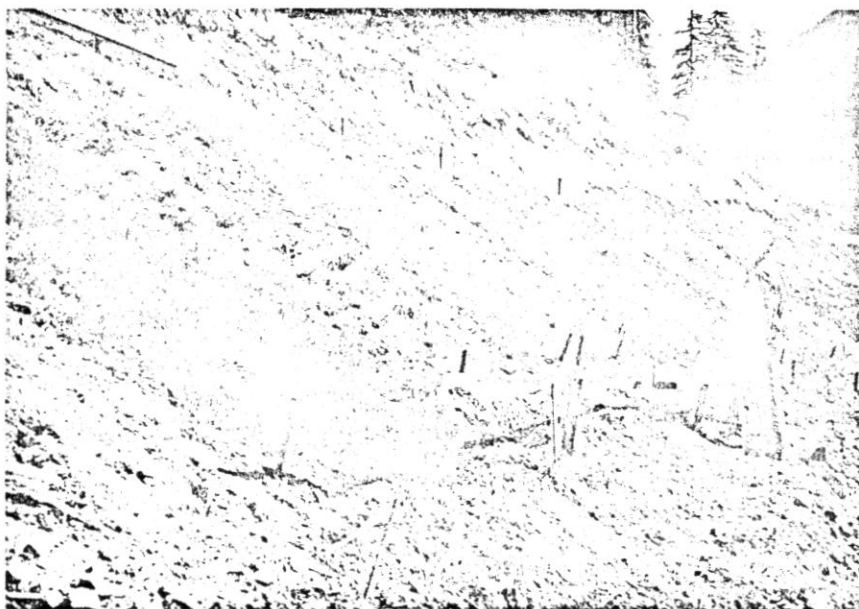
Figure 7.--Side-cast plots 7 months after seeding. The cable for measuring the slope profile is stretched between the channel irons.

Soil movement on the plots was monitored by periodic measurements of the distance between points on a stretched wire cable and the mineral soil surface directly beneath. The measurement was accomplished with a steel tape and attached plumb bob held next to the profile cable at the appropriate point. Three transects, 1 foot apart and extending up and down slope in the central 2-foot strip, were measured in each plot. Fifteen measurements were made along each transect at 1-foot intervals. The first measurement was made 1 foot below the upper boundary of the plot. Therefore, the elevation of the upper 15 feet of slope was measured.

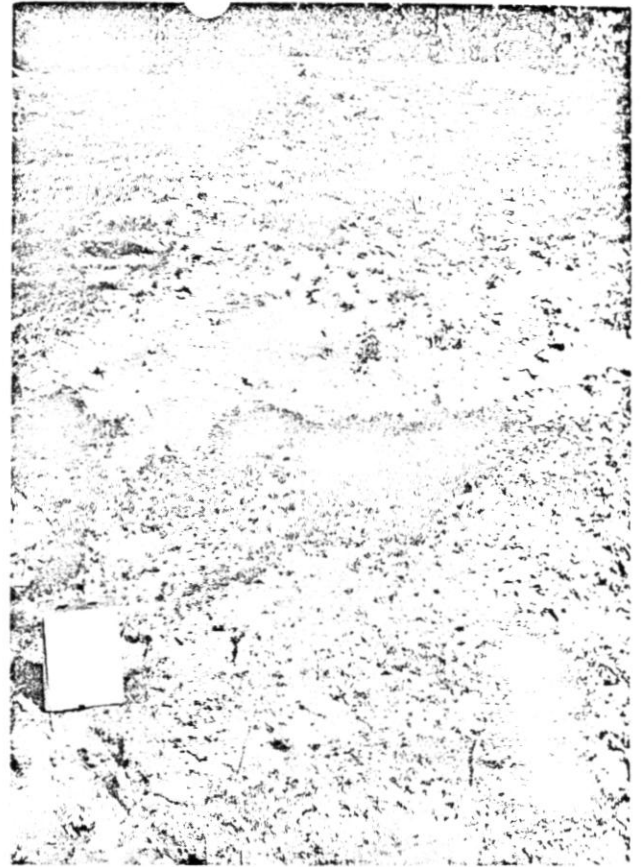
**Figure 9.--Blue River District mixture
on backslope 7 months after
seeding. Note absence of cover
on the steep, middle portion of
the slope.**

The difference is apparently once again tied to the absence of straw mulch on Blue River mixture plots.

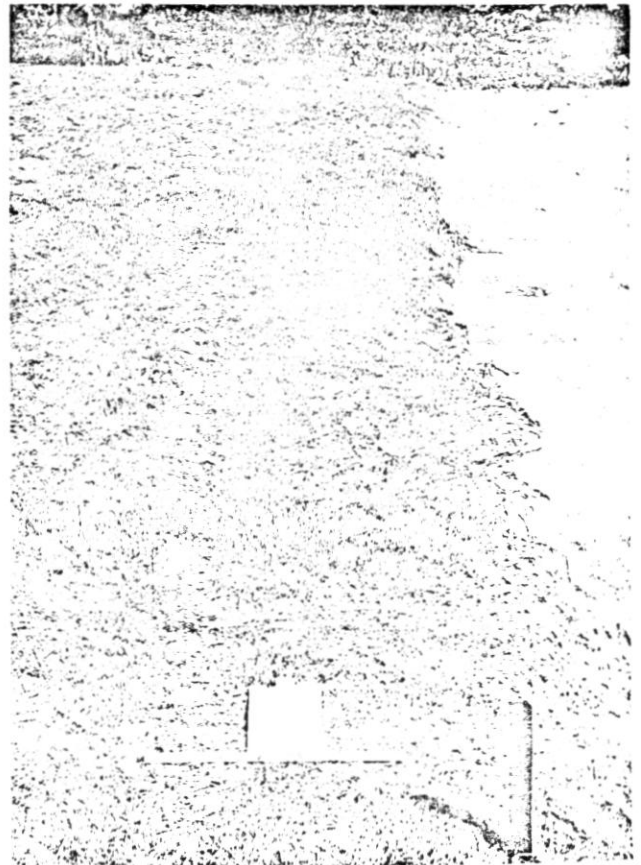
**Figure 10.--Experimental mixture No. 2
on backslope 7 months after seeding.**
