Title: Long-Term Stream Channel Response to a Large Flood in a Forested Mountain Watershed

Long-Term Stream Channel Response to a Large Flood in a Forested Mountain Watershed

A THESIS

Oregon State University

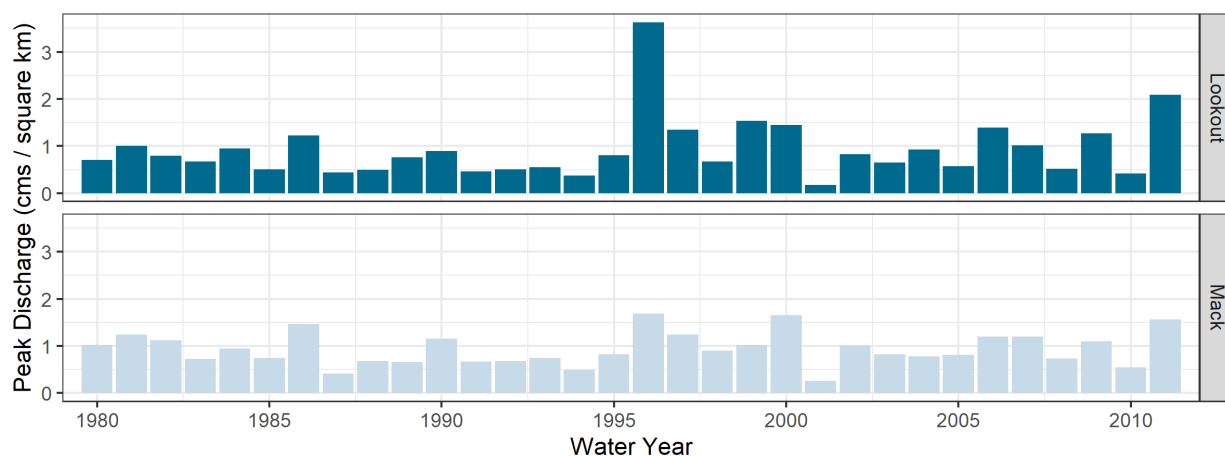
Figure 5: Time series of annual peak flows at the Lookout Creek and Mack Creek gages from Water Year 1980 to Water Year 2011. The greatest annual peak flow at both gages occurred in water year 1996. The second greatest flow within this time period occurred in 2011 at Lookout Creek and in 2000 at Mack Creek. The second greatest flow on record at Lookout Creek occurred in Water Year 1965 (December 1964).

At Lookout Creek, the peak flow of the 1996 flood was 290% greater than the mean annual peak flow recorded between water years 1950 and 2018. The peak flow was 20% greater than the second greatest annual peak flow on record (recorded in December 1964 [water year 1965]) and 70% greater than the second greatest annual peak flow that occurred within this study period (recorded in 2011, Figure 5). At Mack Creek the peak flow was 80% greater than the mean annual peak flow recorded between water years 1980 and 2018. The peak flow at Mack Creek was 2% greater than the second greatest annual peak flow, which was recorded in 2000. The second largest flow occurred in 2011 at Lookout Creek (120% greater than mean annual peak flow) and in 2000 at Mack Creek (70% greater than mean annual peak flow, Figure 5).

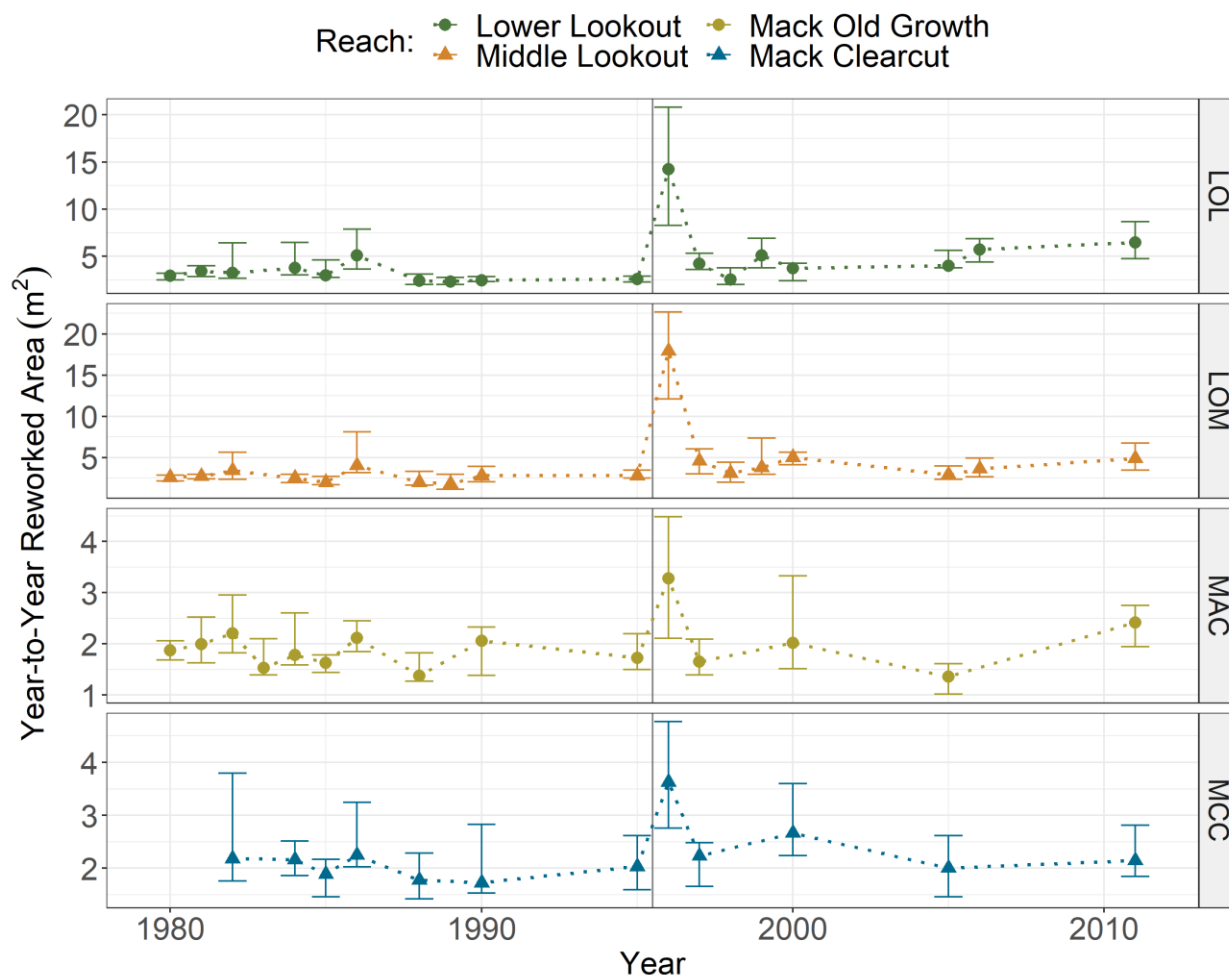
Figure 6: Median (dots) and interquartile range (bars) of year-to-year reworked cross-sectional area. Reaches experienced the most change between 1995 and 1996. The black vertical line shows the 1996 flood.

Channel response in terms of reworked cross-sectional area paralleled peak flow magnitude at all sites. At Lower Lookout, the greatest reworked cross-sectional areas were observed between 1995 and 1996 and the second greatest were observed between 2006 and 2011. At Middle Lookout, the greatest reworked cross-sectional areas were observed between 1995 and 1996 and the second greatest were observed between 1999 and 2001. At Mack Old Growth, the greatest reworked cross-sectional areas were observed between 1995 and 1996 and the second greatest were observed between 2005 and 2011. At Mack Clearcut, the greatest reworked cross-sectional areas were observed between 1995 and 1996 and the second greatest were observed between 2005 and 2011 (Figure 6).

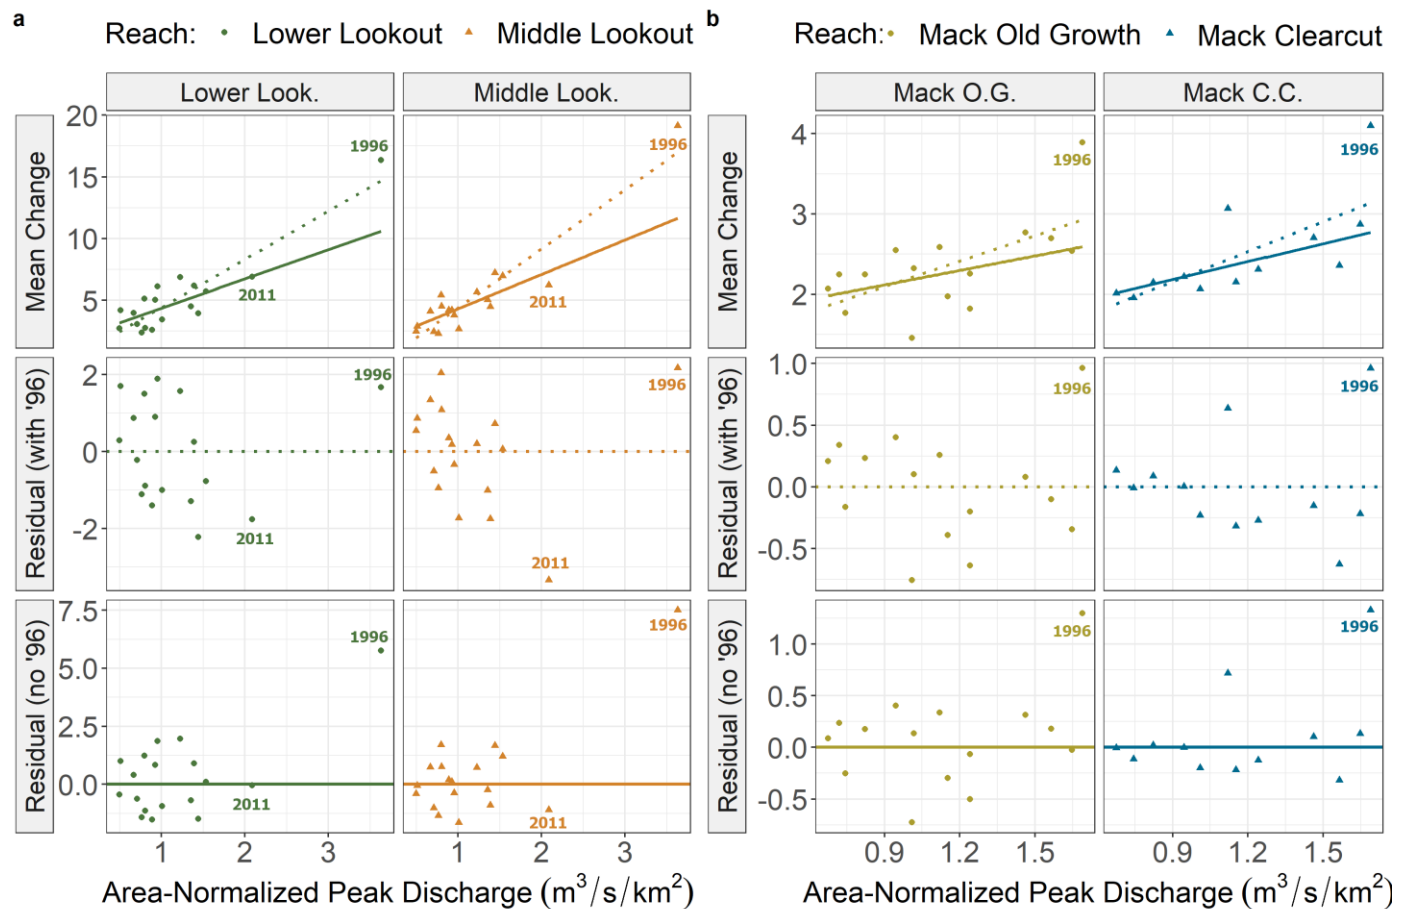
Figure 7: (a) Top row: total reworked channel area (i.e., area eroded plus area deposited) versus peak discharge for two reaches in Lookout Creek. Dashed lines represent linear regression including 1996. Solid lines represent linear regression excluding 1996. Middle and bottom rows: Residuals for each regression are shown in the second and third rows respectively. Residuals from the regression that included 1996 were not evenly distributed. Markers from 1996 and 2011 are labeled. All y-axis values are in m^2 . (b) Top row: total reworked channel

The unusual geomorphic effectiveness of the 1996 flood (Figure 7) suggests an important role of thresholds in channel adjustments in forested mountain watersheds. This over-competence suggests that large, debris-laden flows may play a fundamentally different role in fluvial adjustment than smaller, lower density flows. Support for the exceptional nature of this type of event has been observed in a step pool stream in Switzerland (Turowski et al., 2009), in Redwood Creek in California (Janda et al., 1975; Madej, 1992), and in the Oregon Cascades (Grant & Swanson, 1995).

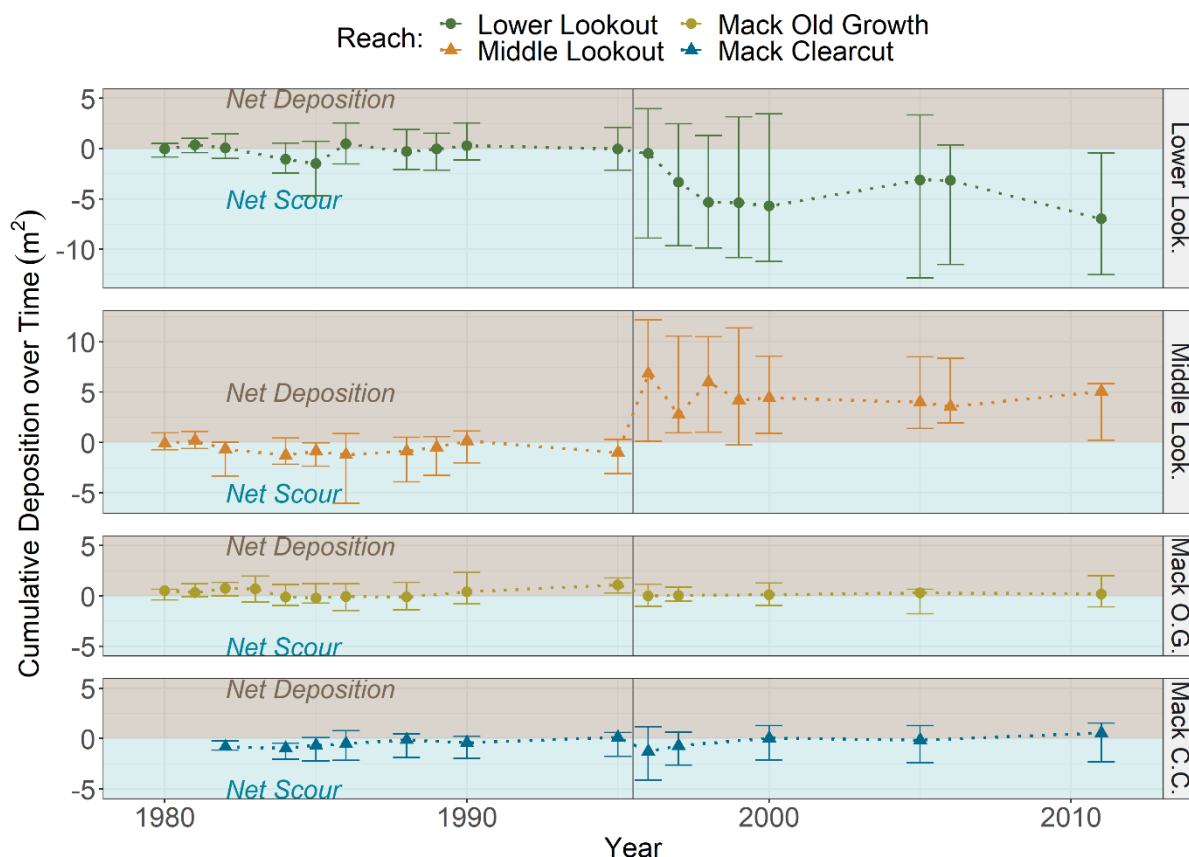
Figure 8: Median (dots) and interquartile range (bars) of cumulative scour and deposition relative to the start of monitoring in 1978 (or 1981 for Mack Clearcut). Points in the brown field (positive values) represent net deposition while points in the blue field (negative values) represent net erosion. Lower Lookout overall eroded while Middle Lookout experienced net deposition. Mack Creek reaches showed little change in median values. The black vertical line shows the 1996 flood.

Study reaches varied in their scour or depositional response to the 1996 flood. In the pre-flood period from 1980 to 1995, study reaches showed only minor changes in net deposition. Median values of net deposition in this pre-period ranged from -1.5 m^2 to 0.9 m^2 with an interquartile range of 1.1 m^2 to 6.9 m^2 (Figure 8). Comparison between cross-sectional profiles in 1995 and 1996 indicated that the 1996 flood resulted primarily in sediment deposition in Middle Lookout (deposition at 80% of cross sections, median depositional area 8.3 m^2) while Lower Lookout showed an erosional response (erosion at 65% of cross sections, median scour area of 1.3 m^2). After 1996, Lower Lookout continued to show an erosional response over the next 4 years between 1996 and 2000 (Figure 8). In contrast, the depositional response at Middle Lookout did not continue over the following years. The two Mack Creek reaches also showed an erosional response from 1995 to 1996 (erosion at 75% of cross sections at Mack Old Growth and 60% of cross sections at Mack Clearcut with median erosional area of 1.2 m^2 at both reaches) (Figure 8).

Middle Lookout showed a return to pre-flood conditions by the end of monitoring in 2011 (Figure 8, Figure A.5).

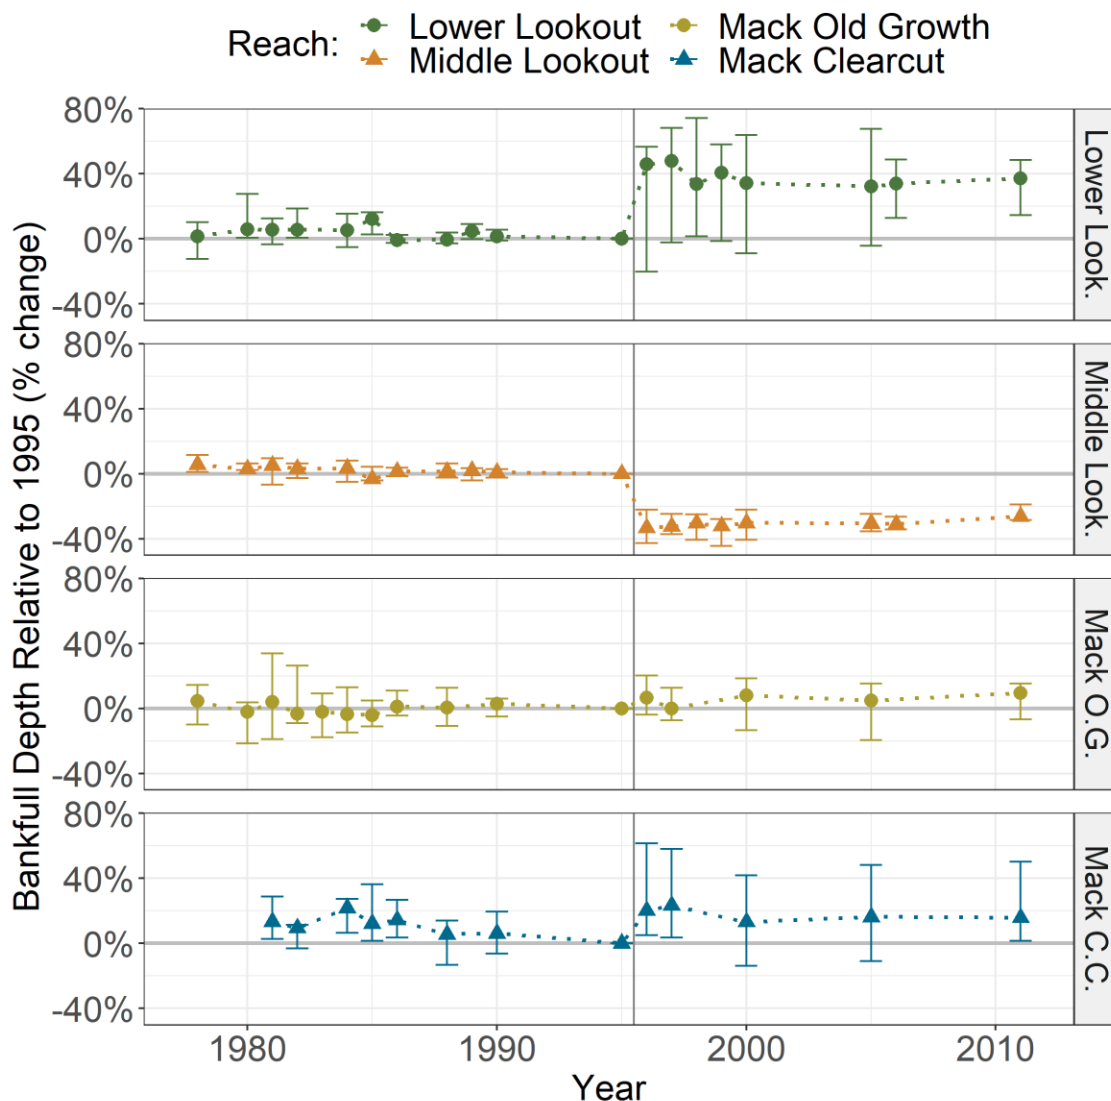
Figure 9: Bankfull depths as a ratio relative to the 1995 values at each reach. Median values represented by dots and interquartile range represented by bars. Values above 1 indicate that bankfull depths deeper than those in 1995 while values below 1 indicate bankfull depths shallower than those in 1995. Median bankfull depths in Lower Lookout and Mack Clearcut increased after the flood of 1996 although both reaches displayed a wide range of post-flood variability. Median bankfull depths at Middle Lookout became shallower following the flood of 1996.

Bankfull channel dimensions changed after the 1996 flood, and many of these changes persisted through the end of monitoring in 2011. Overall, the 1996 flood triggered a reduction of bankfull depths at Middle Lookout, deepening of bankfull depths at Lower Lookout, minor deepening in Mack Clearcut and little change in Mack Old Growth (Figure 9). Changes varied between cross sections. The variability in magnitudes and directions of change were greater in Lower Lookout and Mack Clearcut than in Middle Lookout (where most cross sections experienced a reduction in bankfull depth) or in Mack Old Growth (where most cross sections experienced minor changes, Figure 9). These changes in bankfull depths persisted over the 15 years of post-flood monitoring. At Lower Lookout, the median increase in bankfull depth from 1995 to 1996 was +46% or +29 cm. Bankfull depths then became only slightly shallower in the following 15 years at Lower Lookout. The median change in bankfull depths from 1995 to 2011 was +37% or +25 cm. At Middle Lookout, the median decrease in bankfull depth from 1995 to 1996 was -34% or -27 cm. Bankfull depths then deepened only slightly in the following 15 years. The median change in bankfull depths at Middle Lookout from 1995 to 2011 was -27% or -20 cm. At Mack Old Growth, the median increase in bankfull depth from 1995 to 1996 was only +7% or +4 cm. Bankfull depths then remained steady over the following 15 years. At Mack Clearcut, the median increase in bankfull depth from 1995 to 1996 was -20% or +8 cm. Bankfull depths then became only slightly shallower in the following 15 years. The median change in bankfull depths at Middle Lookout from 1995 to 2011 was -16% or +7 cm. (Figure 9).

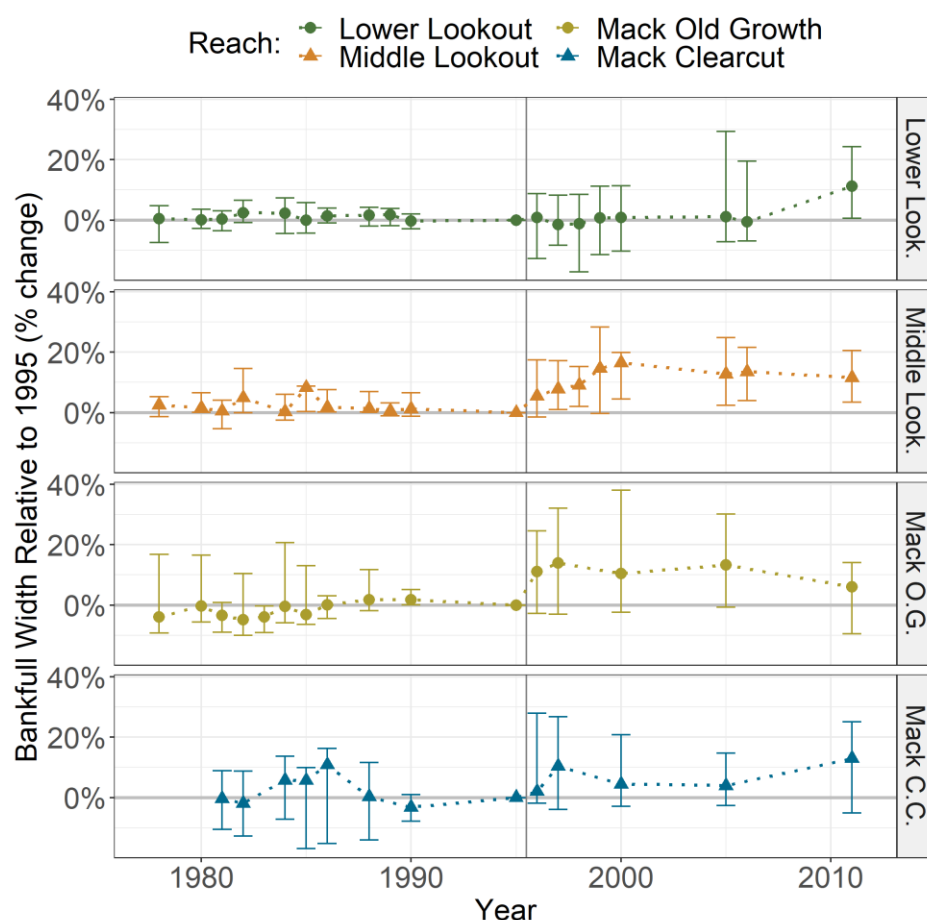
Figure 10: Bankfull widths as a ratio relative to the 1995 values at each reach. Median values represented by dots and interquartile range represented by bars. Lower Lookout shows stable median values from the start of monitoring through the mid-2000s, while Middle Lookout and Mack Old Growth show widening bankfull widths for several years following the 1996 flood. Mack Clear Cut displays fluctuating bankfull widths throughout the full time series.

Patterns in bankfull width adjustment after the 1996 flood differed from patterns in bankfull depth adjustment. At Lower Lookout, median bankfull widths did not change substantially between the start of monitoring in 1978 and the mid-2000s (Figure 10). However, the variability between cross sections increased following the 1996 flood. At both Middle Lookout and Mack Old Growth, bankfull widths increased over the course of several years following the 1996 flood. The variability in bankfull width also increase in these two reaches after 1996 (Figure 10). Middle Lookout reached an increase of 4.4 m or 17% between 1995 and 2000, and Mack Old Growth reached an increase of 1.6 m or 10% in the same time period. Neither of these reaches narrowed back to their pre-flood widths by the end of monitoring in 2011 (Figure 10). Mack Clearcut also showed some post-flood narrowing, but the scale and variability of the change at this reach was not unique to this time period matching patterns displayed at that reach in the 1980s (Figure 10).

Additionally, the lagged responses in bankfull width and D_{50} (Figure 10, Figure 11) suggest that extreme events might place streams in a temporarily unstable configuration and make them more susceptible to additional changes. While there are fluvial and hydraulic mechanisms that might account for the presence of these thresholds (e.g. bank failure, altered fluid density, loss of armoring) non-fluvial interactions cannot be ignored. Patterns of adjustment in Lower Lookout and Middle Lookout suggest that colluvial sediment supply, the supply of instream wood, and patterns of valley confinement all have played major roles in shaping flood response. Previous work in Mack Creek in the Andrews Forest also suggests that in the absence of wood, boulders have also played a major role in shaping step-pool morphology of steep reaches (Faustini & Jones, 2003).

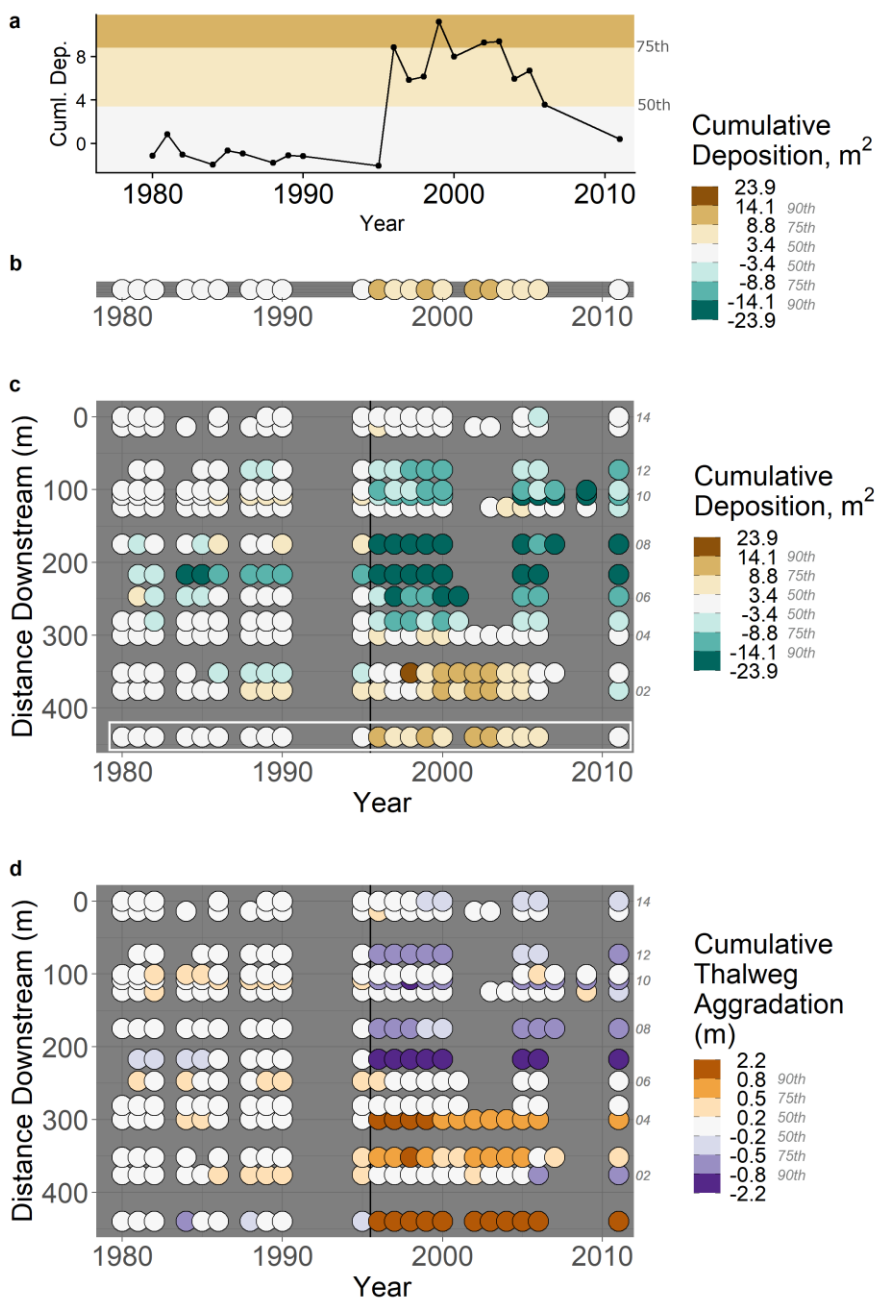
Figure 13: (a) Example of cumulative cross-sectional deposition (m^2) at a cross section (LOL01, Figure 2) over time. Black dots show values at each survey year and colored bands classify

Between 1978 and 1995, thirteen out of fourteen cross sections showed minimal changes of less than 8.8 m^2 (the 75th percentile of total change) in either direction of cumulative deposition (Figure 13c). The two cross sections within 20 m of the top of the reach continued to show minimal change throughout the monitoring period. In contrast, seven out of the eight cross sections near the river bend showed net scouring between 1995 and 1996. This scouring trend persisted over time, and by 2011 all eight of these cross sections had scoured by at least 3.3 m^2 relative to their initial conditions. In the lower sub-reach downstream of the river bend three of the four cross sections show net deposition by 1996 and all of them show net deposition by 2000. This depositional pattern mirrors the scouring seen in the cross sections directly upstream. By 2011, scouring had reversed the depositional trends on these four cross sections. Three of the four cross sections in this downstream sub-reach had returned to levels of deposition within the pre-flood range of variation and one of the four cross sections had scoured beyond the pre-flood range at a cumulative loss of 6.5 m^2 of sediment relative to 1978 (Figure 13c).

previous thalweg observed at those cross sections. These four cross sections did not return to pre-flood thalweg elevations by 2011. Three of the four cross sections in the downstream sub-reach showed thalweg aggradation, and one of these (LOL03) returned to pre-flood thalweg elevations by 2011 (Figure 13d).

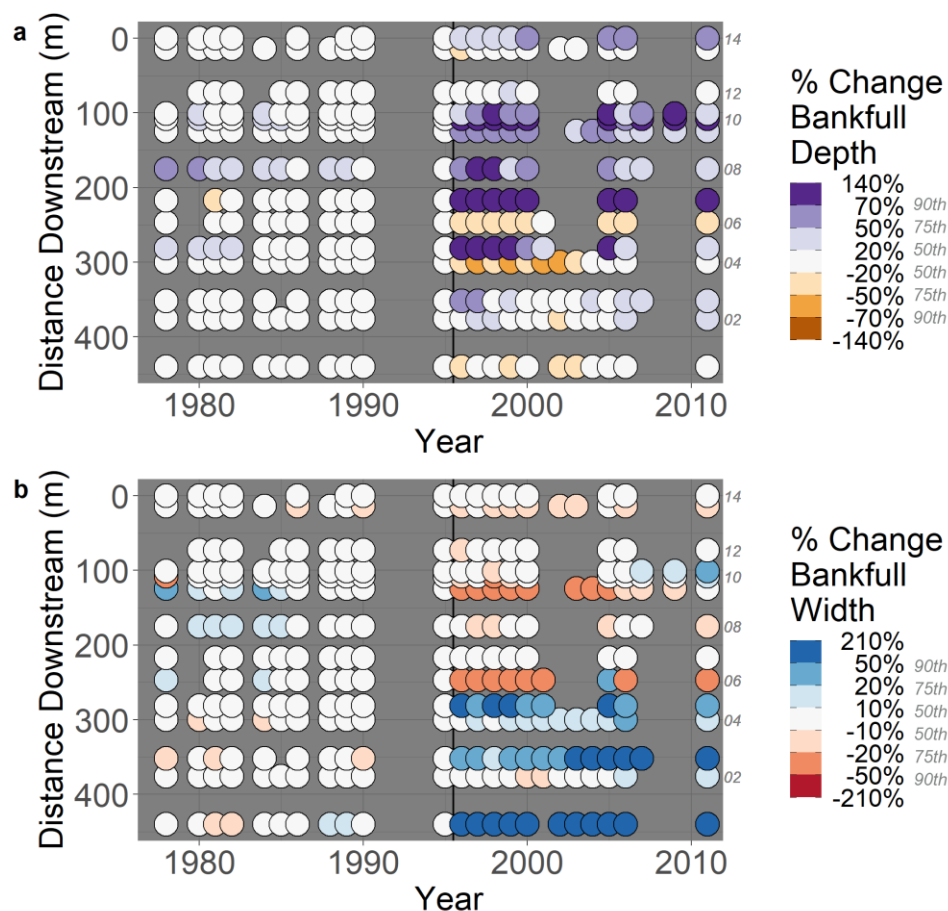
Figure 14: (a) Bankfull depths from every cross section in Lower Lookout represented as colored dots. Values are shown as percent change relative to 1995 values. The Y axis represents distance downstream from the top of the reach. Values are binned into divergent color groups based on the 50th, 75th, and 90th percentile of the absolute values of the data set. Brown colors (negative values) represent shallower bankfull depths relative to 1995 while purple colors (positive values) represent deeper bankfull depths relative to 1995. Select cross section numbers are labeled on the right axis. Percentiles are shown in italic text in the legend. (b) Bankfull widths from every cross section in Lower Lookout represented as colored dots. Values are shown as percent change relative to 1995 values. Red colors (negative values) represent narrower bankfull widths relative to 1995 while blue colors (positive values) represent wider bankfull widths relative to 1995.

Between 1978 and 1995, twelve out of the fourteen cross sections varied in width by no more than 20%. While the bankfull depths generally increased near the bend and decreased downstream of the bend, the pattern was reversed for widths – bankfull widths generally decreased near the bend and increased downstream of the bed. Between 1995 and 1996, bankfull widths decreased at one out of two cross sections in the upstream subreach and decreased at six of the eight cross sections near the bend. Downstream of the bend, bankfull widths increased at all four cross sections. The increase in width downstream of the bend where substantial scour took place may represent the river widening to evacuate material (Figure 14).

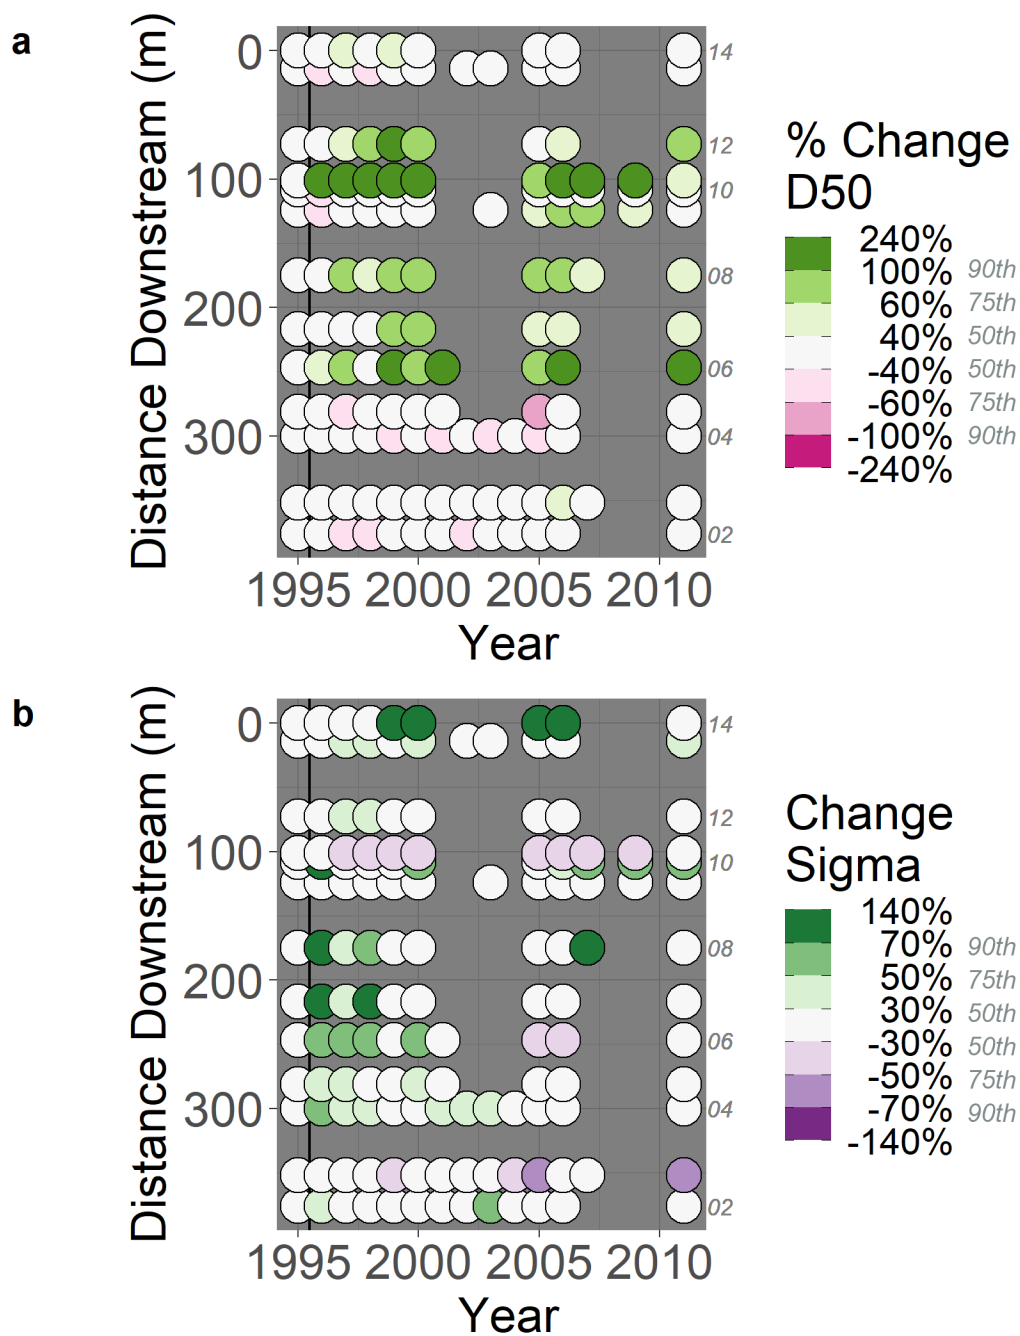
Figure 15: (a) D_{50} from every cross section in Lower Lookout represented as colored dots. Values are shown as percent change relative to 1995 values. The Y axis represents distance downstream from the top of the reach. Values are binned into divergent color groups based on the 50th, 75th, and 90th percentile of the absolute values of the data set. Magenta colors (negative values) represent finer median grain sizes relative to 1995 green colors (positive values) represent coarser median grain sizes relative to 1995. Select cross section numbers are labeled on the right axis. Percentiles are shown in italic text in the legend. (b) σ_ϕ from every cross

Spatial patterns of grain sorting differed slightly from the patterns in sediment storage, bankfull geometry, and median grain size. While most changes in sediment storage and bankfull geometry occurred between sections LOL05 and LOL12, the largest changes in sorting occurred slightly downstream at cross sections LOL04–LOL08. This is the straighter section of the reach below the river bend. In this region, sediment became less sorted by at least 30% at all cross section between 1995 and 1996, while only two of the eight other cross sections showed changes in sorting greater than 30%. However, adjustments to sorting did not persist over time. By 2011 ten out of thirteen cross sections (LOL01 was not sampled in 1995) in the reach had returned to within 30% σ_ϕ of their 1995 distributions (Figure 15b).

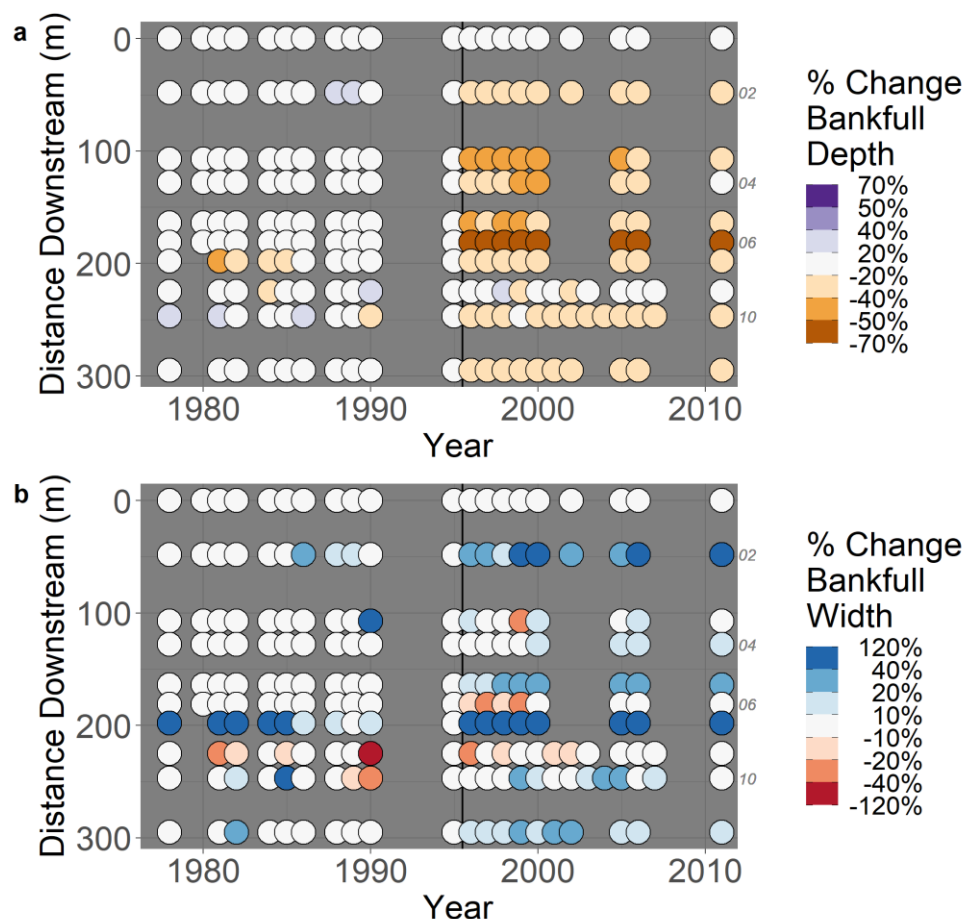
Figure 18: (a) Bankfull depths from every cross section in Middle Lookout represented as colored dots. Values are shown as percent change relative to 1995 values. The Y axis represents distance downstream from the top of the reach. Values are binned into divergent color groups based on the 50th, 75th, and 90th percentile of the absolute values of the data set. Brown colors (positive values) represent shallower bankfull depths relative to 1995 while purple colors (negative values) represent deeper bankfull depths relative to 1995. Select cross section numbers are labeled on the right axis. (b) Bankfull widths from every cross section in Lower Lookout represented as colored dots. Values are shown as percent change relative to 1995 values. Red colors (positive values) represent narrower bankfull widths relative to 1995 while blue colors (negative values) represent wider bankfull widths relative to 1995.

The reach accommodated the reduction in bankfull depth via widening. However, changes in bankfull width do not spatially coincide with the changes in depth and sediment storage. Cross sectional profiles suggest dynamic changes to bankfull width before 1995 in at least three cross-sections (LOM07, LOM08, and LOM10). From 1995 to 1996, five out of ten cross sections widened by at least 10% while two out ten narrowed by at least 10%. Cross-section LOM07 experienced the more dramatic relative increase in channel width of 12 m (87%) between 1995 and 1996. Between 1996 and 2011 the channel increased in width in nine out of eleven cross sections. Width adjustments in that time period ranged from -8% at LOM03 to +49% at LOM09. By 2011, five out of ten cross sections were still 14 – 90% wider than they were in 1995 (Figure 18).

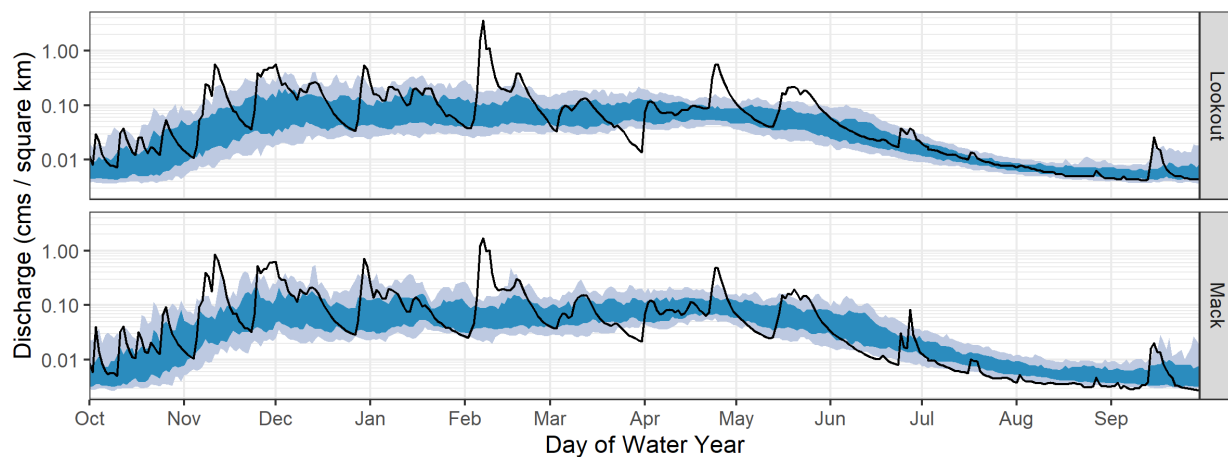
Figure A.1: Summary of daily maximum discharge values for the Lookout Creek gage (top) and Mack Creek gage (bottom). The 10th–90th percentile flows are shown as a light blue band. 25th–75th percentile flows are shown in dark blue. Daily maximum flows for the 1996 water year are shown in black.

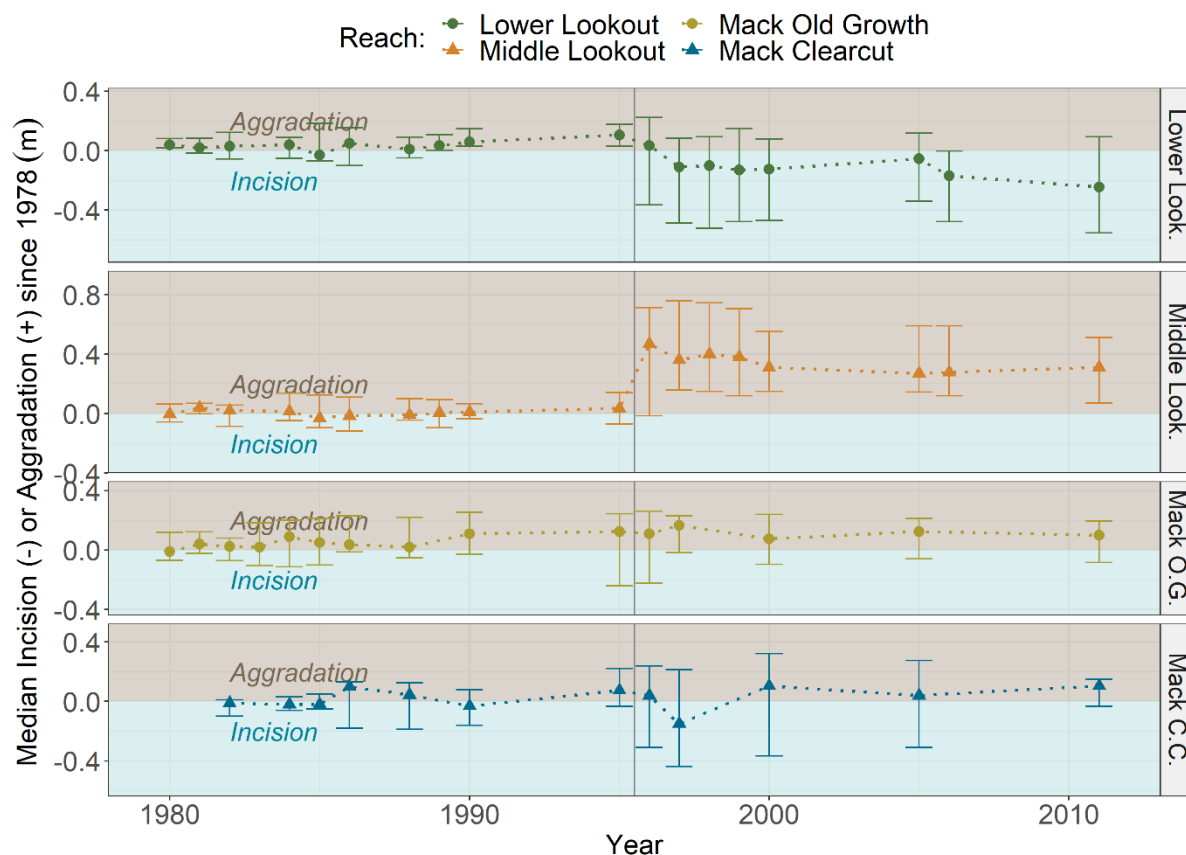
Figure A.5: Median (dots) and interquartile range (bars) of cumulative thalweg incision and aggradation relative to the start of monitoring in 1978 (or 1981 for Mack Clearcut). Points in the brown field represent cumulative aggradation while points in the blue field represent cumulative incision. Lower Lookout overall incised while Middle Lookout experienced aggradation. Median values changed very little at the Mack Creek reaches between 1995 and 1996, but the interquartile range increased after the flood of 1996. The black vertical line shows the 1996 flood.

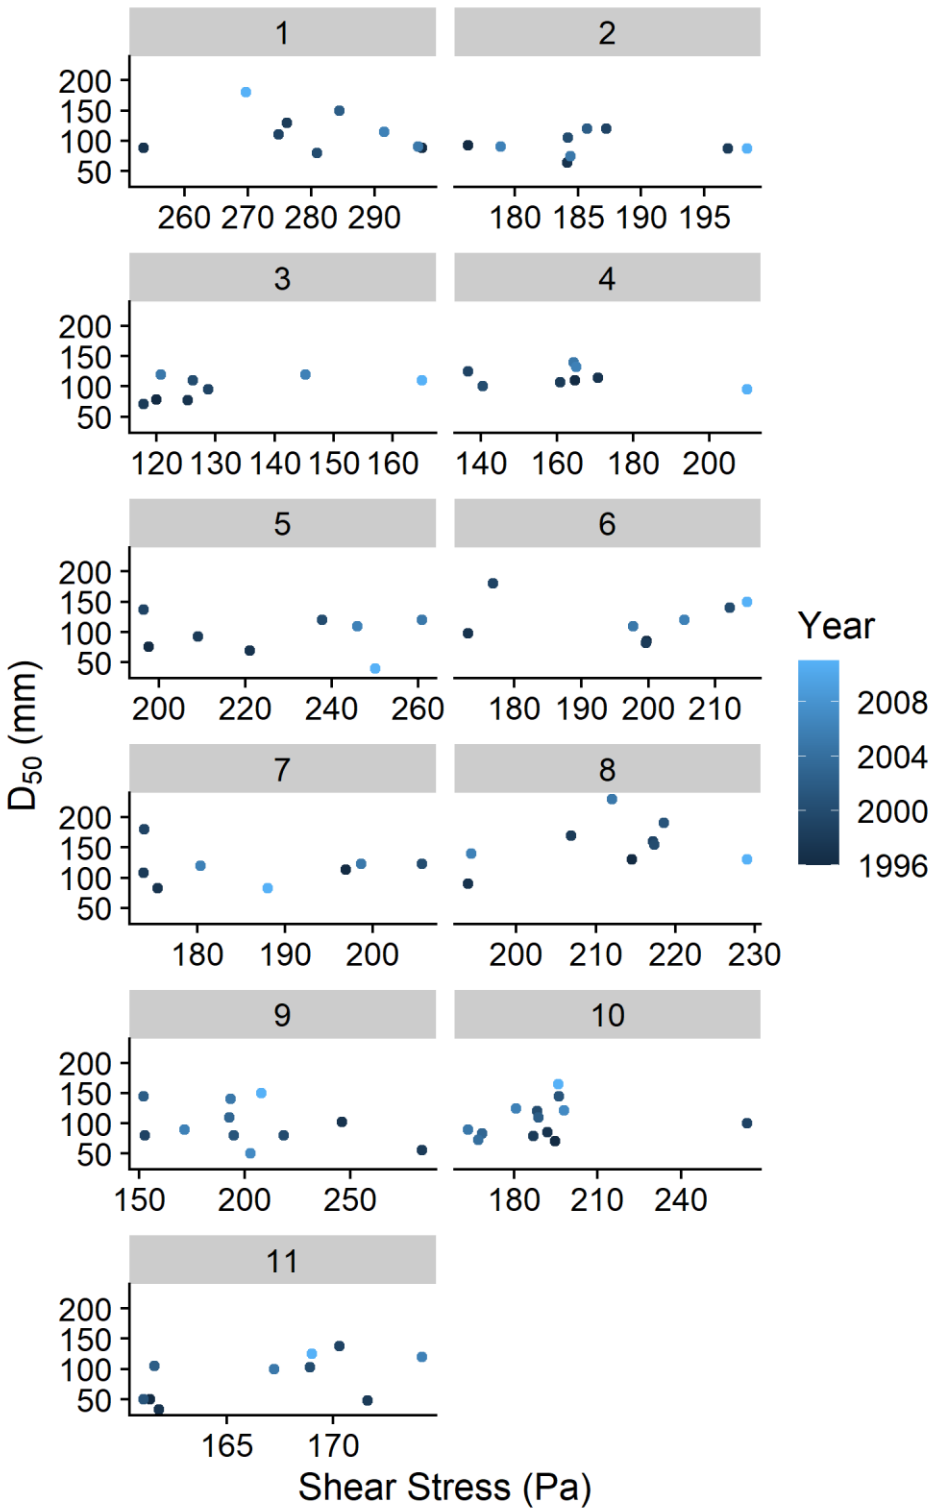
Figure A.7: Scatter plots of shear stress (Pa) versus D_{50} (mm) for each cross section in Middle Lookout. Significant relationships are seen at cross sections LOM02 and LOM03

Figure 20). The spatial discrepancy between changes in bankfull depth and changes in Shields stress may reflect a bed texture adjustment (fining) that accommodates some of the reduction in shear stress. However, D_{50} and shear stress are linearly related only at cross sections LOM02 and LOM03 ($R^2 = 0.55-0.75$, $p = 0.003-0.01$, Table A.4, Figure A.7).

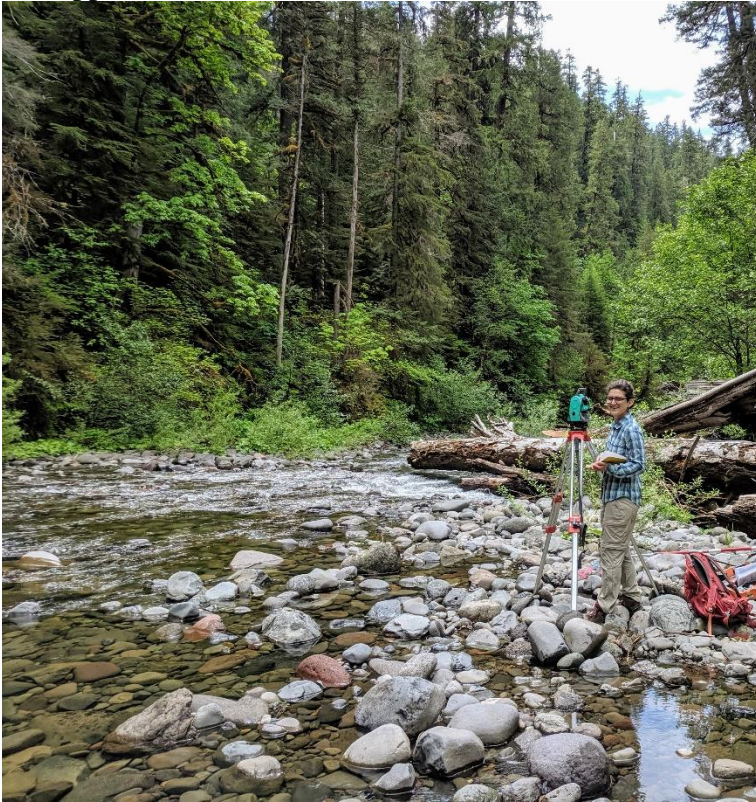
Figure B.1: Total station surveying in Lower Lookout during summer 2019

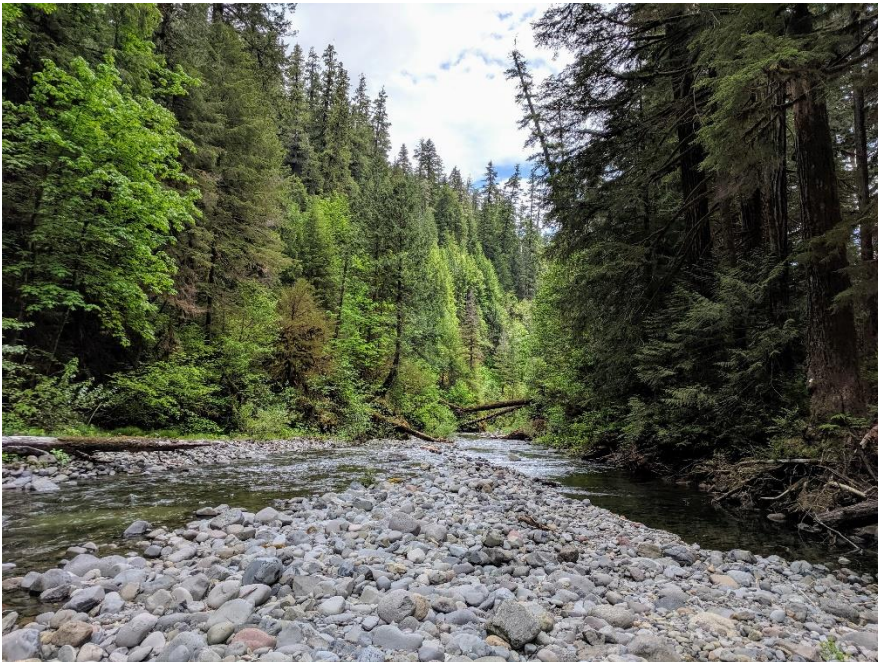
Figure B.2: Midchannel bar visible at low flow in Lower Lookout during summer 2019

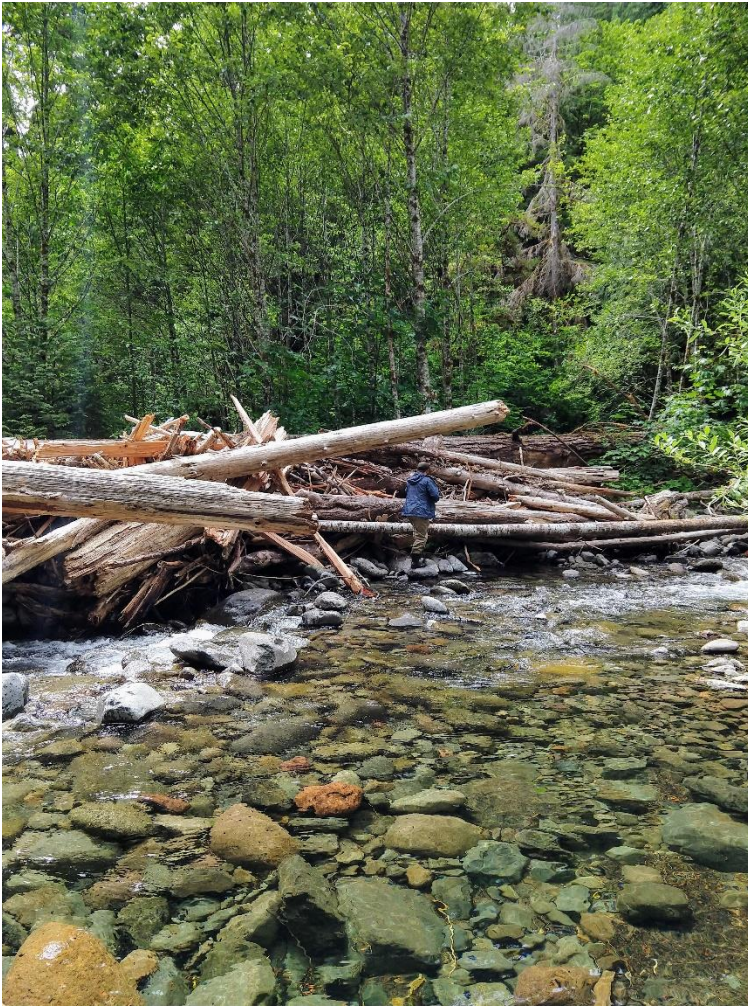
Figure B.3: Large channel-spanning wood jam in Lower Lookout near channel bend during summer 2019

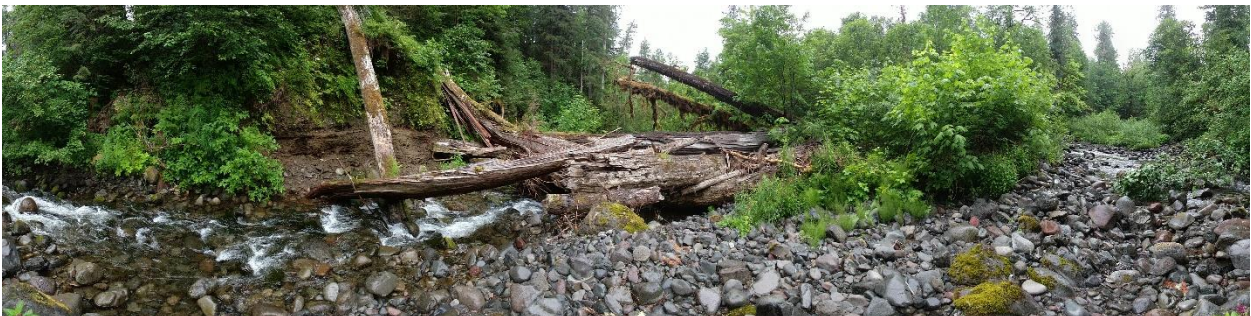
Figure B.4: Channel-spanning wood jam in Middle Lookout near LOM08 during summer 2019

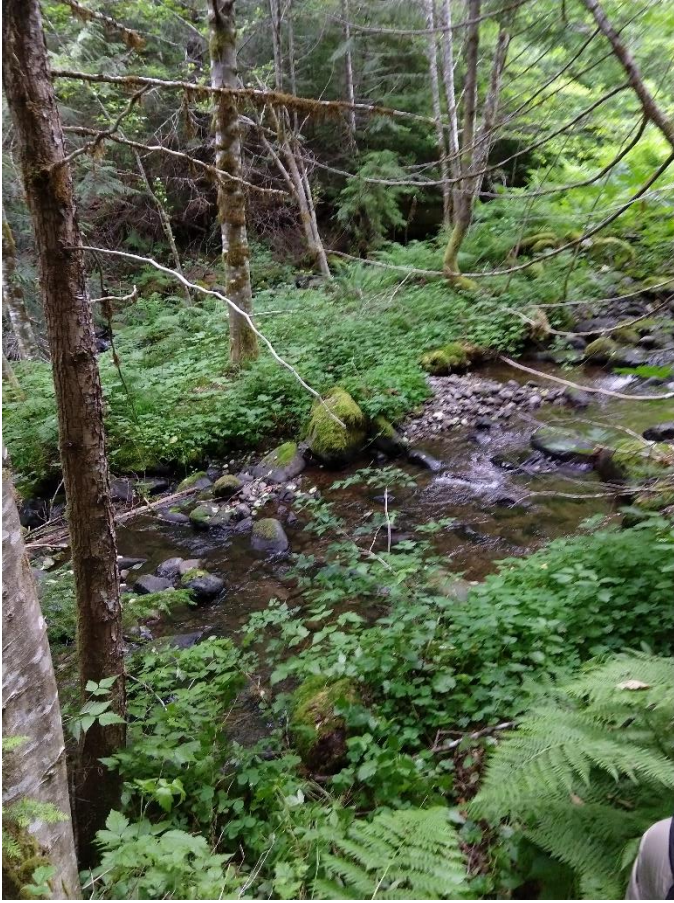
Figure B.5: Boulders in stream near Mack Clearcut during summer 2019

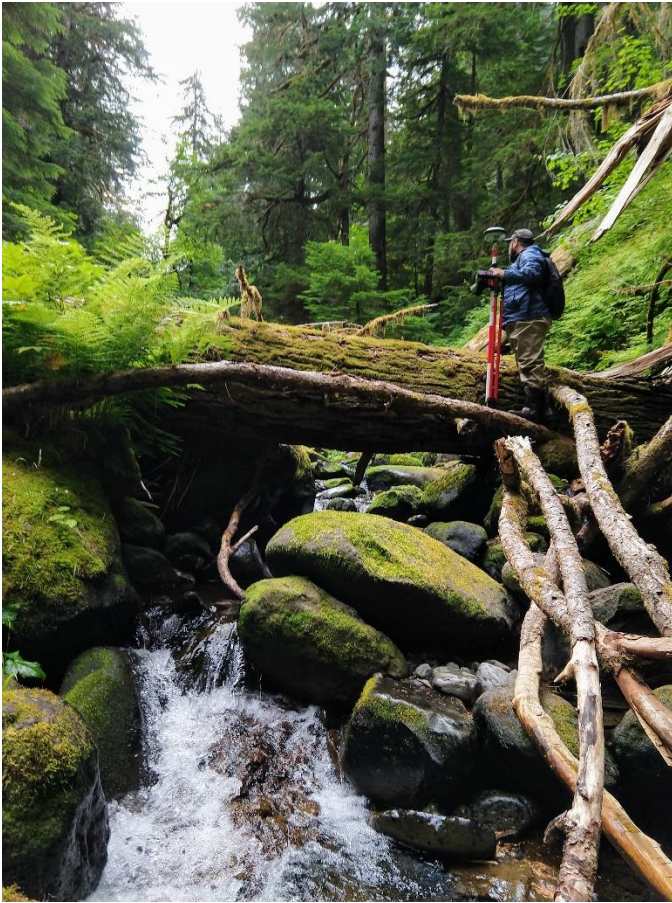
Figure B.6: Field assistant holding RTK GPS unit above channel spanning logjam at Mack Old Growth near cross section MAC07
