Hydrogeomorphic response of steep streams following severe wildfire in the Western cascades, Oregon

David M. Busby | Andrew C. Wilcox

Department of Geosciences, 32 Campus Drive, University of Montana, Missoula, Montana, USA

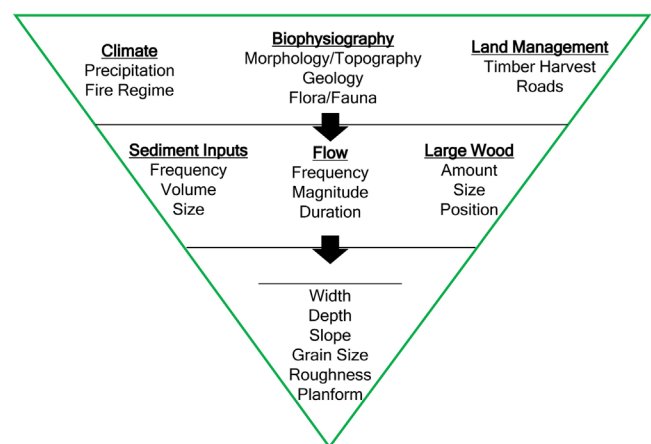
FIGURE 1 Conceptualization of the tiered controls on steep stream morphology. Wildfire influences steep-stream morphology via its effect on sediment, flow, and wood regimes. Specific attributes of the fire regime (e.g. burn severity), post-fire precipitation (timing, magnitude, and intensity), biophysiology (e.g., vegetation regeneration rates, hillslope gradient), and human interventions will govern the extent to which the balance of sediment supply and transport capacity shifts following wildfire, and in turn the potential for geomorphic adjustments.

Post-fire-hydrogeomorphic responses are highly variable across regions and watersheds due to interacting climatic, biophysiological, and anthropogenic factors (e.g. Benda & Dunne, 1997; Florsheim, O'Dowd, & Chin, 2024; Moody et al., 2013; Shakesby & Doerr, 2006). Influential factors include burn severity and extent, precipitation (magnitude, duration, intensity), dominant runoff mechanisms (e.g., overland versus subsurface flow), channel and basin morphology (e.g., gradient, confinement), vegetation (type, coverage, rate of regrowth), soils (type, thickness), lithology, and land management (e.g., timber harvest, road construction) (Swanson, 1981; Sidle, Pearce, & O'Loughlin, 1985; McNabb & Swanson, 1990; Montgomery & Buffington, 1998; Cerda & Doerr, 2005; Shakesby & Doerr, 2006; Moody et al., 2013; Vieira et al., 2015; Ebel et al., 2023; Figure 1).

Our observations shed light on the influence of tiered controls on the hydrogeomorphic responses to wildfire (Figure 1). The high burn severity of the 2020 fires, steep topography, and high long-term mean annual precipitation of study basins (Table 1) suggested that these streams would be susceptible to geomorphic change from post-fire flooding and debris flows. On the one hand, the post-fire sediment-supply increases, wood recruitment, and resultant sequence of channel aggradation followed by erosion in burned reaches that we observed are consistent with previous studies of steep stream response to wildfire (e.g. Florsheim et al., 2017; Florsheim & Chin, 2024; Florsheim, Keller, & Best, 1991; Keller, Valentine, & Gibbs, 1997; Minshall, Robinson, & Lawrence, 1997). On the other

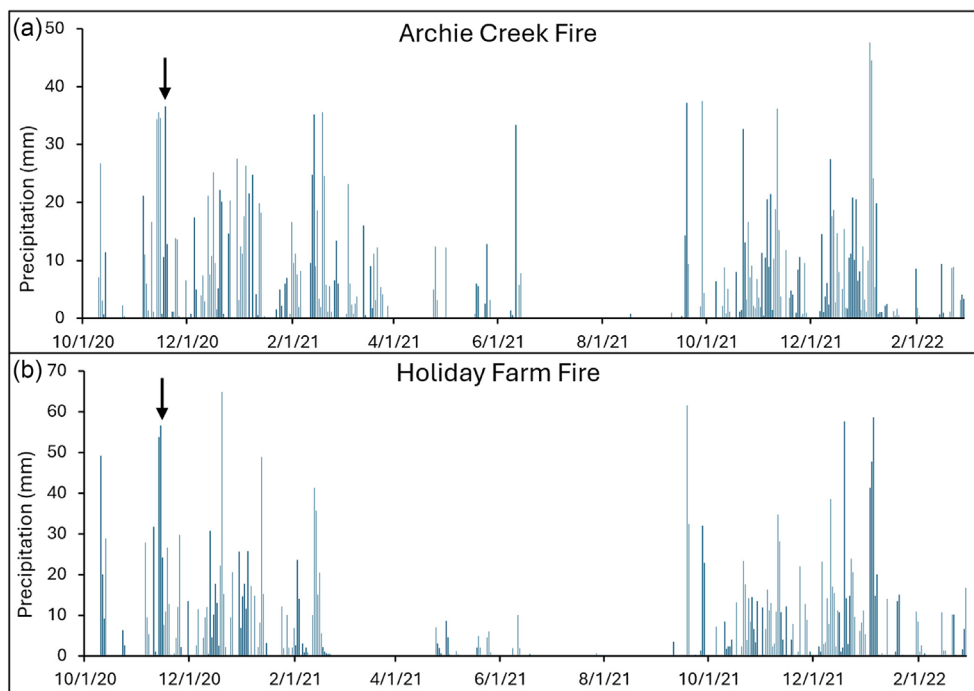
FIGURE 3 Daily precipitation during study period near (a) Archie Creek Fire (1 October 2020 to 4 November 2020 data from PRISM, 5 November 2020 to 16 September 2021 data from Archie1 tipping-bucket gage, 17 September 2021–28 February 2022 data from PRISM) and (b) Holiday Farm Fire study sites (1 October 2020 to 21 November 2020 data from USGS Cougar Dam Met Station Near Rainbow, OR, # 440752122143200, 22 November 2020 to 10 September 2021 data from Holiday4 tipping-bucket gage, 11 September 2021 to 28 February 2022 data from USGS Blue River Dam Met Station near Blue River, OR, #441016122194300). Arrows denote mid-November 24-h, 58 mm (Archie Creek) and 76 mm (Holiday Farm) rain events prior to initial field surveys.

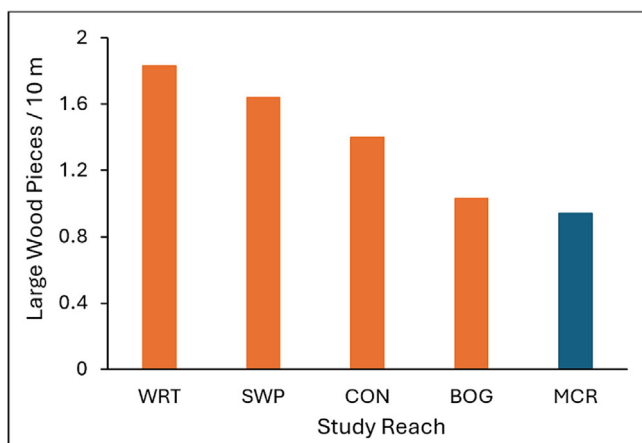
FIGURE 4 Large wood pieces per 10 m stream length in burned (orange) and unburned (blue) study reaches.

Burned areas had abundant downed wood on hillslopes, in riparian areas, and in streams. We measured between 1.0 (BOG) and 1.8 (WRT) pieces of large wood per 10 m stream length in burned reaches (Figure 4); 85% of these pieces were partially or completely burned. We recorded slightly lower wood loading, 0.9 pieces per 10 m, in the unburned study reach, MCR, where all pieces showed signs of decay and did not appear to be recently recruited to the channel. About a third (29%) of large wood pieces formed channel-spanning jams in WRT, SWP, and CON; no jams were observed in BOG. Pieces that were not in jams were ramped at various angles in the channel, in some cases contributing to sediment aggradation and bar formation,

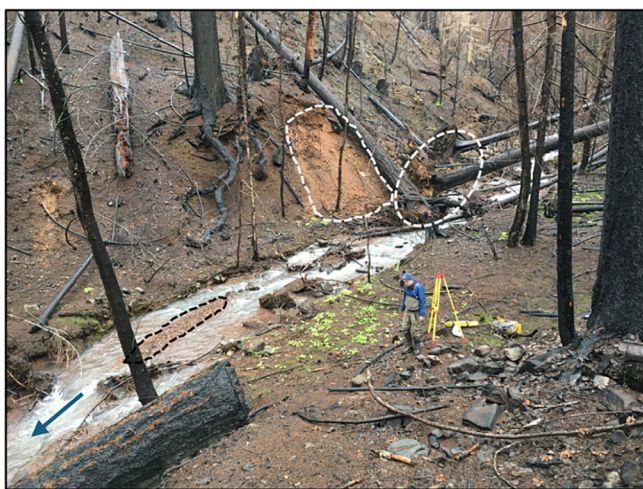
FIGURE 8 BOG study reach in December 2020, showing post-fire geomorphic change (inferred from observational evidence) including treefall, slumping, and a mid-channel gravel bar; blue arrow indicates flow direction. BOG, Bogus Creek.

BOG showed the most immediate geomorphic response to the fires. As of initial field surveys, 1.5 months after the fires, we observed a small landslide/slump along the channel margin (Figure 6), a rill and associated fan of fine to cobble-sized sediment on the floodplain just upstream of the study reach, and fresh overbank fine-sediment deposition and gravel aggradation within the channel. Based on their appearance and mobility, we infer that these erosional and depositional features are post-fire (Figures 6, 8, 9), most likely as a result of the mid-November 2021 precipitation event described above. Gravel aggradation in BOG mostly persisted during the first winter after the fires, and further aggradation occurred locally, but this sediment was largely eroded during the second winter rainy season (Figures 5, 9).

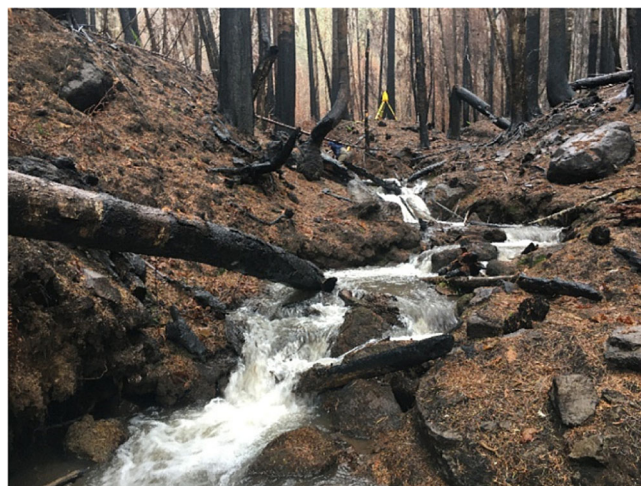
FIGURE 10 SWP study reach in December 2020, showing steep, entrenched, step-pool channel. SWP, Swamp Creek.

SWP, the steepest and smallest-drainage area study reach, exhibited the most continuous step-pool system, with boulder and wood steps, an entrenched channel, and undercut banks (Figure 10). The D_{50} (excluding step-forming boulders) was 3 mm 1.5 months after the fires (Table 3), suggesting substantial fine-sediment supply and fine-sediment trapping by steps and in pools. Subsequent surveys showed incision (32% increase; +0.16 m in average bankfull depth during the study, but not statistically significant) and significant bed-material coarsening over the study period (300% increase in D_{50} ; Table 3; Figure 6).

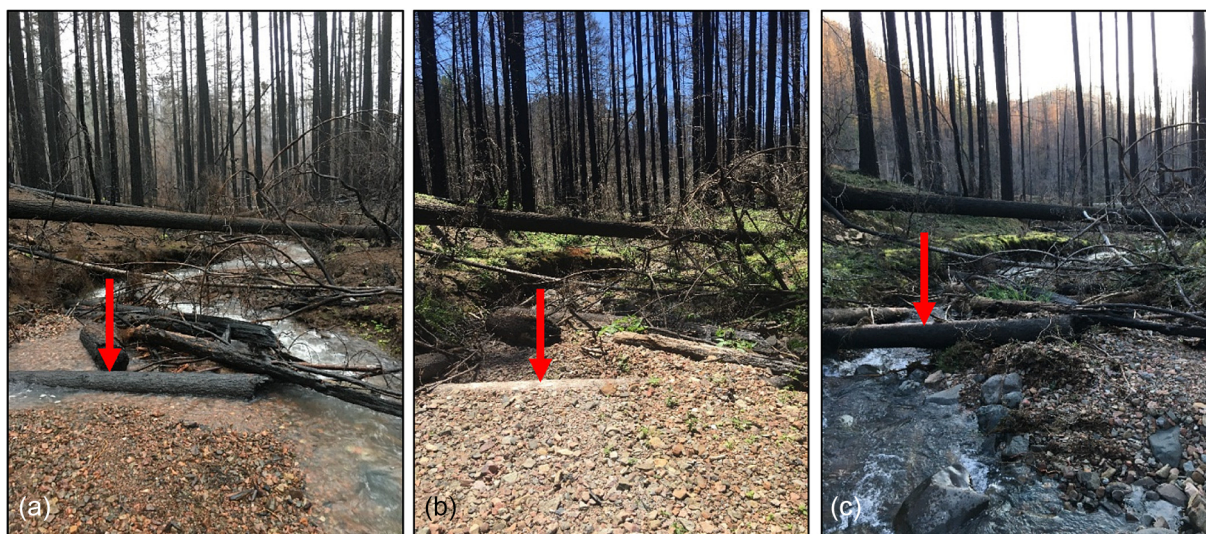
FIGURE 9 Repeat photos looking downstream in BOG study reach showing wood-forced gravel aggradation between (a) December 2020 and (b) June 2021 and erosion by (c) March 2022. Between (b) and (c), there was >0.6 m of channel incision at the location indicated by the arrow. BOG, Bogus Creek.

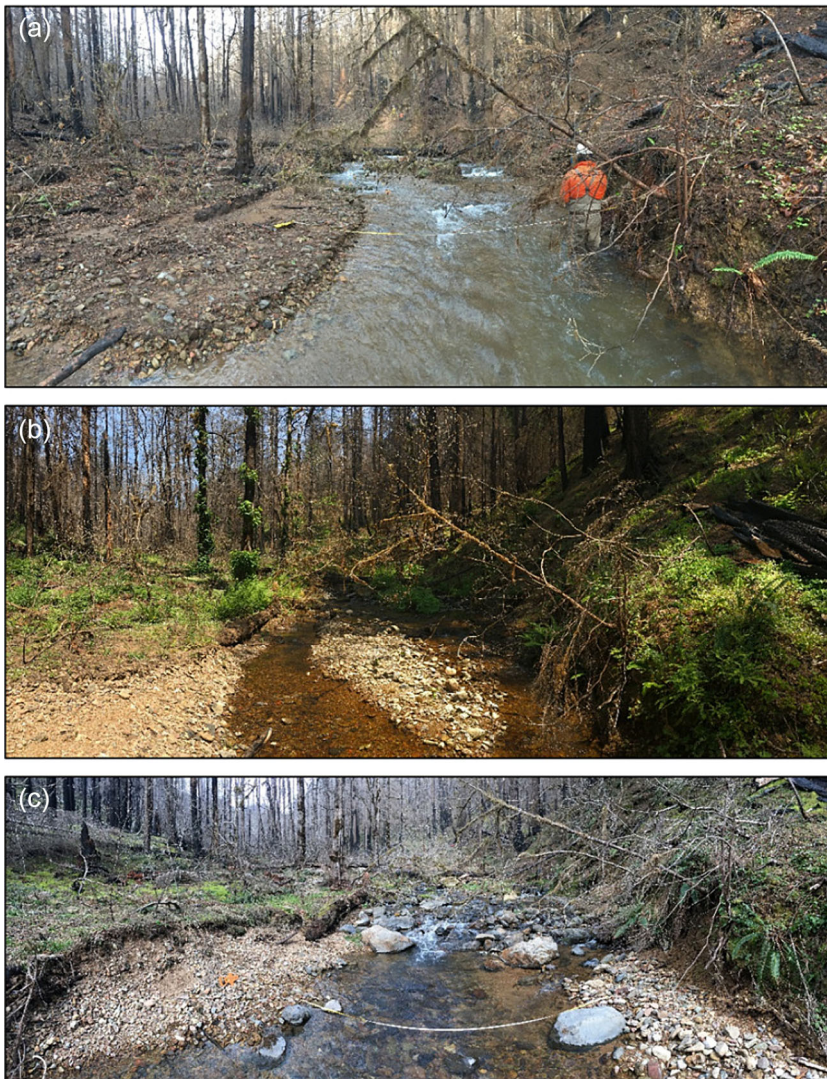
FIGURE 11 Repeat photos looking upstream in CON showing mid-channel bar formation between (a) December 2020 and (b) June 2021 and erosion by (c) March 2022, as well as bank erosion and channel widening in (c). CON, Cone Creek.

Channel conditions in CON fluctuated following the fires. Initial surveys documented what appeared to be new, post-fire marginal channel bar deposition comprising fine to cobble-sized sediment at the downstream end of CON, as well as overbank fine-sediment deposition. During the first winter rainy season after the fires, the marginal bar began to erode, and a mid-channel bar formed (by June 2021) and then eroded (by March 2022) (Figure 11). As of March 2022, bank erosion resulted in localized widening and deepening of the bankfull channel (Figure 11(c)), although reach-averaged changes were not statistically significant (Table 3). Ground photos showed substantial gravel deposition above wood jams at the upstream and downstream ends of the reach during the initial rainy season, which persisted through the second rainy season. Bed material coarsened significantly (86% increase in D_{50}) during the initial winter, and then remained consistent (Table 3; Figure 6). Two channel-margin slumps occurred at the downstream end of CON during the second winter
