A REPORT ON THE MASS WASTING (LANDSLIDE)
HAZARDS IN THE URBAN AND
URBANIZING AREAS OF
THE CITY AND BOROUGH OF JUNEAU, ALASKA

GEOPHYSICAL HAZARD INVESTIGATION
Juneau, Alaska

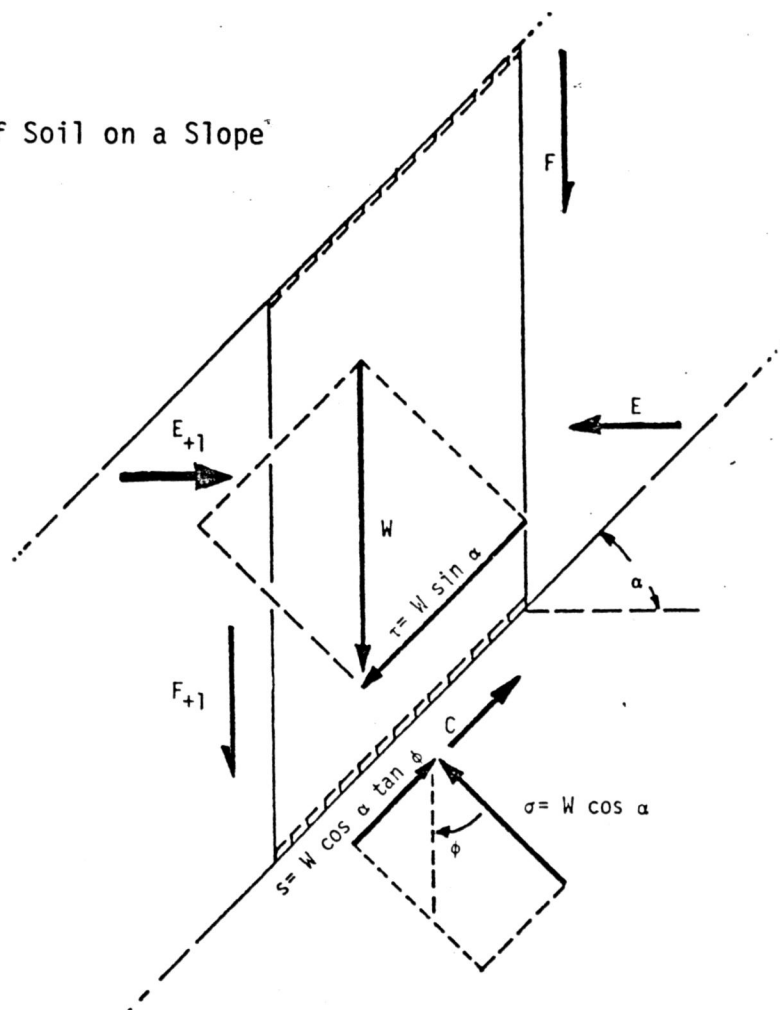
Figure 2
 Forces Acting on a Mass of Soil on a Slope

Figure 2 depicts the principal forces acting on a unit mass of soil on a slope in the Juneau area.

For simplicity, the lateral and shear forces acting on the mass are assumed equal and opposite and therefore cancel. The driving forces tending to cause downslope movement then consist of the weight of the soil mass (W) and its tangential component (τ) or shear stress. Resisting forces consist of cohesion (c)⁵ which is independent of the frictional forces and frictional resistance (s) which is proportionally related to the normal component of the soil weight ($W \cos \alpha$) through the angle of internal friction (ϕ).

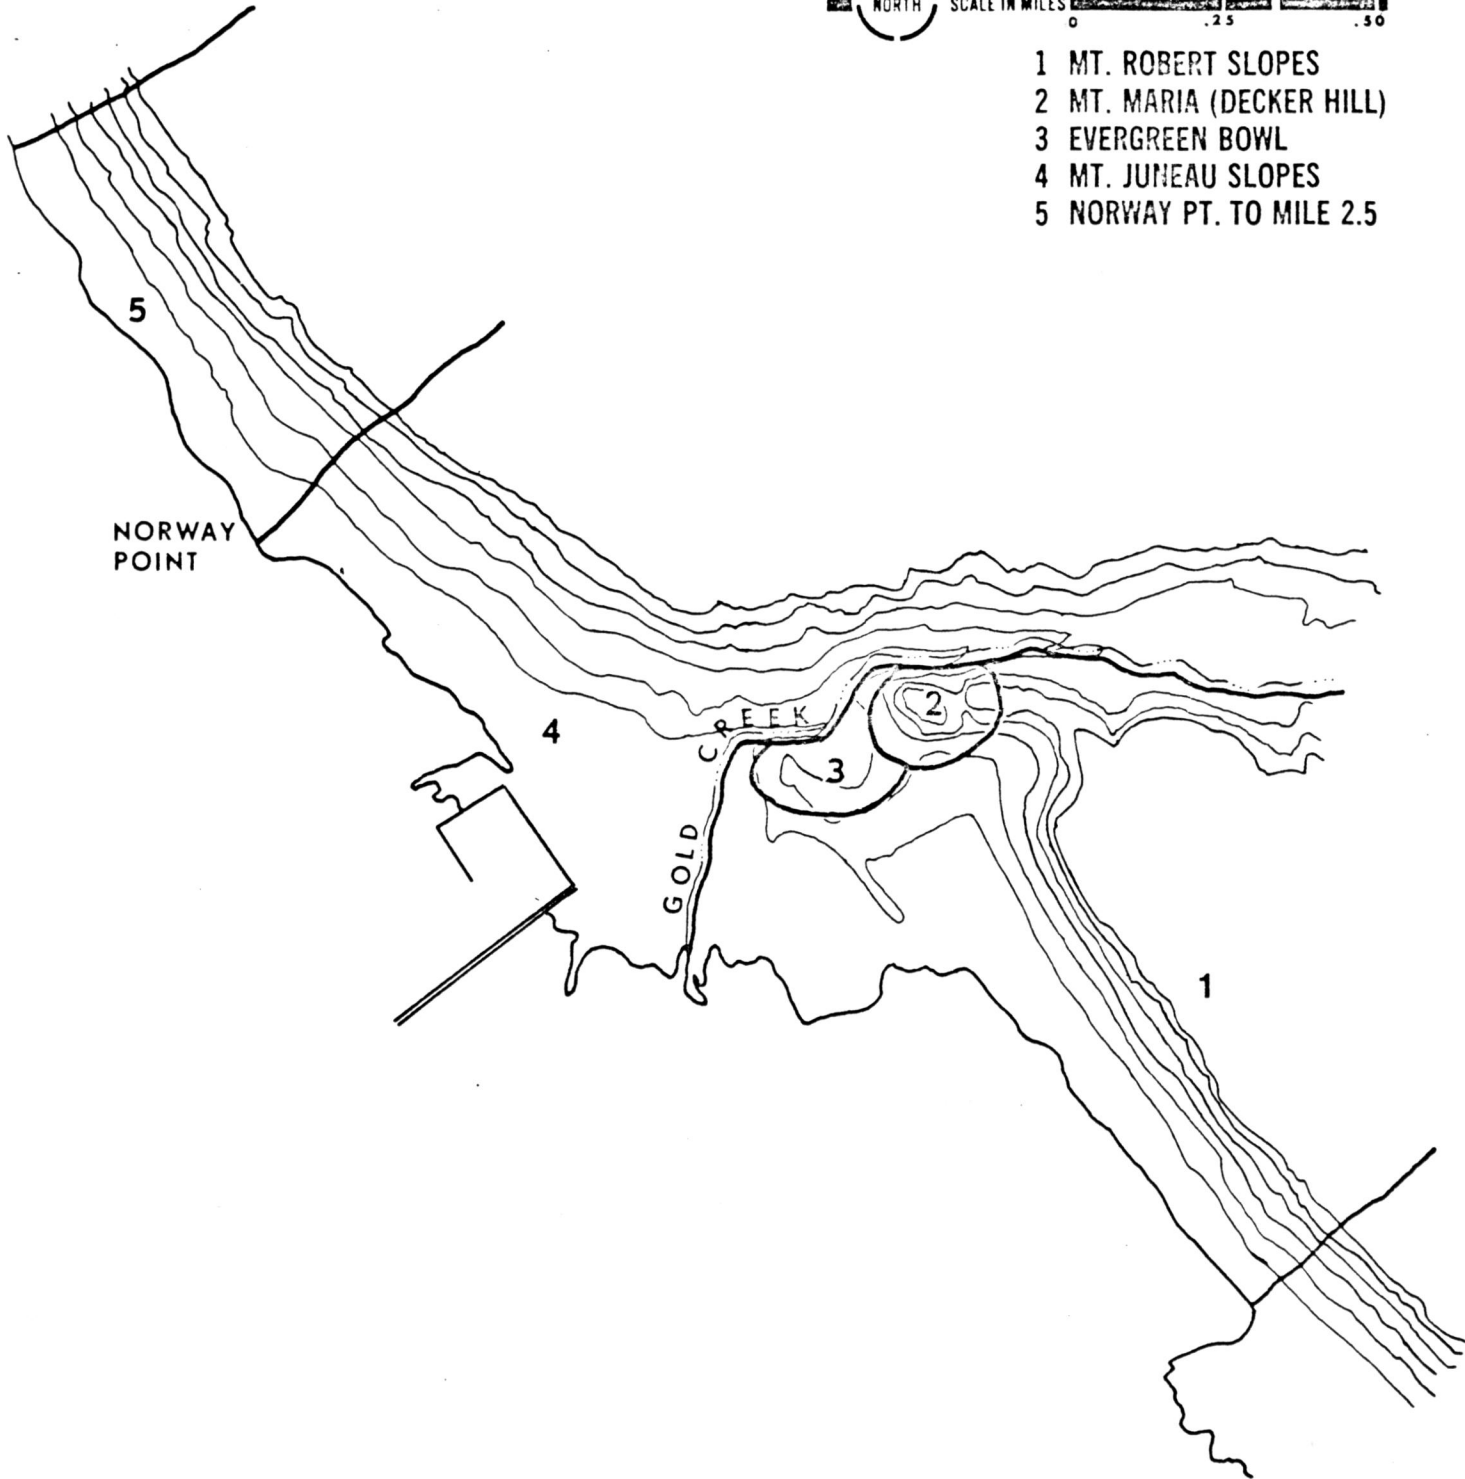
FIGURE 8

URBAN AREA SOUTH OF GOLD CREEK TO THE CITY LIMITS (See Fig. 8)

By far the most hazardous area in terms of potential destruction of property and loss of life from landslides is that area at the base of the Mt. Roberts slope extending from the corner of 3rd and Harris Streets to the beginning of Thane Road. Eleven major debris avalanche-debris flow deposits have been identified and mapped on this slope. Three of these are massive in size and occurred before Juneau settlement. The remaining eight were smaller but still destructive in size. All are identifiable on the ground and the eight post-settlement slides were well documented by local newspapers at the time of their occurrence (Appendix X).

- 1 MT. ROBERT SLOPES
- 2 MT. MARIA (DECKER HILL)
- 3 EVERGREEN BOWL
- 4 MT. JUNEAU SLOPES
- 5 NORWAY PT. TO MILE 2.5

In summary, 21 gullies have been mapped on the Mt. Roberts slope above the city; 15 identified as having a high debris avalanche-debris flow hazard. Considering the extremely steep slopes, unstable bedrock and soil conditions, numerous high hazard gullies extending directly into the urban area and its past history of landsliding, most of the Mt. Roberts slope above South Franklin Street and Gastineau Avenue must be considered as highly hazardous in terms of damage and potential loss of life from landslides.
