THE FOREST ECOSYSTEM OF SOUTHEAST ALASKA

5. Soil Mass Movement

Douglas N. Swanston

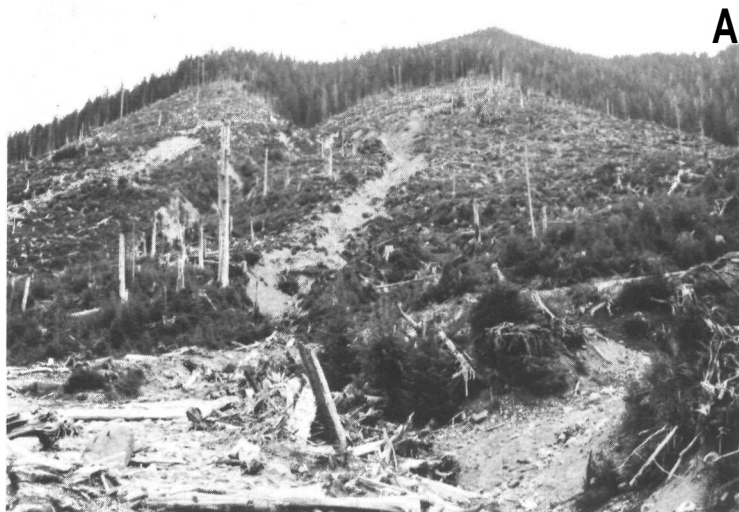
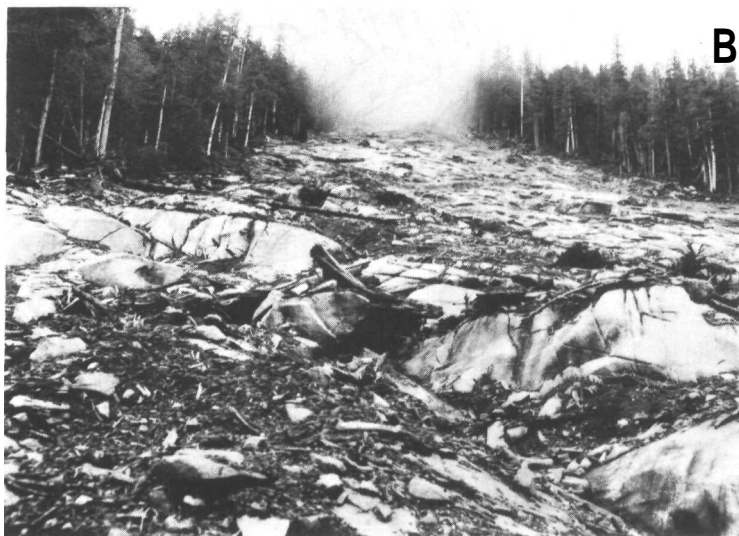
Figure 2. --Recent debris avalanches and debris flows in southeastern Alaska: A, Debris avalanche-debris flow combination developed in a shallow, glacial till soil in the Maybeso valley, Prince of Wales Island. Slope at point of initiation, 37°. B, Debris avalanche on thin, bedrock-derived soil, Martin Creek valley, mainland, Bradfield Canal. Bedrock is diorite jointed parallel to slope. Slope at point of initiation, 40°.

All these types of soil mass movement occur in varying degrees in southeast Alaska, but the great majority develop as debris avalanches and debris flows involving the rapid downslope movement of a mixture of soil, rock, and forest litter with relatively high water content (Swanston 1969) (fig. 2).

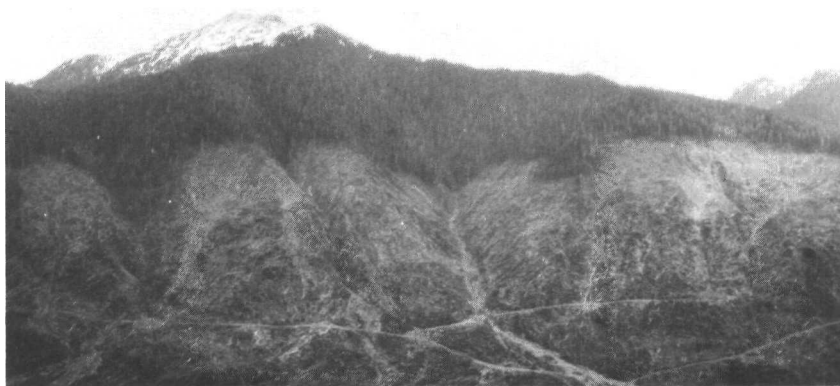
Figure 3.--Debris torrents developed in deep, V-notch side drainages to Maybeso Creek, Prince of Wales Island. All three developed initially above the cutting boundary, probably due to failure of a natural debris dam.

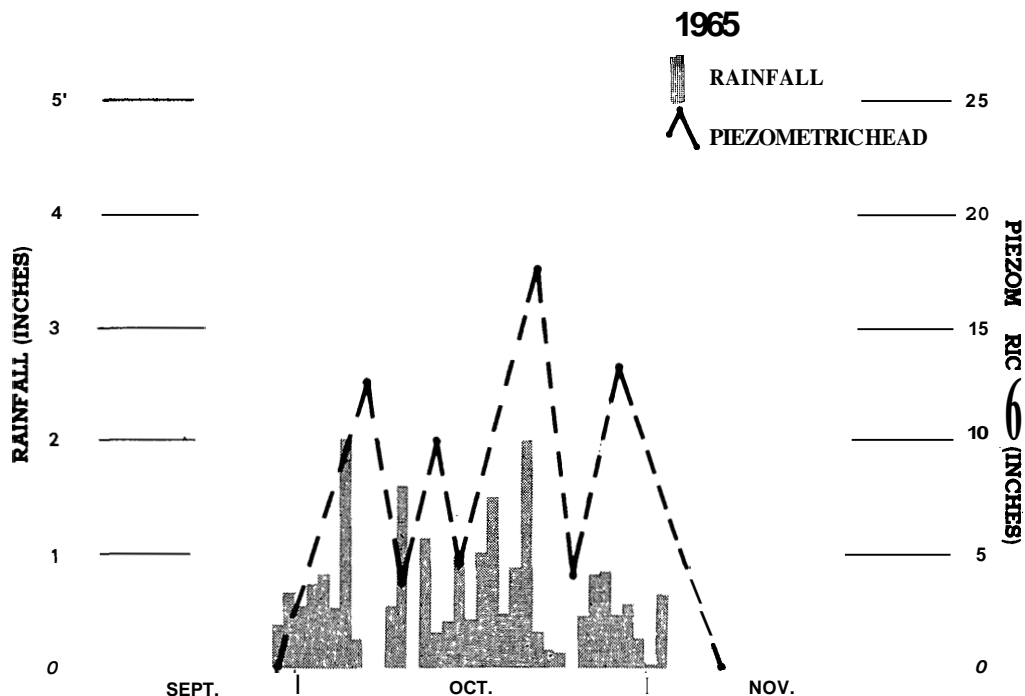
Figure 6.--Representative curve showing relationship between rainfall and piezometric head on slide prone slopes of Maybeso valley, Prince of Wales Island.

(Swanston 1967c; fig. 6) tend to verify this rapid recharge. These measurements show a close correlation between rise in ground water level and increases in rainfall. A short lag in ground water level increase occurred at the beginning of the rainy season reflecting the time necessary for soils to reach saturation after a summer of evapotranspiration, but thereafter, fluctuations in water level closely followed rainfall variations.

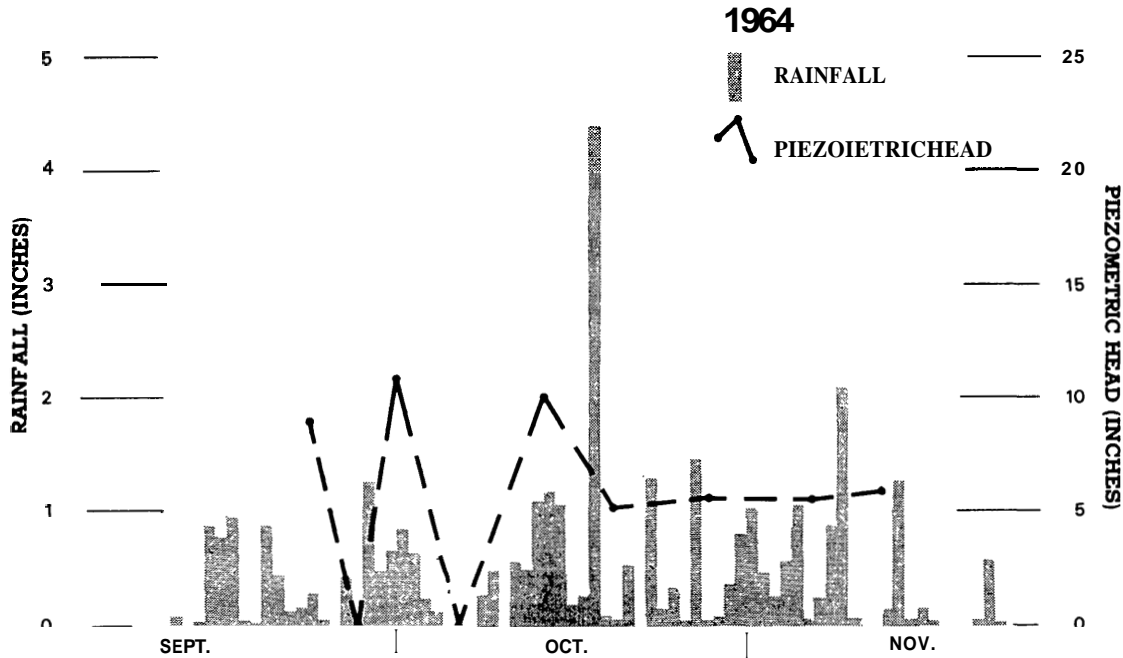
Figure 7.--Representative curve showing relationship between rainfall and piezometric head during the 1964 field season.

Snow accumulations and timing of snowmelt on the upper slopes may add substantial amounts of water to the soil--primarily through retention of rainfall in the snowpack and delayed release of large quantities of water during spring melt. Snow cover early in the fall may also reduce the fluctuations in ground water level with rainfall variations and thus indirectly reduce the maximum pore-water pressure developed in a potentially unstable soil. Again, the ground water measurements at Hollis in 1964 provide an example (fig. 7). Measurements during the fall rainy season exhibited the anticipated rapid fluctuations in water level with rainfall in September and early October; but by late October the fluctuations ceased, and the water level remained relatively constant through the remainder of the recording period. This reduction in ground water flow coincided with the appearance of a semipermanent snow cover on the slope above the measurement sites. Presumably, the snow cover intercepted a large part of the subsequent rainfall above the site and released a fairly constant amount into the soil despite subsequent major storms (Swanston 1967c).
